BRIDGE PRESERVATION REPORT

Identification of Bridge Preservation Candidates, Treatments, and Costs for Locally Owned Capital District Bridges

August 2021

Capital District
Transportation
Committee

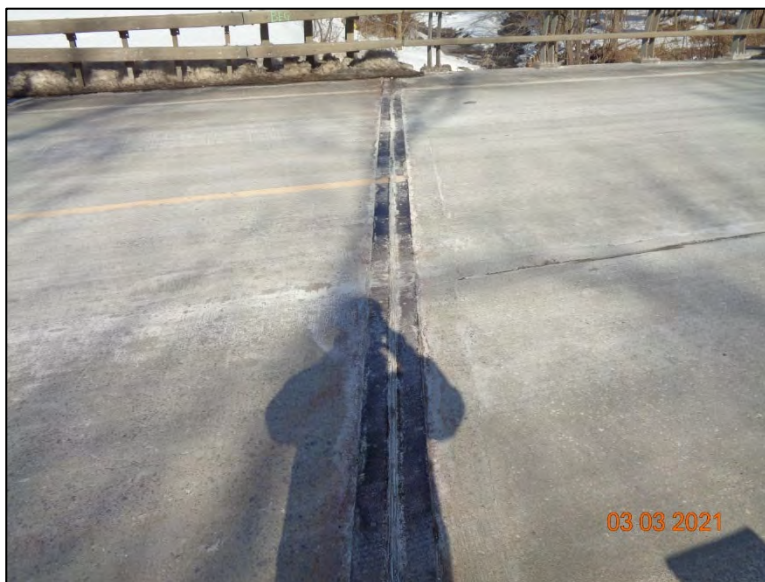
Photo 1: BIN 3301500 - Looking Towards Left Across Top of Begin Joint

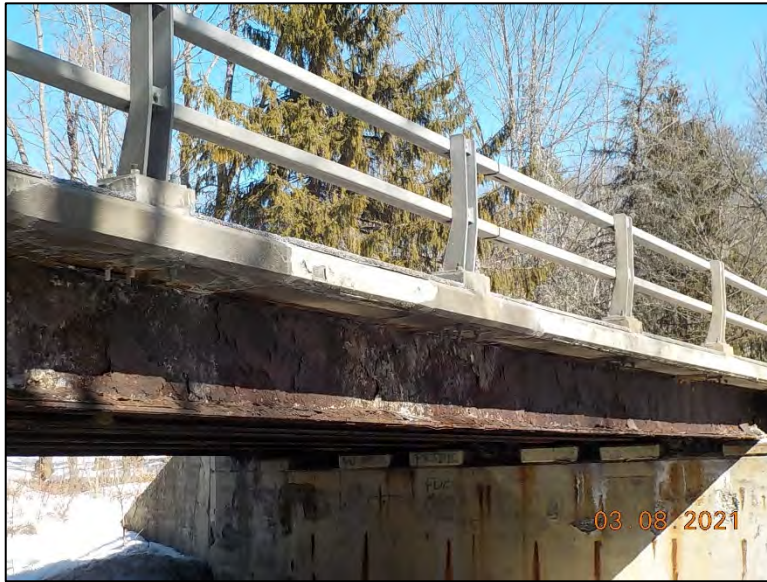
Photo 3: BIN 3304560 – Looking Towards End Left at Right Face of Girder 6

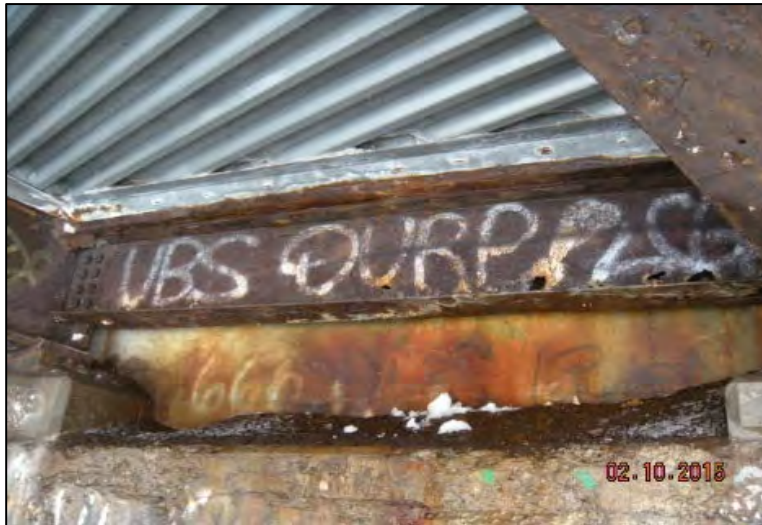
Photo 5: BIN 2203110 - End Diaphragm at Begin Abutment – Holes in Web

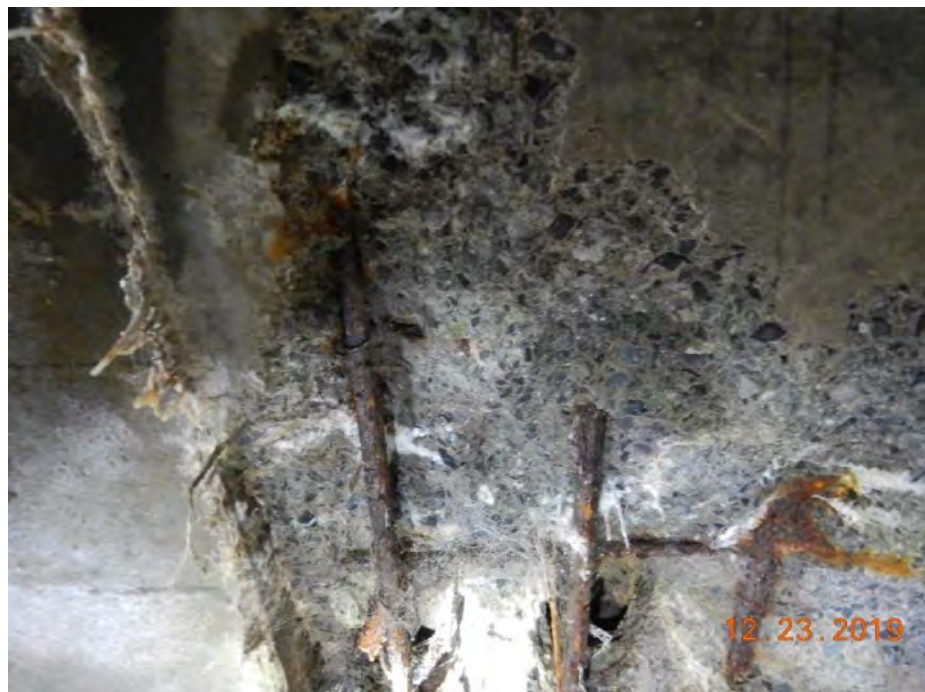
Looking at
Typical Spall in
Roof Slab of
Culvert (Photo
From 2019
Biennial
Inspection
Report)

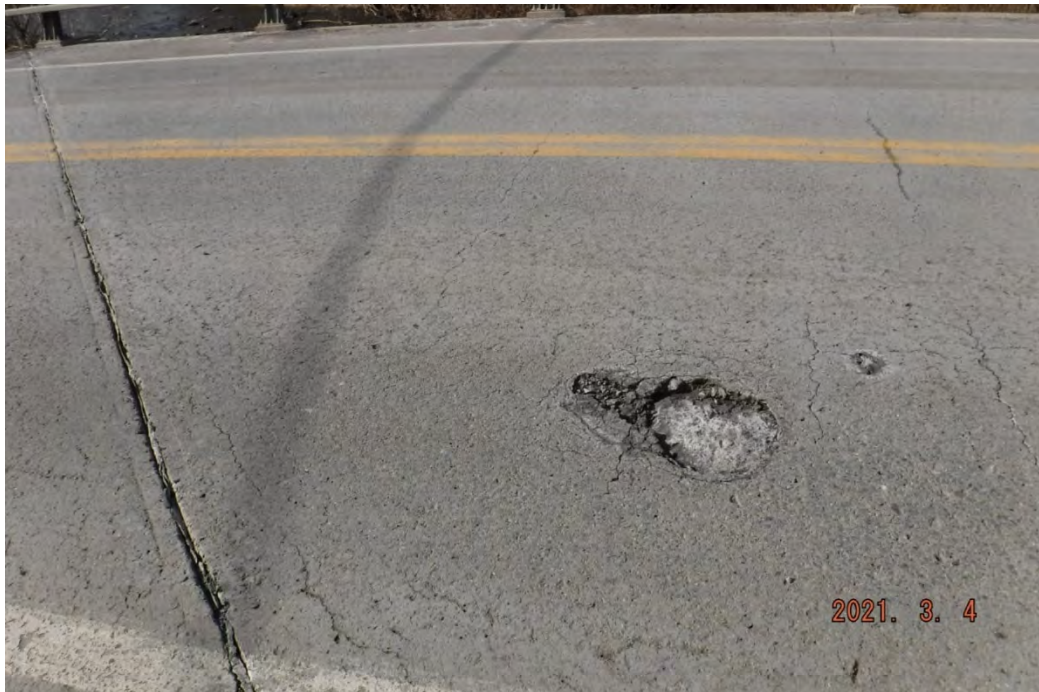
Spall near the
begin, with
some
surrounding
hollowness.

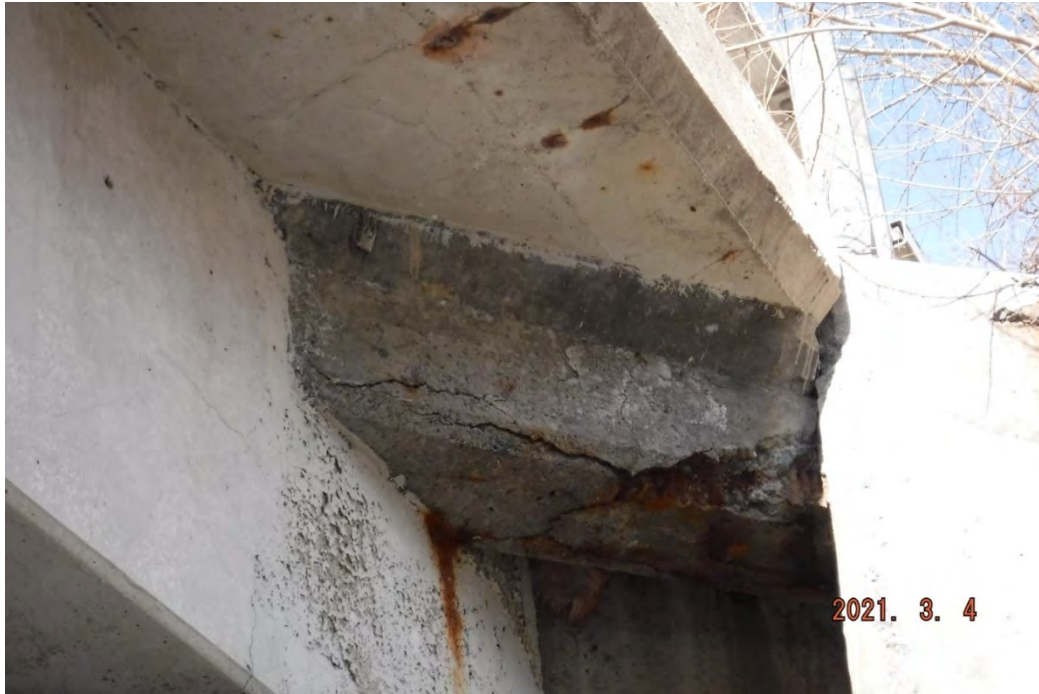
Cracking,
Spalling and
exposed rebar
with rust
staining
visible.

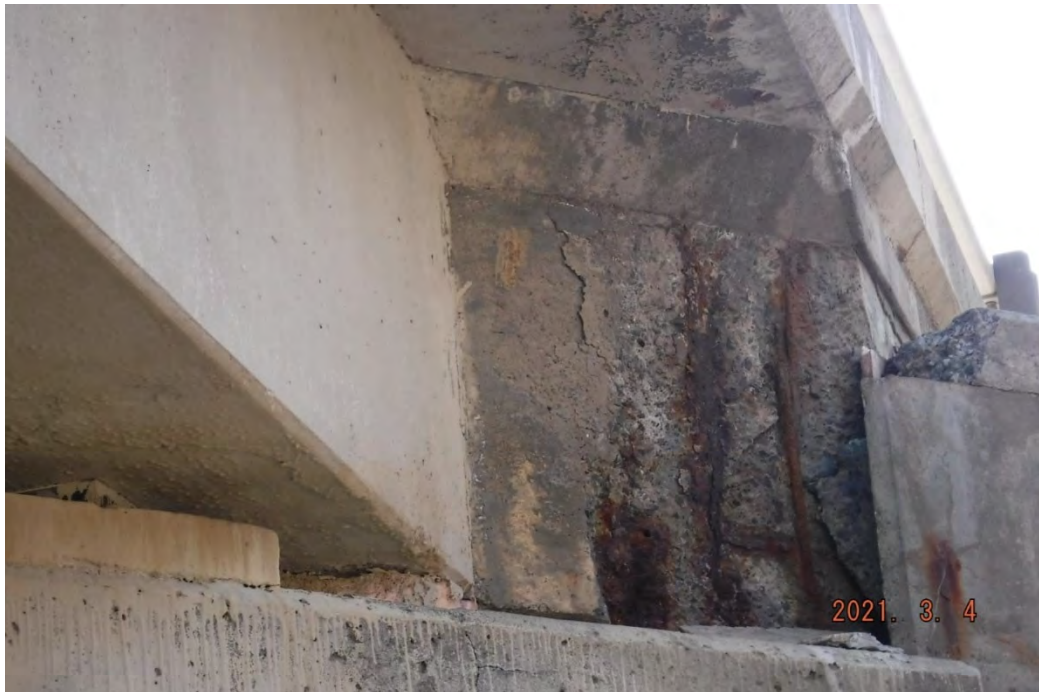
Cracking,
Spalling and
exposed
rebar. Section
loss with rust
staining
visible.

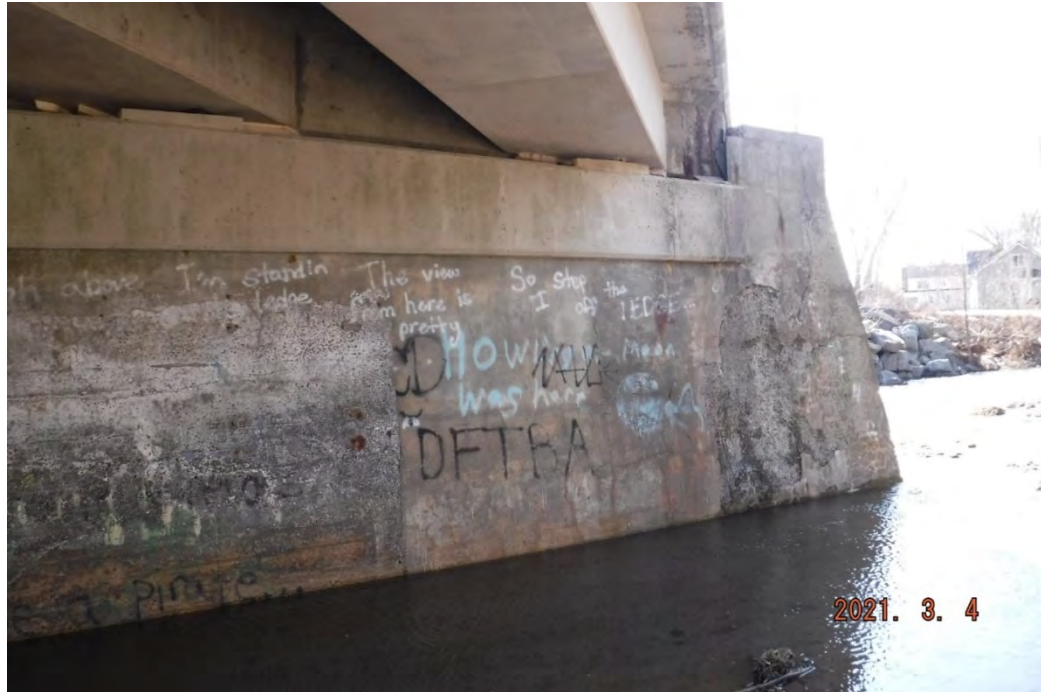
PHOTO NO:
5

Spalling

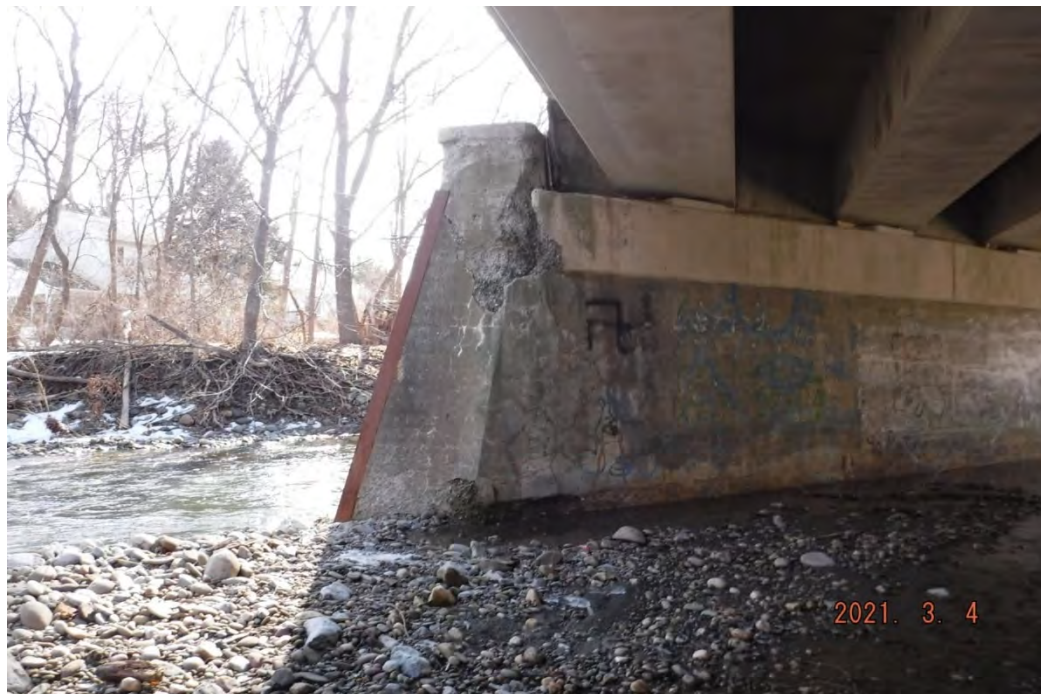
PHOTO NO:
6

Spalling

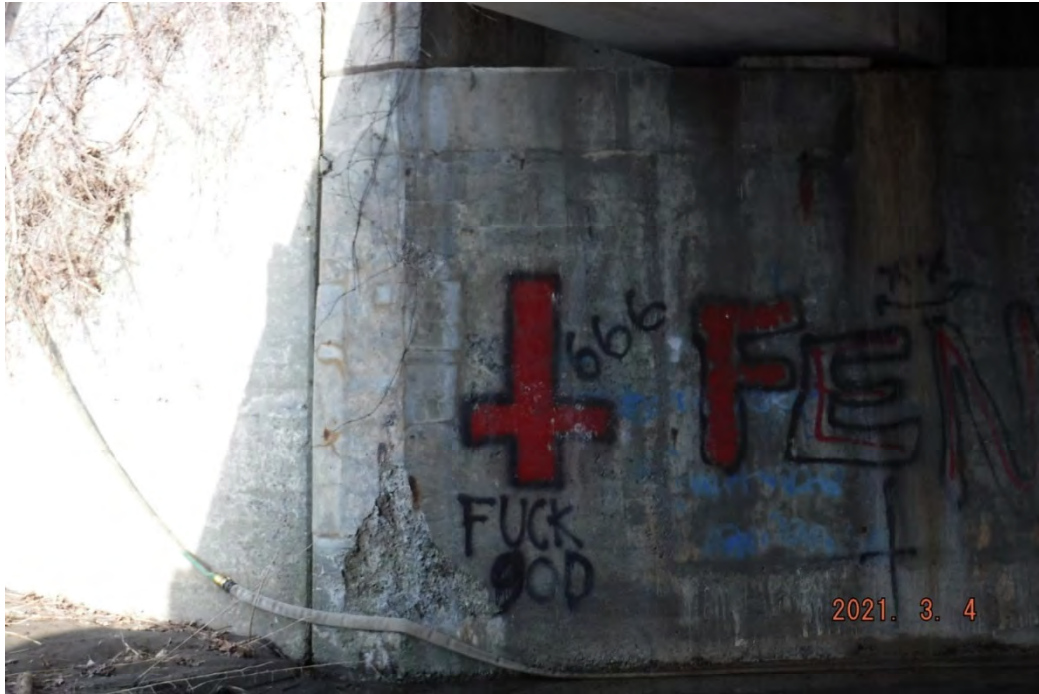
Spalling,
cracking with
some rust
staining, and
some areas of
de-
laminations/
hollowness

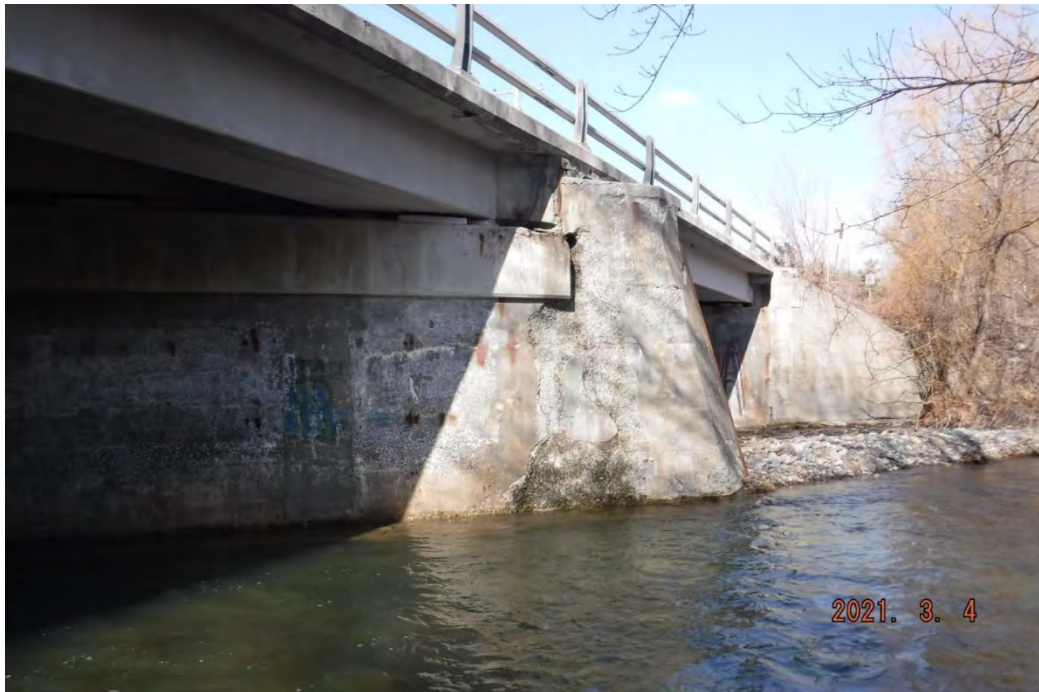
Spalling with
no exposed
rebar.

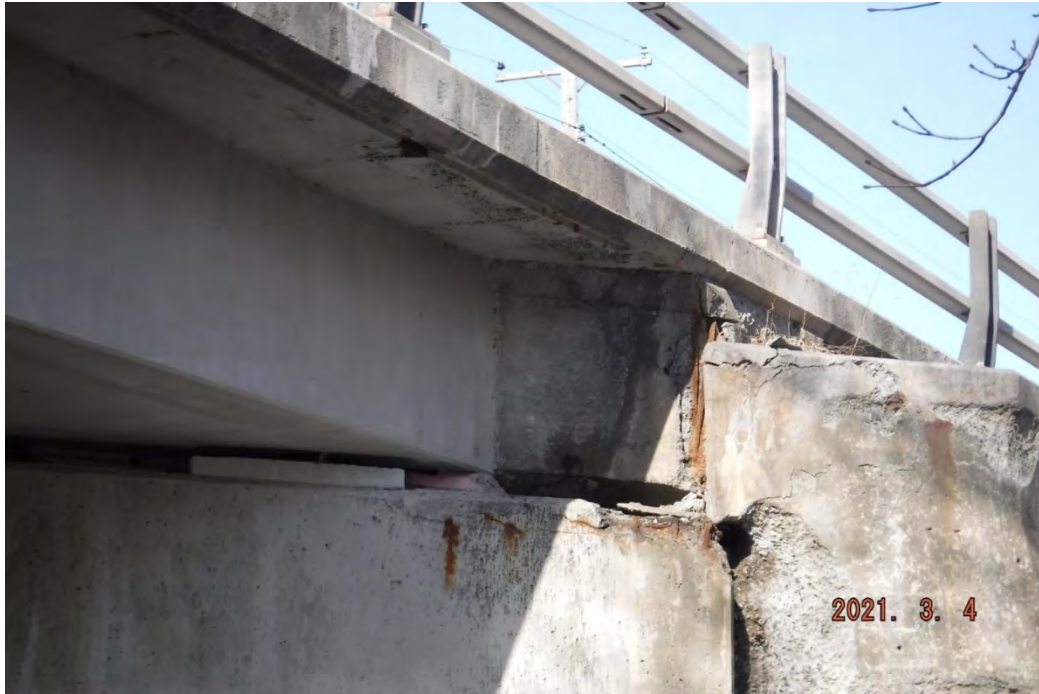
Deck support
has spalling
with cracking
and rust
staining on
the begin
face.

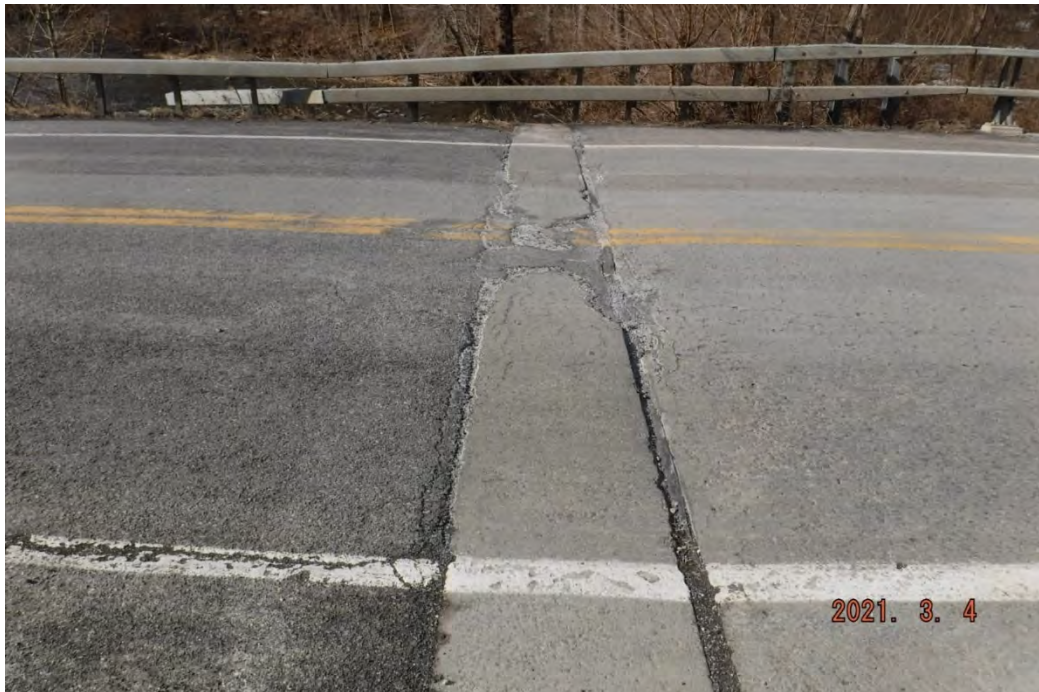
Spalling and
patchwork
exists.

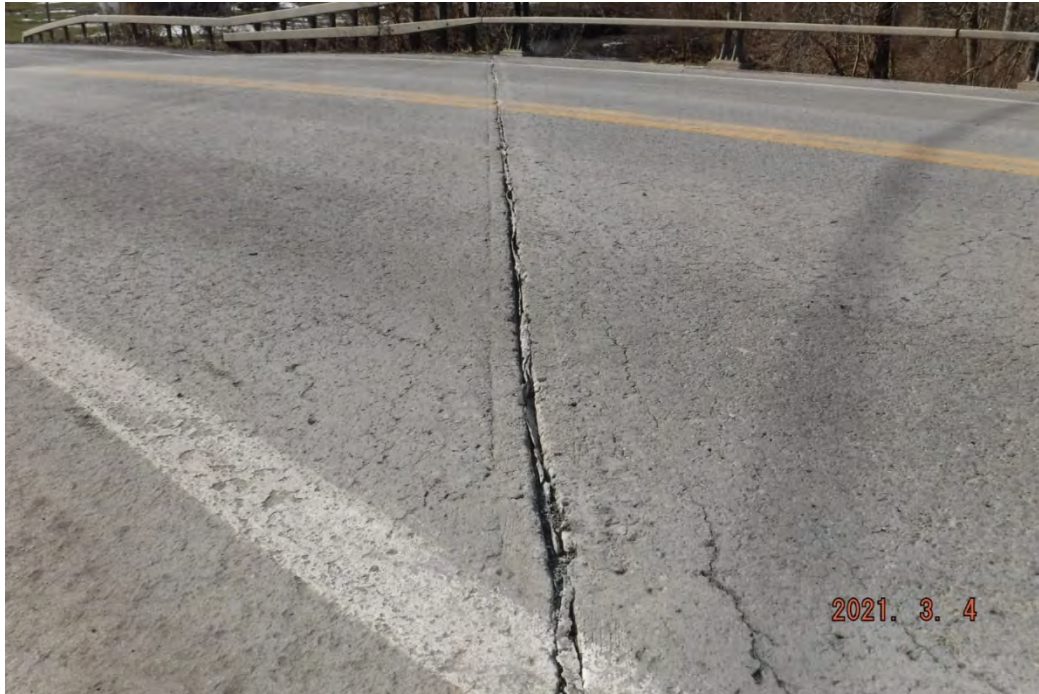
PHOTO NO:
11

Pourable
portion of the
Joint is in
poor
condition

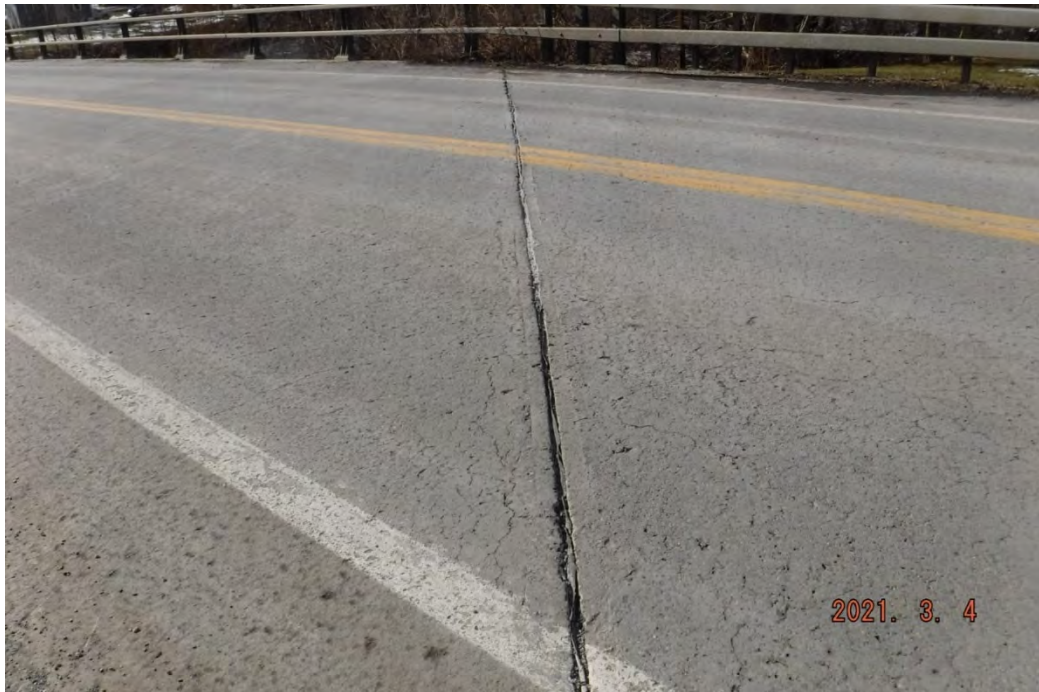
PHOTO NO:
12

Pourable
portion of the
Joint is in
poor
condition.

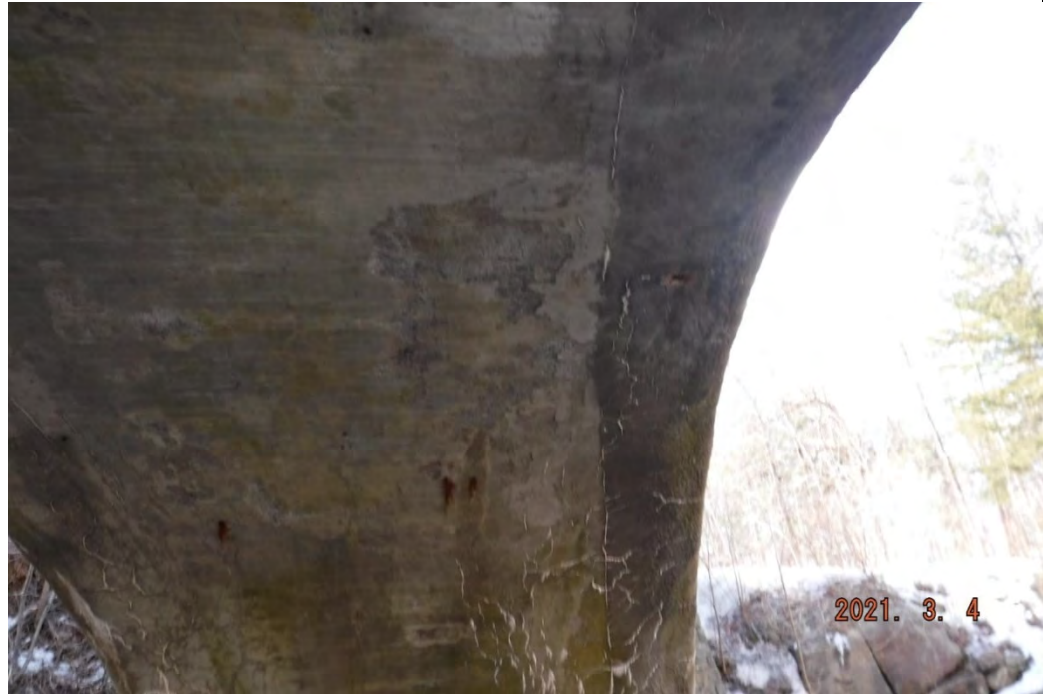
Underside is
damp.
Recommend
sealing along
the curb and
edge of the
wearing
surface to
reduce
infiltration.

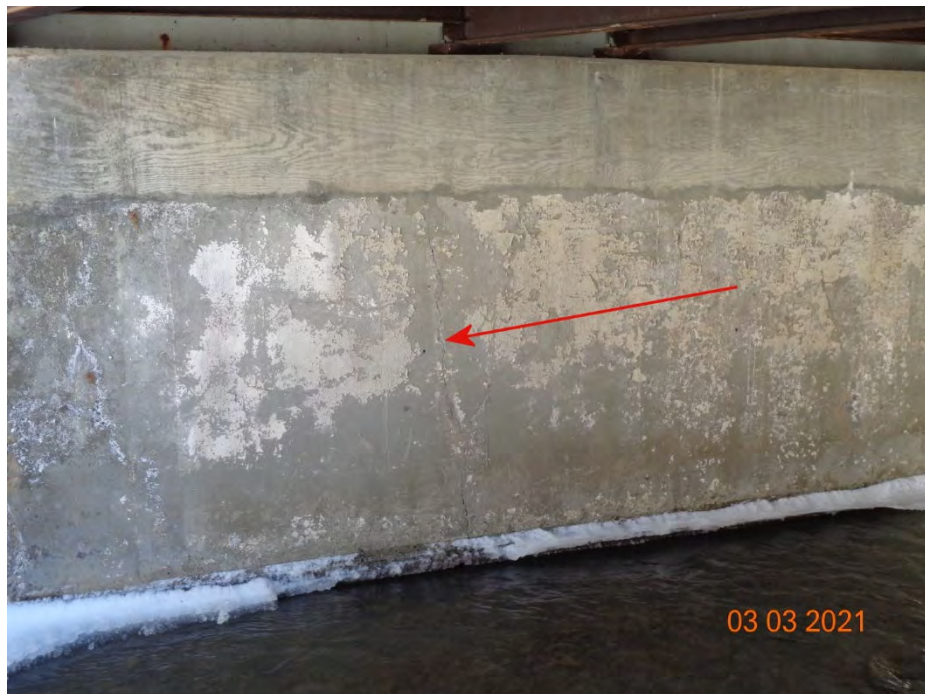
**PHOTO NO:**
6**DESCRIPTION:**
Looking
Towards End
at Top of End
Abutment
Stem Below
Girder G4
(Arrow
Indicates
Location of
Crack, Crack at
Begin
Abutment
Similar)

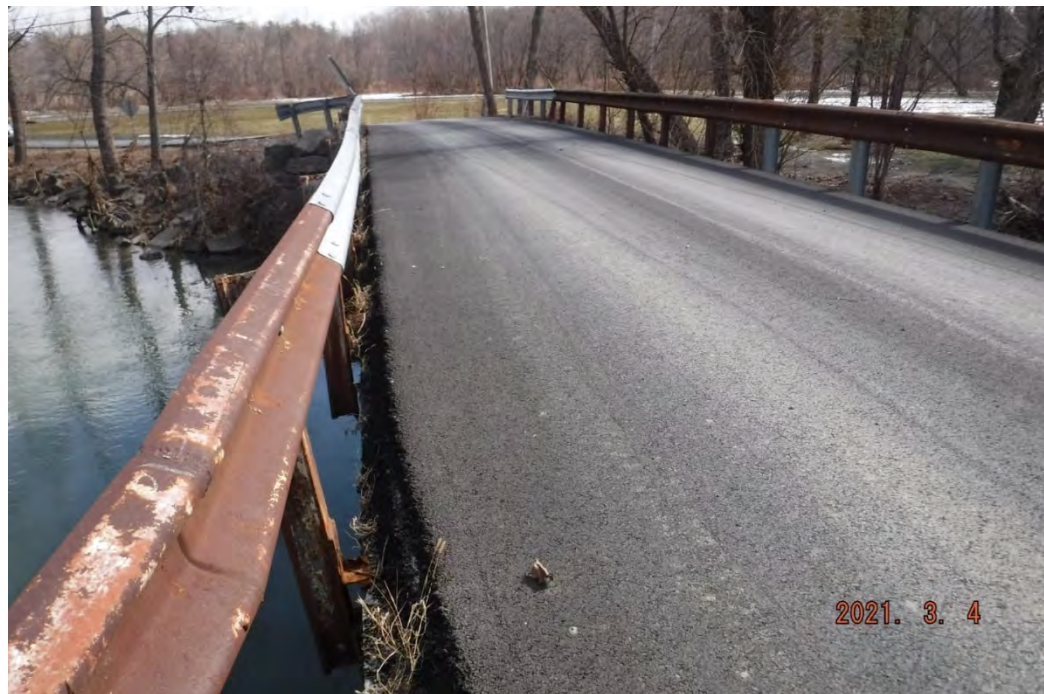
Newley
Placed
Wearing
Surface and
Deficient
Bridge Rail

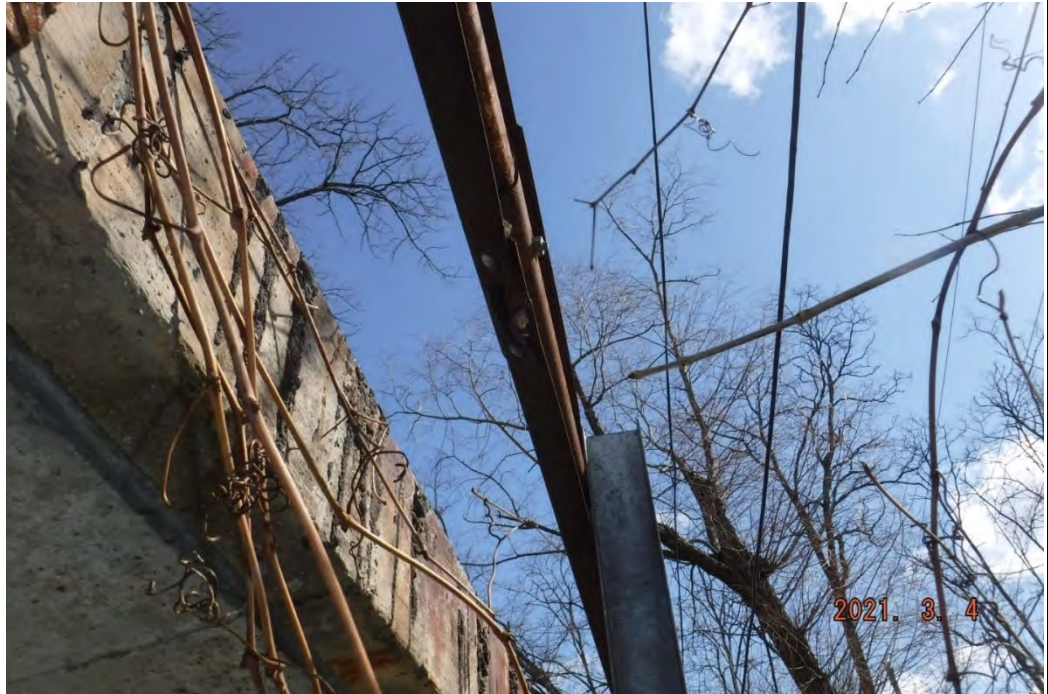
PHOTO NO:
3

DESCRIPTION
:
Right Bridge
Rail, Looking
Up And
Towards The
End

Replace
Deficient
Bridge Rail

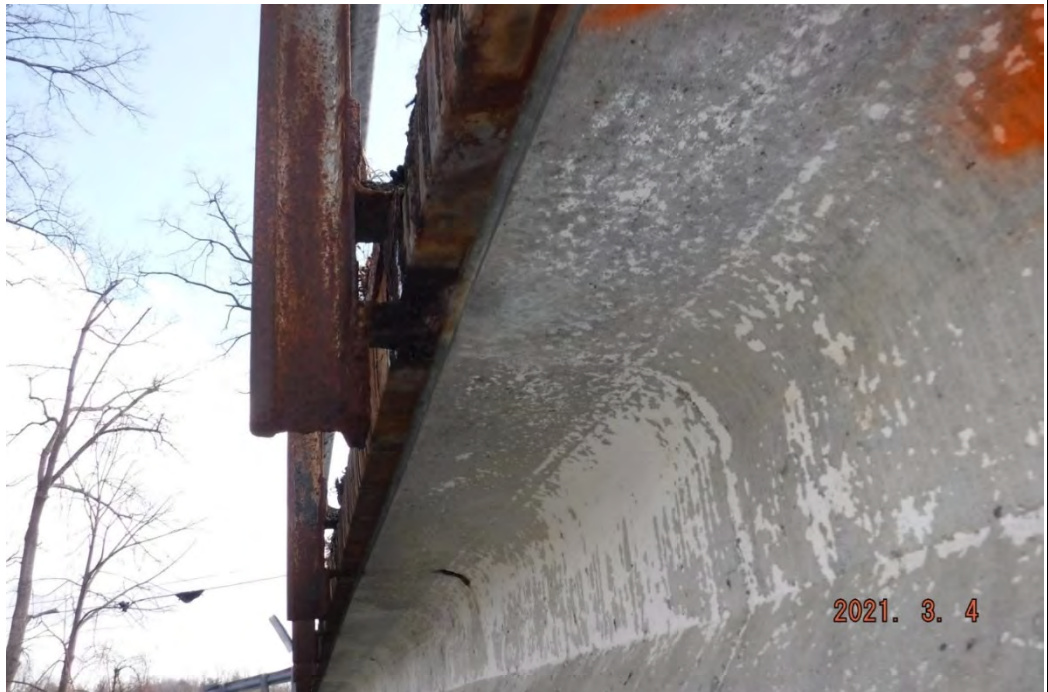
PHOTO NO:
4

DESCRIPTION
:
Left Bridge
Rail, Looking
Up and
Towards The
End

Replace
Deficient
Bridge Rail

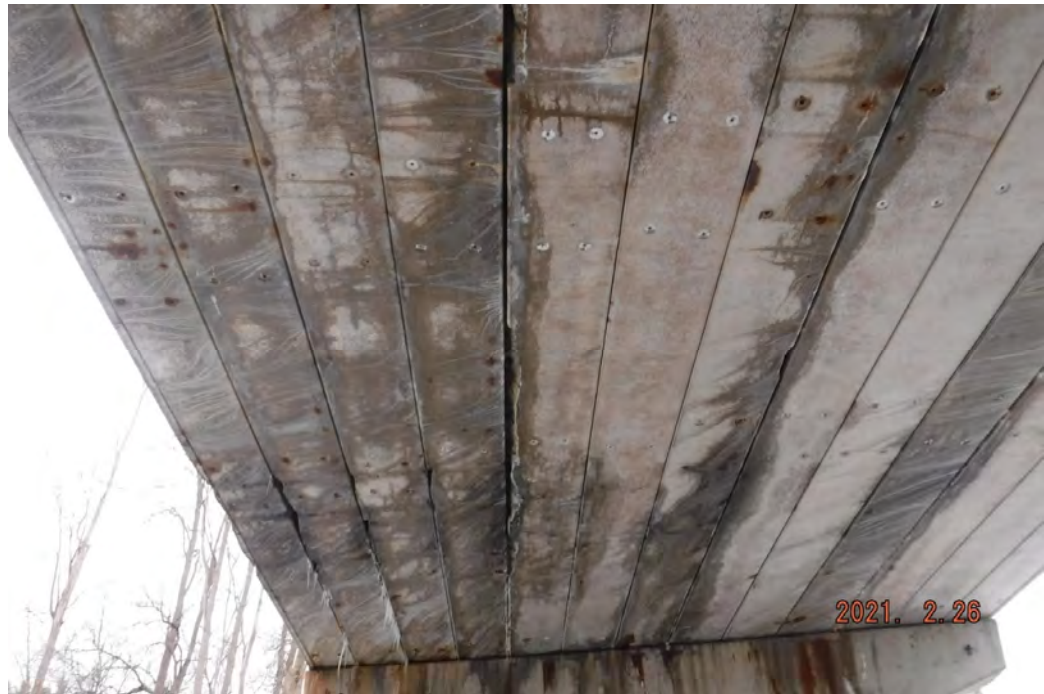
Corner
Spalling, soft
concrete, and
widespread
tight cracking

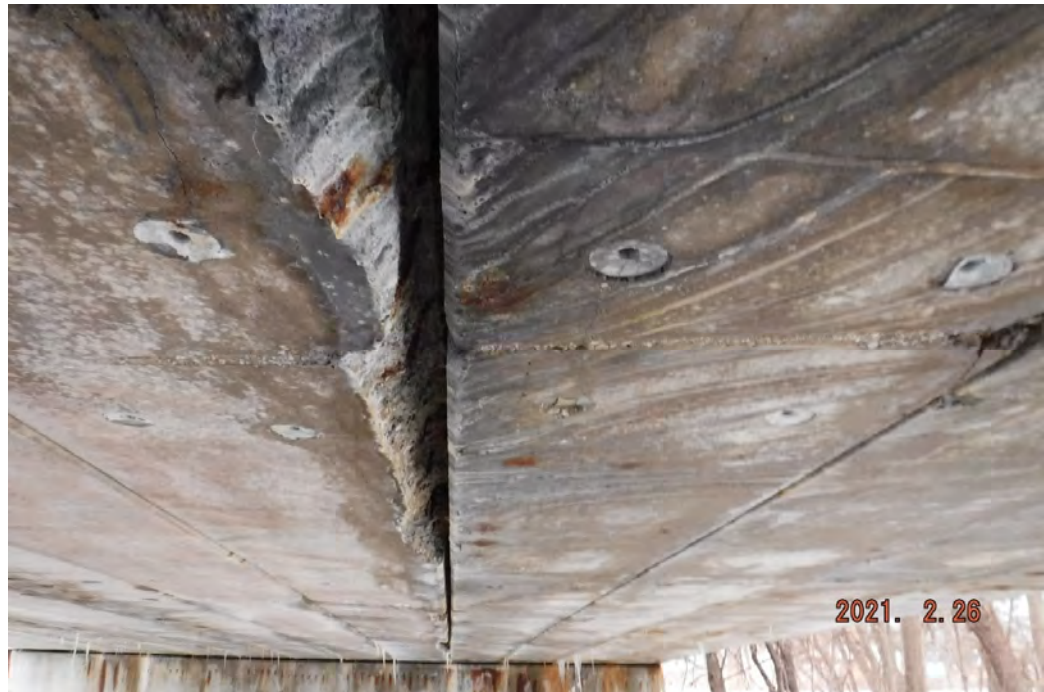
Corner
Spalling, soft
concrete, and
widespread
tight cracking

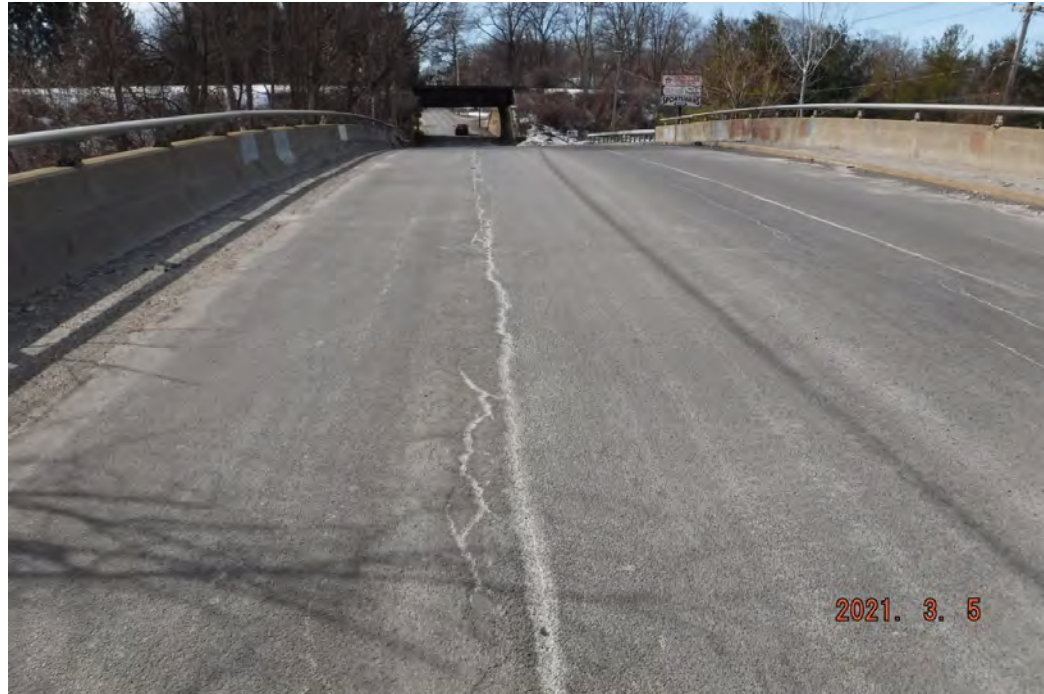
PHOTO NO:
3

Longitudinal
reflective
cracking
along beam
joints

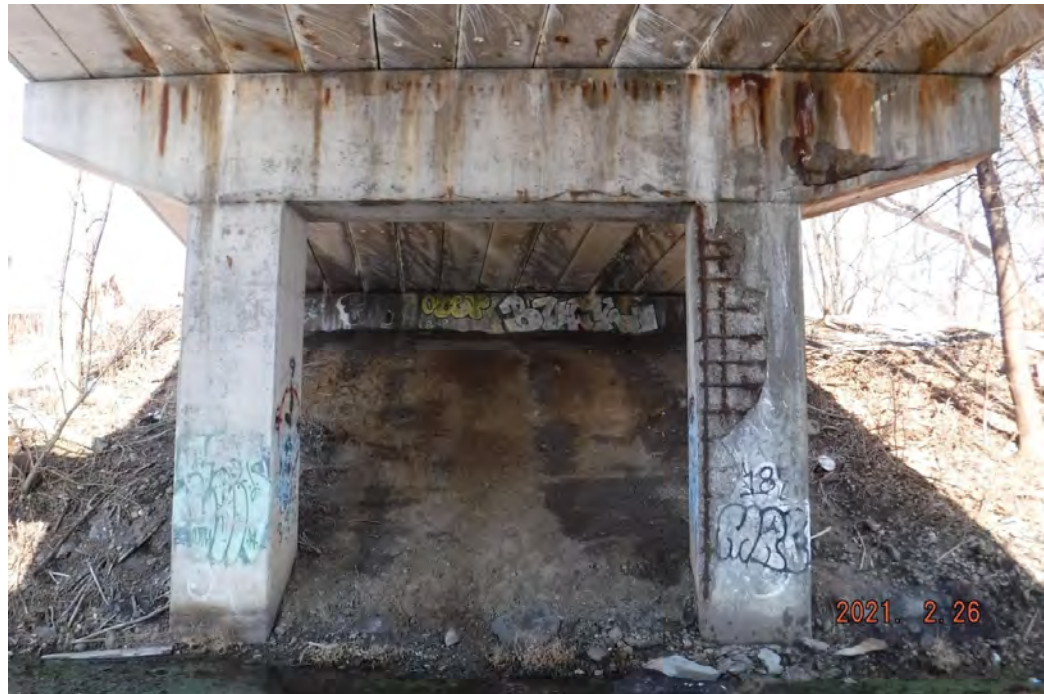
PHOTO NO:
5**DESCRIPTION**
:
Pier 2 Begin
Face, Looking
Towards The
End.The Cap
Beam and
Column #2
has
hollowness,
rust staining,
and spalling
with exposed
rebar.

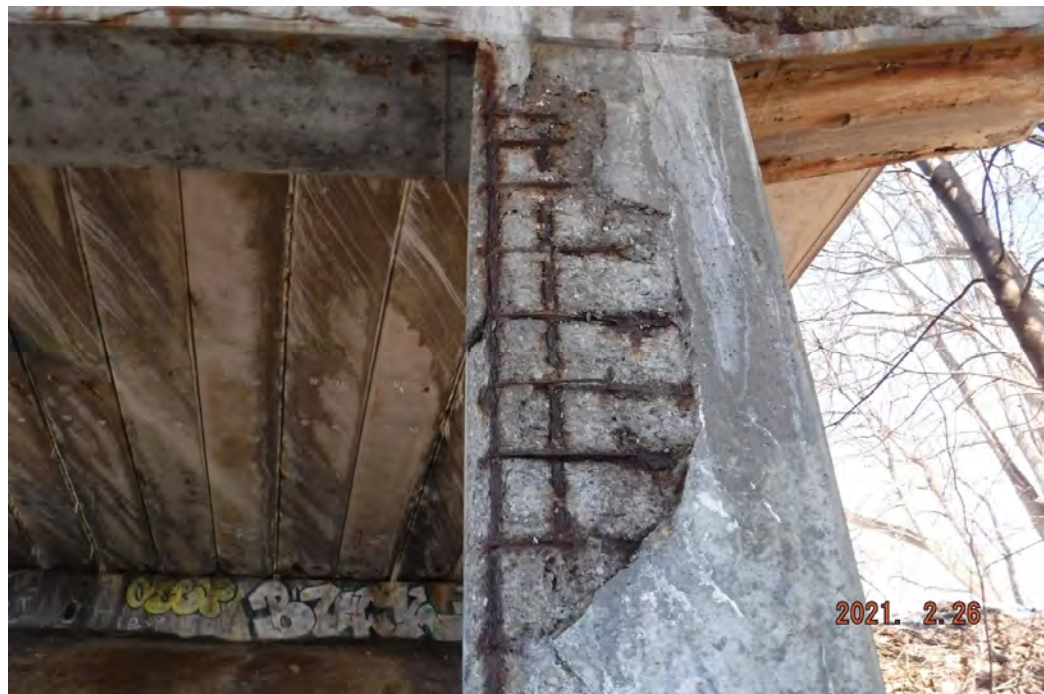
**PHOTO NO:**
6**DESCRIPTION**
:
Pier 2,
Column 2
Begin Face,
Looking
Towards The
End.Advanced
Column
Deterioration
