**Capital District Transportation Committee (CDTC)/ Capital District Regional Planning Commission  
(CDRPC) Technical Assistance Program**

**TECHNICAL MEMORANDUM**

**Town of Glenville – Hoffman Hill Road**

**Hoffman Hill Road Safety Analysis FINAL 4/9/2021**

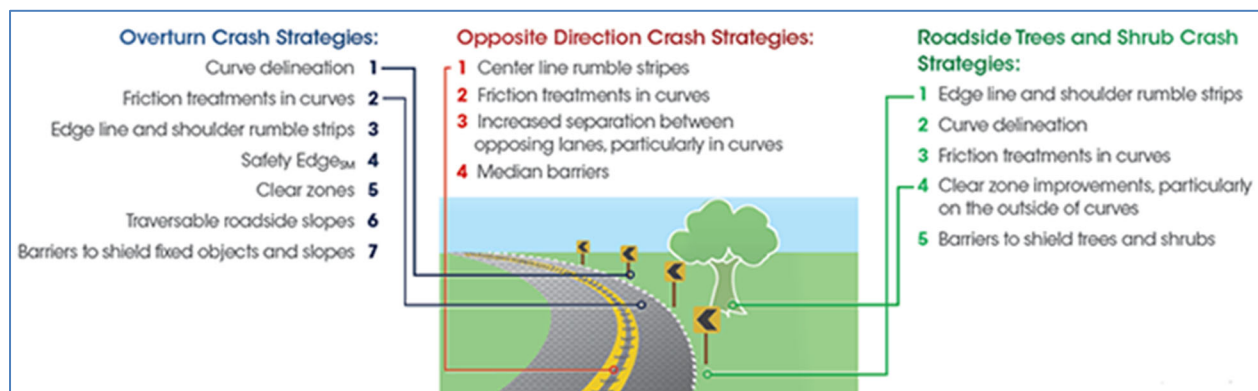
Source: FHWA Roadway Departure Crash Emphasis Areas

FHWA has identified the following treatments for reducing rural roadway departures. These treatments shall be considered for Hoffman Hill Road:

- Signage and markings that delineate lane edges and alignment changes and help drivers navigate.
- Rumble strips that alert drowsy and distracted drivers drifting from their lane.
- Friction treatments at curves or other important locations to reduce loss of control.
- Shoulders, SafetyEdge, and clear zones to provide opportunities for a safe recovery when drivers leave the roadway.
- Roadside hardware that can reduce the severity of roadway departure crashes.

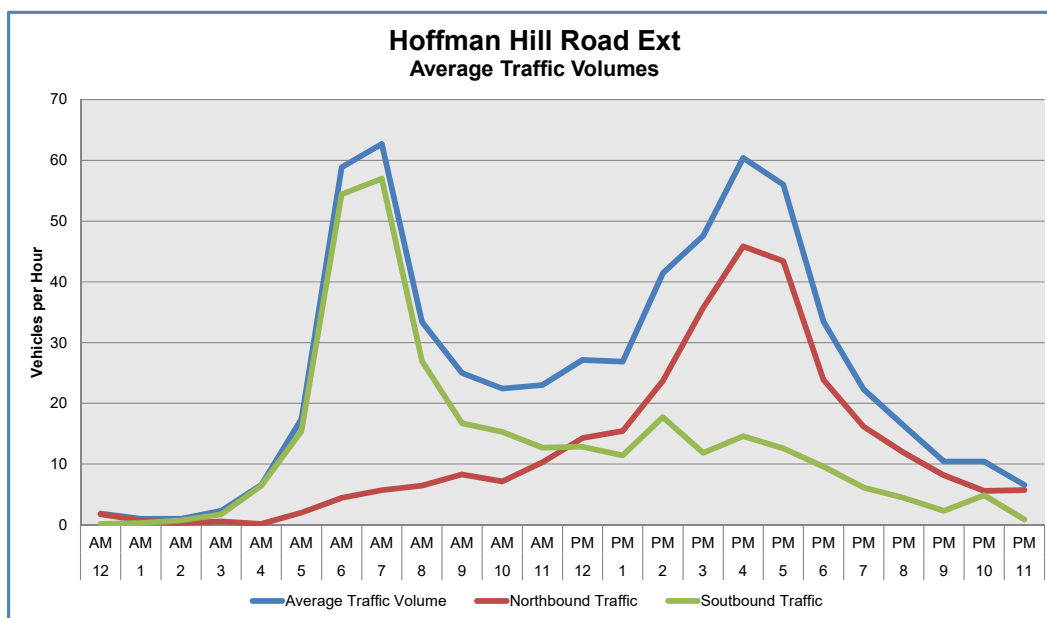
The observed two-way average daily traffic (ADT) was 614 vehicles/day. Peak hour traffic volume was 94 vehicles, observed on Tuesday from 7 to 8 AM. The average weekday traffic volume was 686 vehicles/day.

Strong directionality of traffic was observed by time-of-day, with greater southbound volume in the AM peak period and greater northbound volume in the PM peak period:

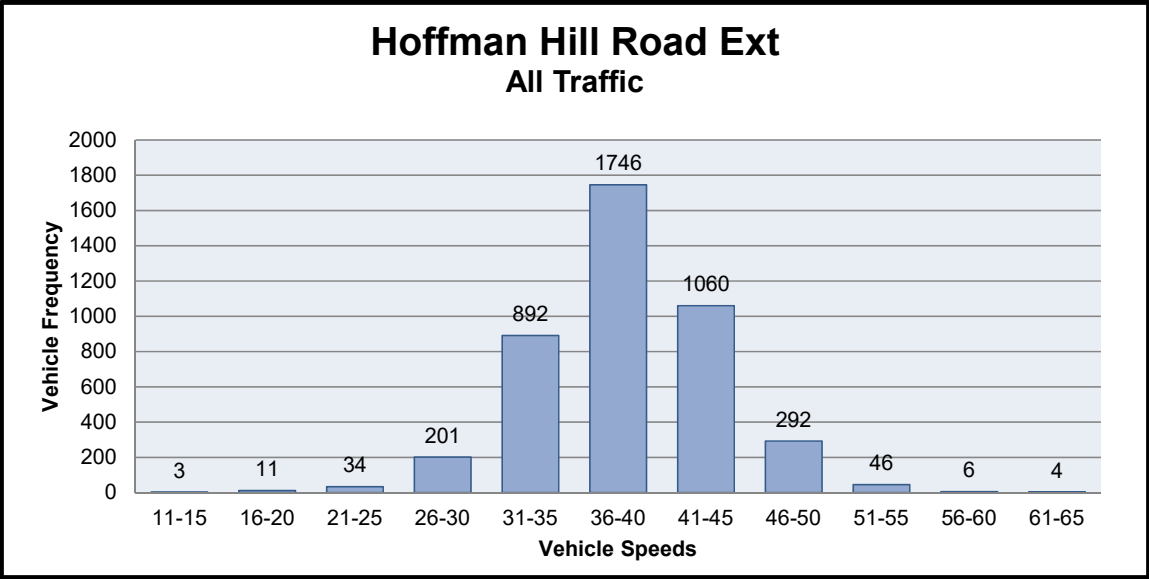
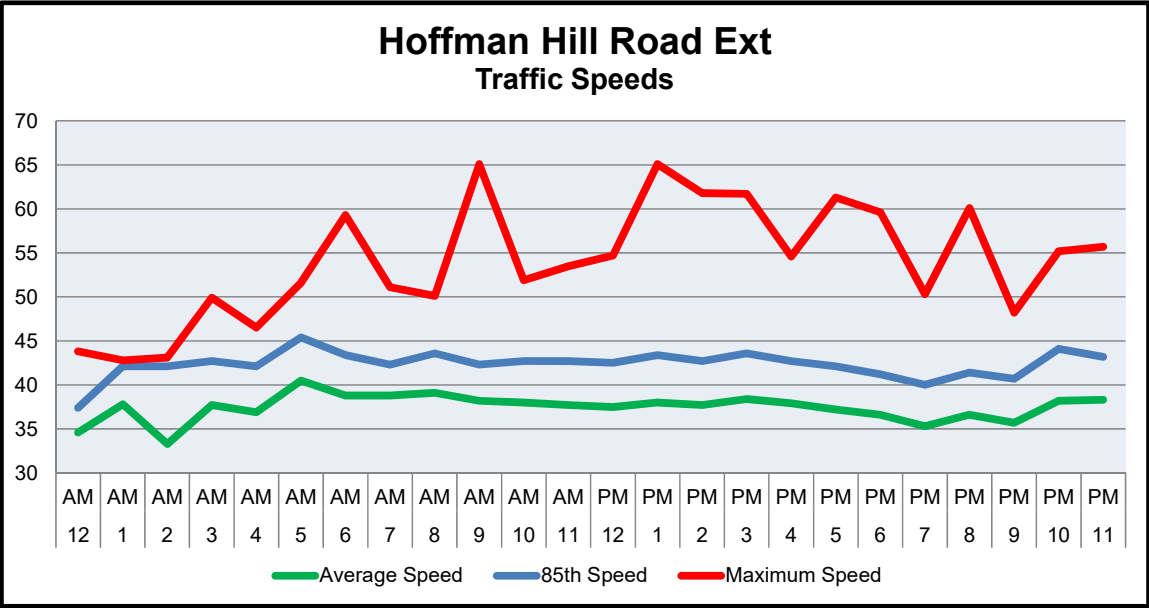
The posted speed limit on Hoffman Hill Road is 30 mph. During the 7-day count conducted from October 19<sup>th</sup> through October 25<sup>th</sup>, the average speed observed was 38 mph. The 85<sup>th</sup> percentile speed was 43 mph for both northbound and southbound traffic. 71% of vehicles were observed to be travelling between 32 and 42 mph.

The diagrams below summarize observed vehicle speed by speed and by time-of-day.

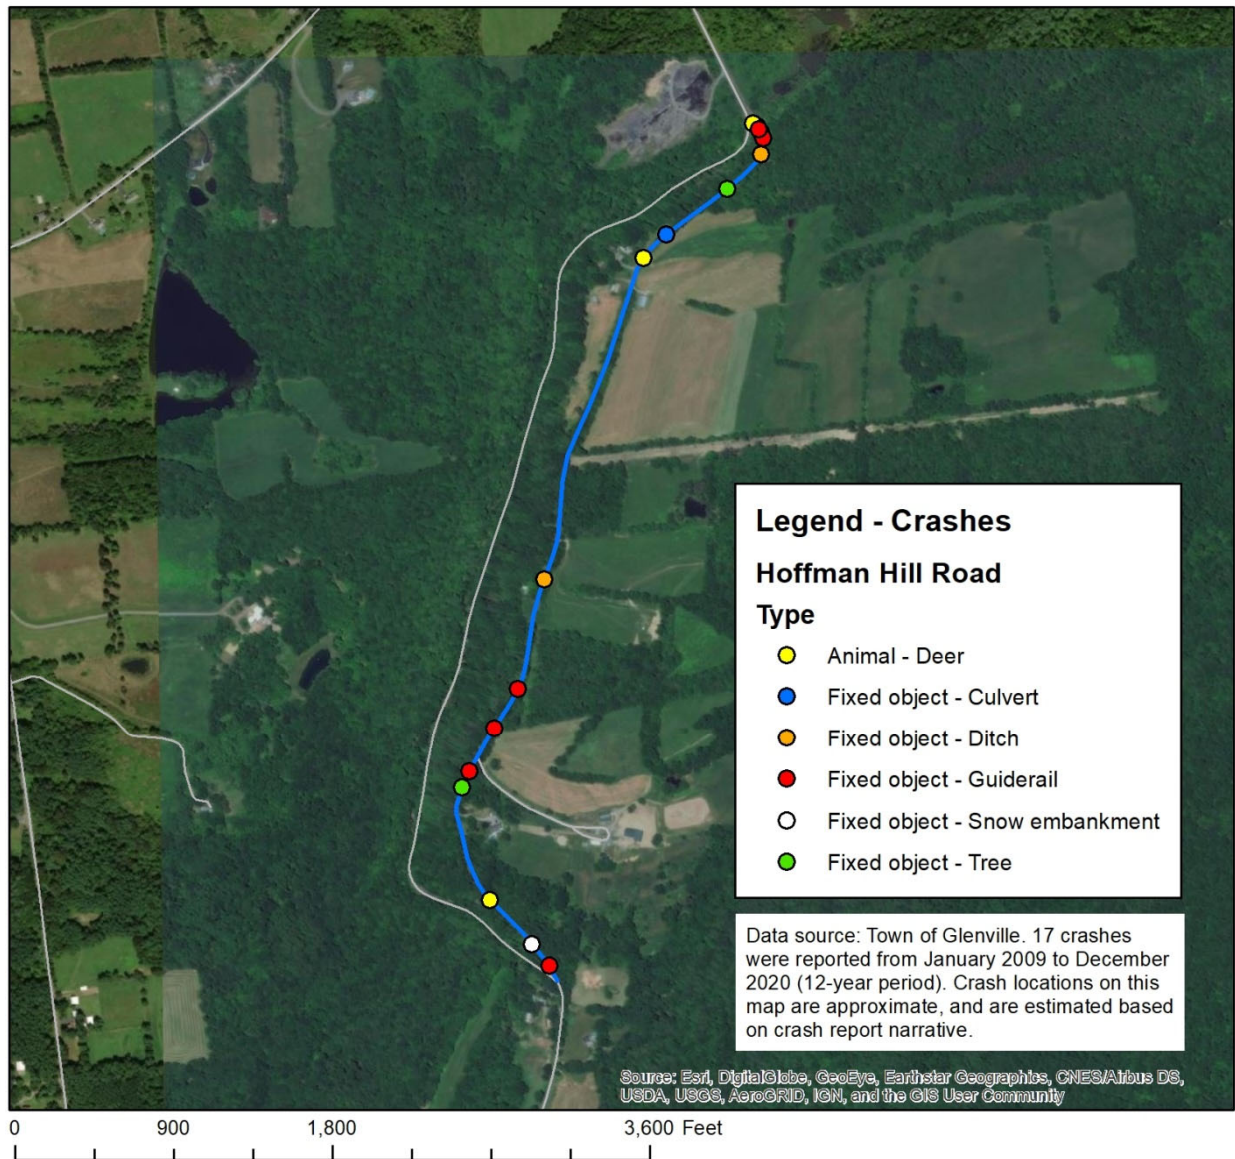
## Glenville - Hoffman Hill Road - Crashes

The diagram on the following page shows the approximate locations of the 17 reported crashes. Locations are approximate, and are estimated based on crash report narrative. There is a cluster of six crashes at the north end of the study area, at the northern intersection with Wolf Hollow Road. Of the six crashes at this cluster, three were collisions with guiderail, two with ditches, and one with a deer.

The crash rate on Hoffman Hill Road is estimated to be 5.75 crashes per million vehicle miles travelled (ACC/MVM). This rate exceeds the average for rural state highways. According to average accident rates published by NYSDOT, the average rate for undivided two-lane rural state highways 2.11 ACC/MVM. The disparity in crash rate is likely due to the high proportion of fixed object collisions reported on Hoffman Hill Road.

At the north end of the study area, there is a crash cluster of guiderail crashes at the bottom of the gradient. The guiderail shields vehicles from going over a steep drop-off and striking trees. This guiderail likely reduces the severity of crashes that occur. Portions of Hoffman Hill Road with similar roadside hazard should be considered for guiderail deployment.

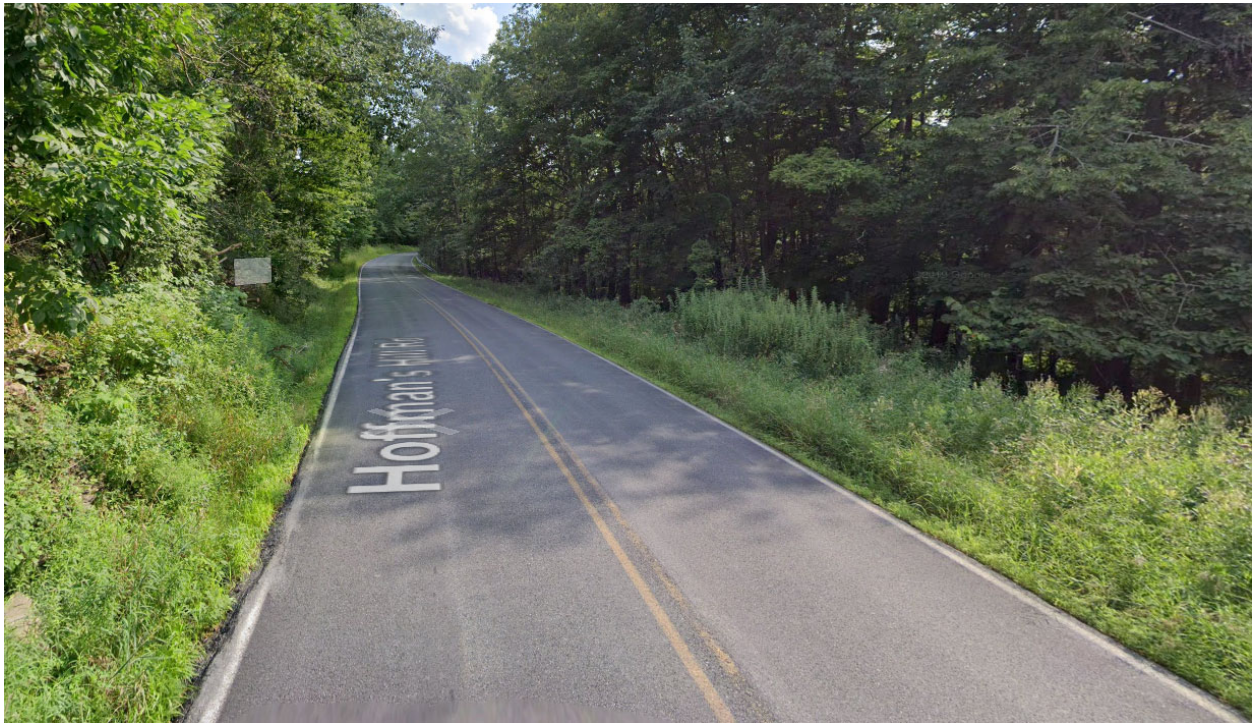
For the entire length of the study area, the pavement width is approximately 20 feet, with two 10-foot travel lanes. Shoulders are not present in the study area. There are no sidewalks or trails in the study area.

*Above: Typical roadway section with 20' pavement width and no shoulders*

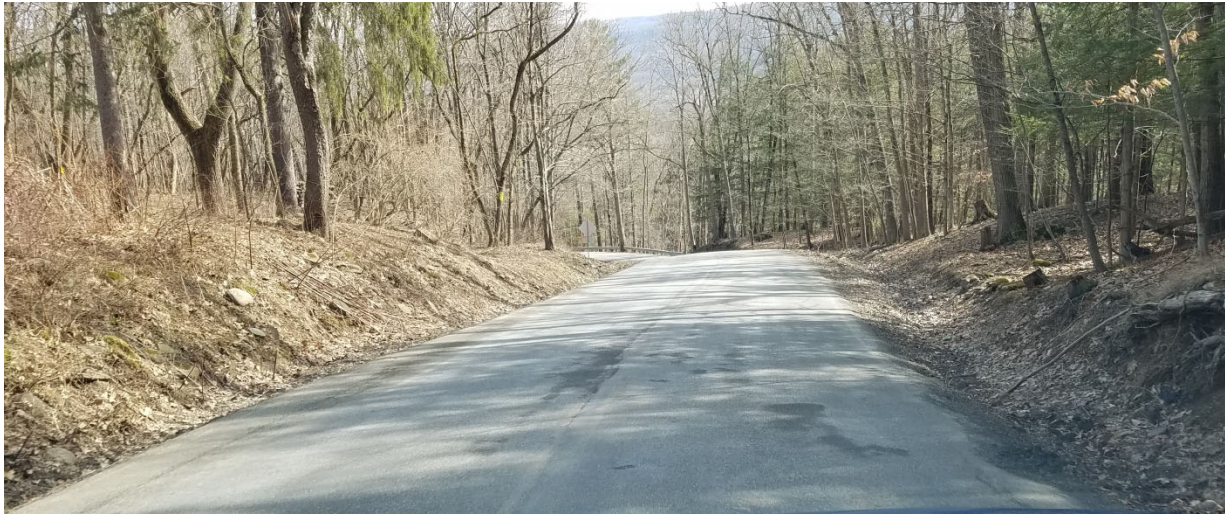
During a March 2021 field visit, pavement was observed to be in poor-to-moderate condition. In some sections, centerline joint cracking was visible. There was considerable erosion of the pavement edge in many places. Centerline and edge line pavement markings are faded, and in some places no longer visible.

*Above: erosion of the pavement edge can be seen in many places*

When resurfacing Hoffman Hill Road, the Town should consider incorporating Safety Edge to help vehicles safely recover. FHWA reports that Safety Edge is a low-cost safety countermeasure that may also help improve pavement edge durability.

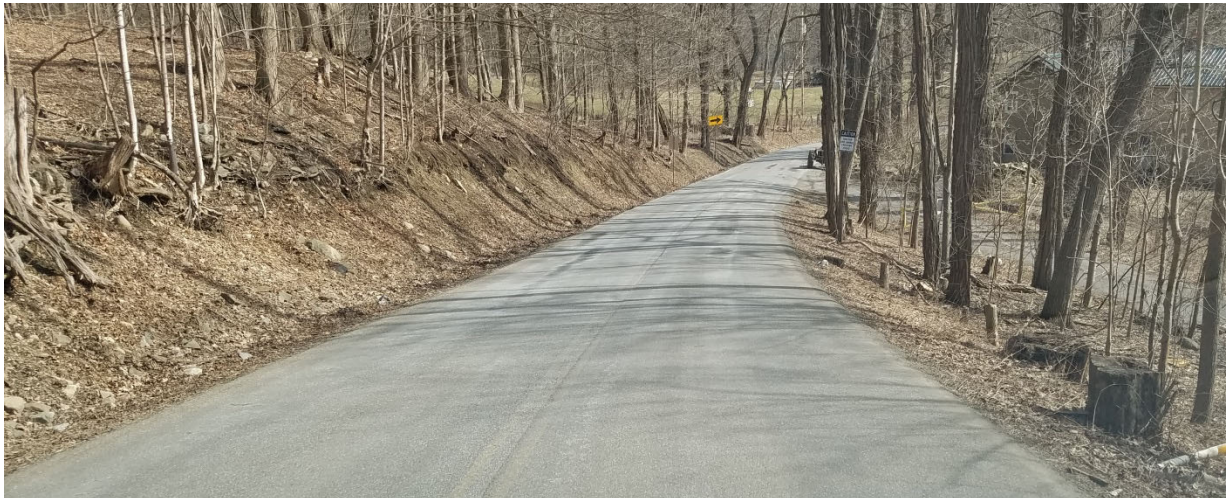
*Above: centerline joint cracking at the south end of the study area*

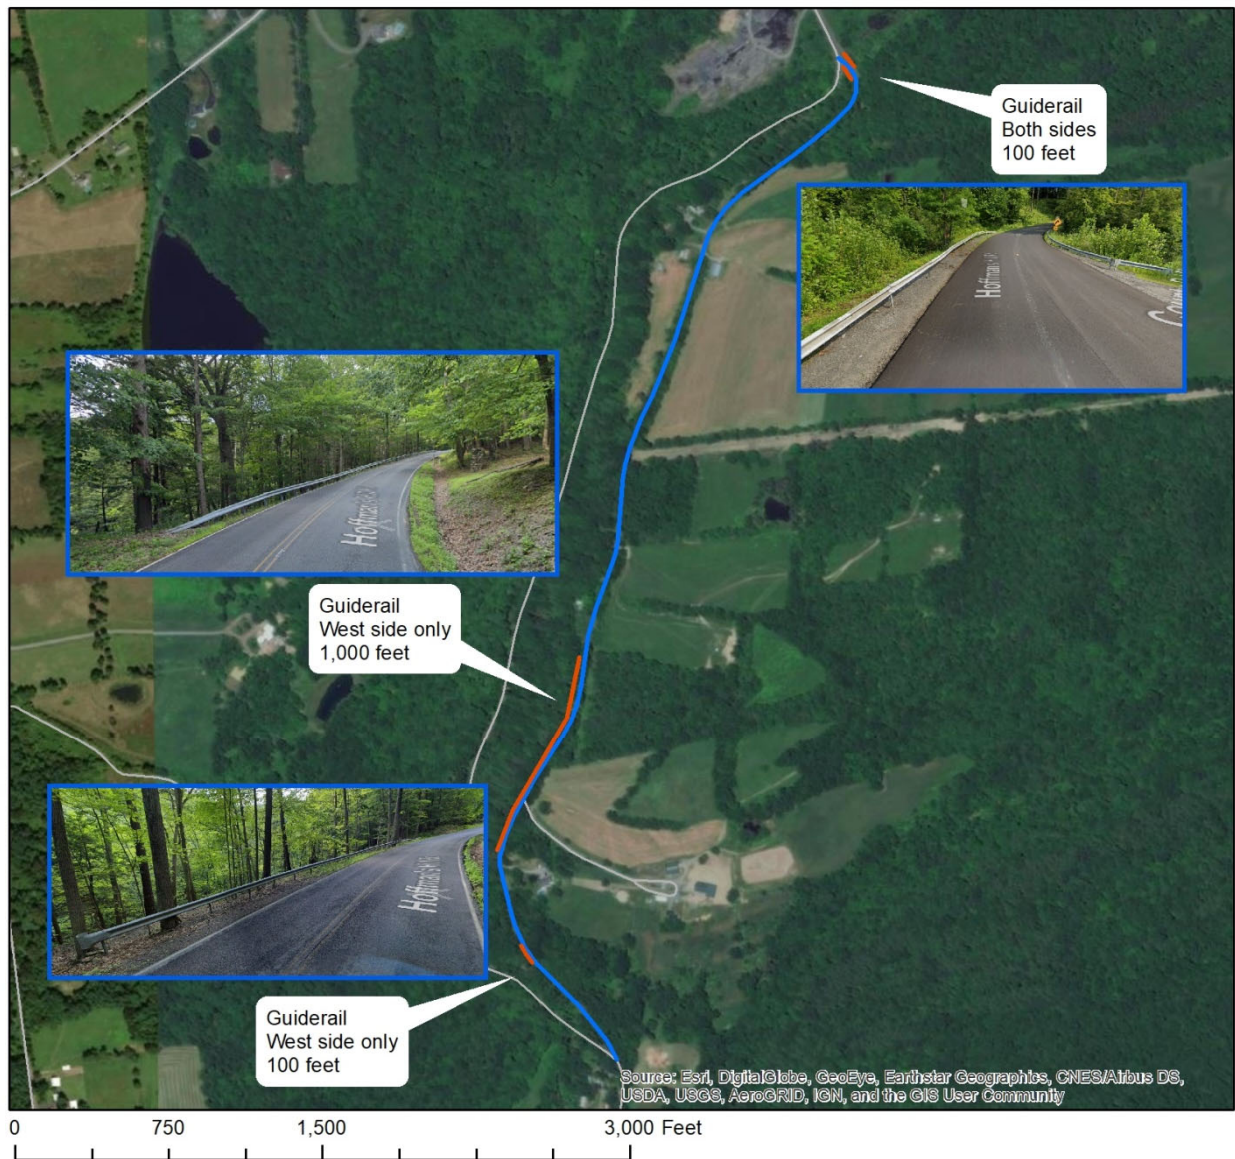
## Glenville - Hoffman Hill Road - Guiderail

Three segments of Hoffman Hill Road have guiderail. At the south end of the study area, there is a short section of guiderail on the west side of the roadway at the southernmost curve. There is approximately 1,000 feet of guiderail on the west side just north of the curves. At the north end of the study area, there are short sections of guiderail on both sides of the road.

Guardrail: There are three segments of Hoffman Hill Road that already have steel guiderail installed. Guiderail on these segments serves to shield vehicles from roadside hazards, such as steep slopes or trees. Additional guiderail should only be installed in areas where vehicles that leave the roadway cannot come to rest safely. The installation of additional segments of guiderail should be considered where roadside hazards are present.

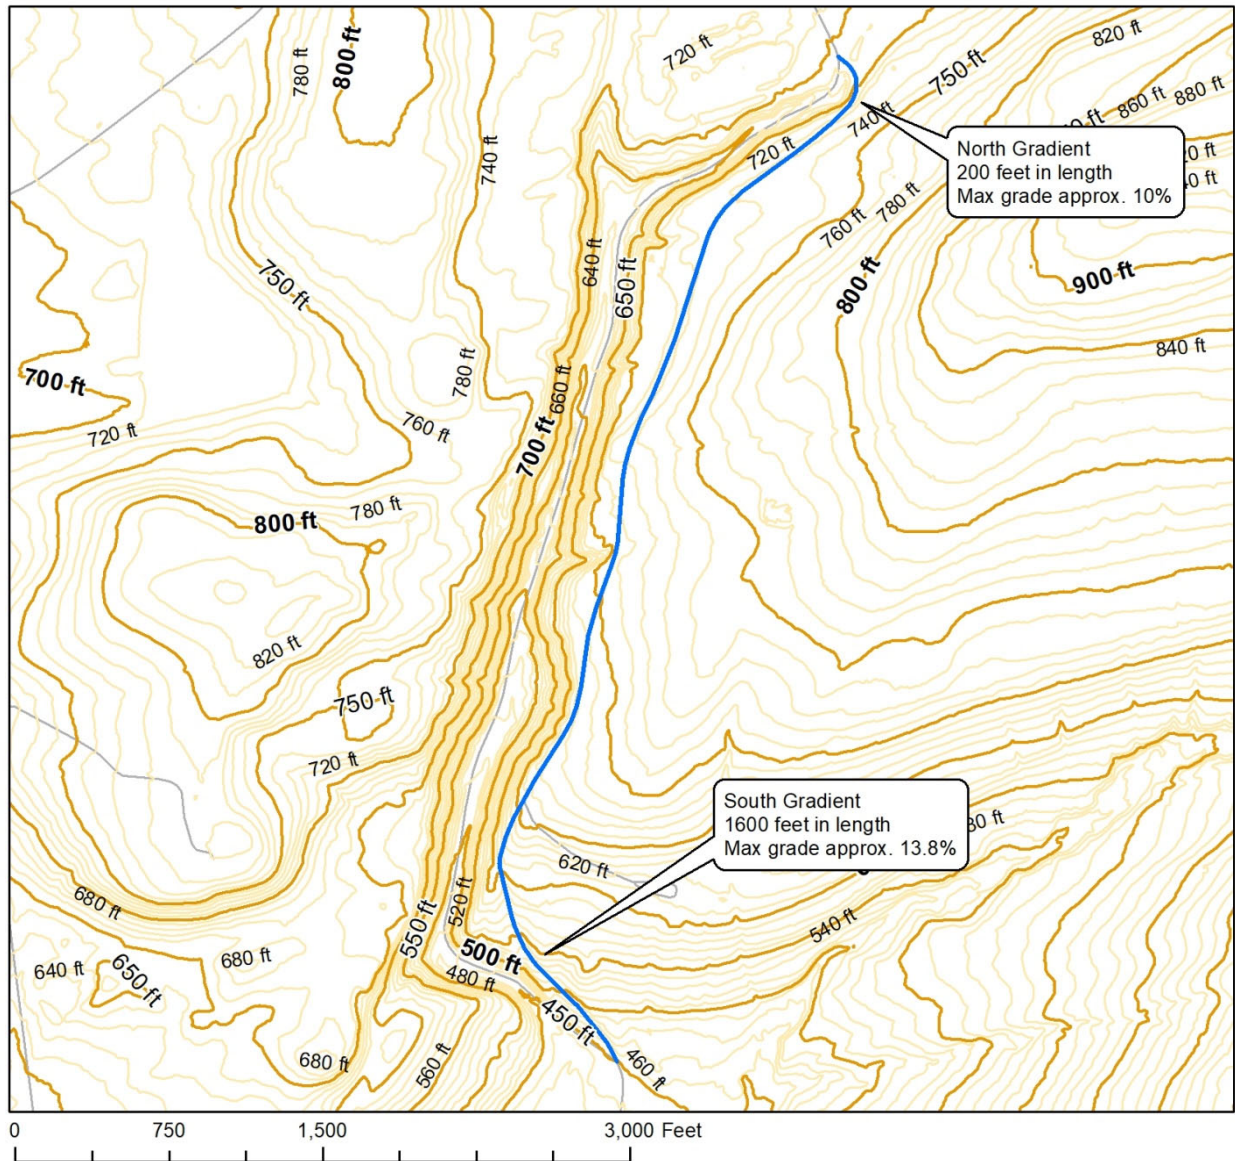
# Glenville - Hoffman Hill Road - Elevation

**South gradient** – from the beginning of Hoffman Hill Road to approximately 1600 feet north, there is a vertical elevation change from 450 feet to 670 feet (+220 feet). This corresponds to a mean grade of approximately 13.8%.

**North gradient** – from the northern end of the study area to approximately 200 feet south, there is a vertical elevation change from 700 feet to 720 feet (+20 feet). This corresponds to a mean grade of approximately 10%.

Per the NYSDOT Highway Design Manual, the maximum percent grade on a local rural road with a design speed of 30 mph is 11% in 'Rolling' terrain. Therefore, the south gradient may exceed the NYSDOT-recommended design grade for this type of roadway, and the north gradient is close to the maximum.

Per MUTCD Section 2C.16, hill signs may be used in areas where the grade exceeds a certain length and steepness. On Hoffman Hill Road, the southern gradient is estimated to exceed 13%; therefore, a W7-1 Hill Sign may be warranted. Although trucks over 4 tons are not permitted on Hoffman Hill Road, the hill sign provides advance warning to all drivers and may help to reduce speeds.

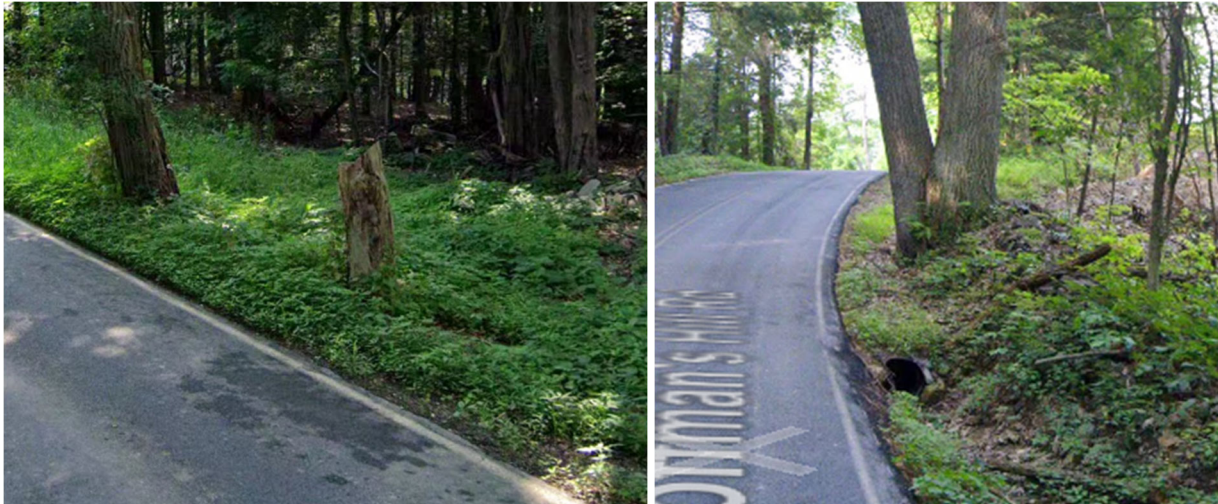
**Trees:** throughout much of the study area, trees are present close to the edge of the road.

*Above: trees close to pavement edge*

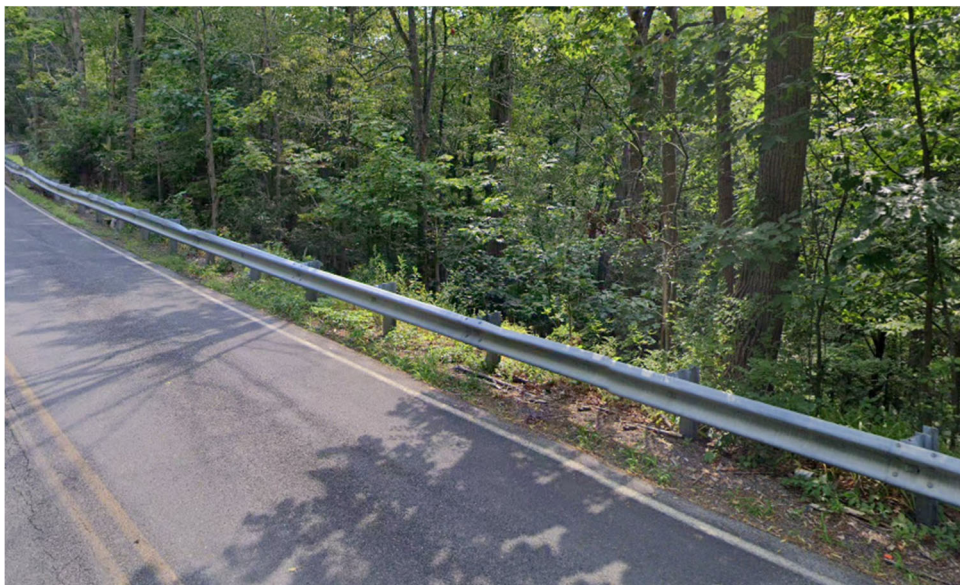
**Steep drop-offs:** On the elevation map on the preceding page, a steep gradient can be seen on the west side of the roadway throughout much of the study area. This drop-off comes close to the roadway in several places. Such drop-offs make vehicles unable to recover from road departures. The steepest off-road gradient is present in the 1,000 foot section with guiderail.

*Above: the steepest roadside drop-off, behind guiderail on west side of roadway*

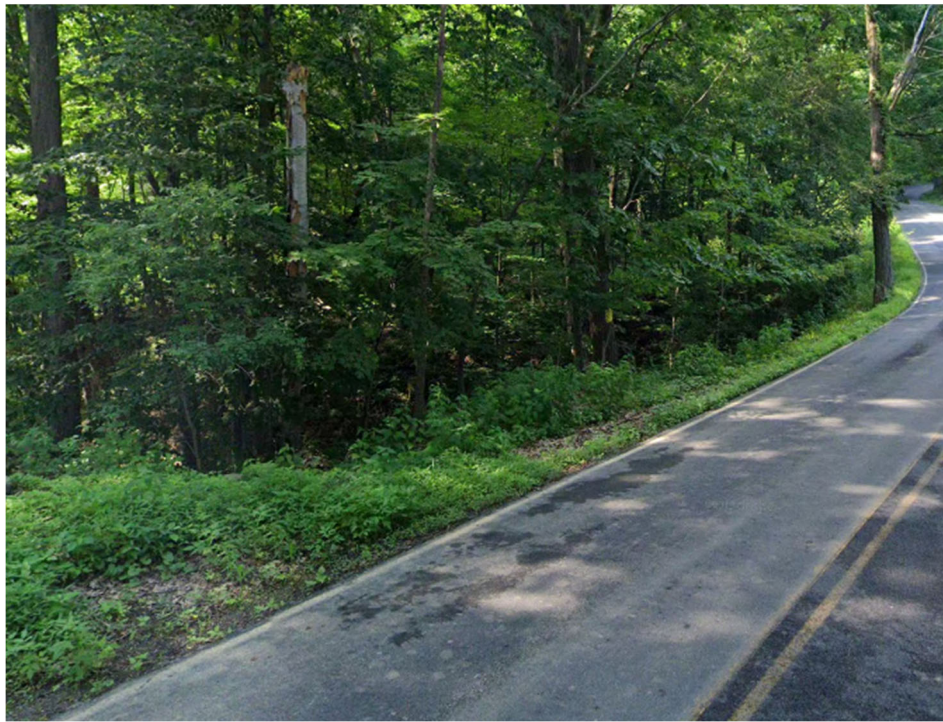
*Above: another roadside drop-off without guiderail*

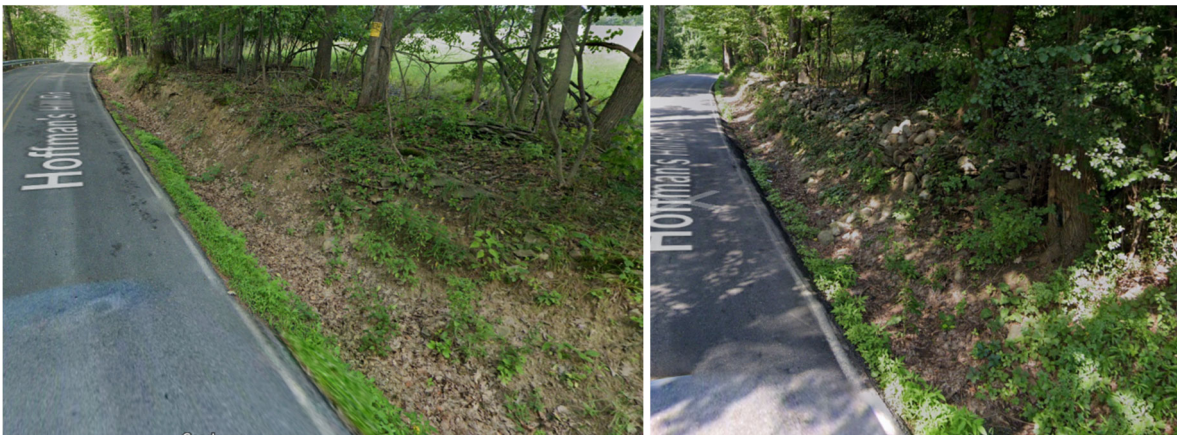
**Ditches:** Drainage ditches are close to the pavement edge throughout much of the study area. Ditches make vehicles unable to recover from road departures.

*Above: ditches on east side of roadway*

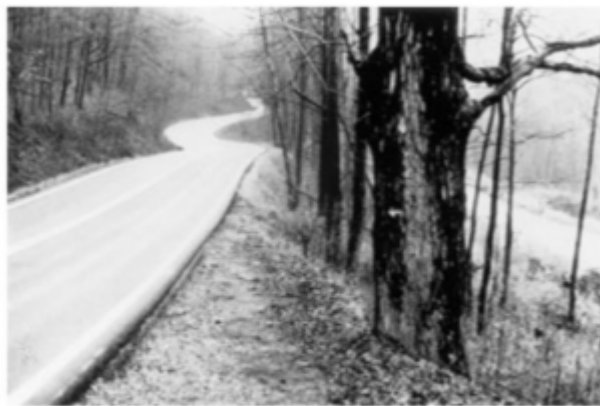
**Typical Roadway with Roadside Hazard  
Rating Equal to 6.**

- Clear zone less than or equal to 5 ft.
- Sideslope about 1:2.
- No guardrail.
- Exposed rigid obstacles within 0 to 6.5 ft of the pavement edgeline.
- Non-recoverable.

*Above: Photo example of Roadside Hazard Rating of 6. Source: FHWA MIRE Version 2.0*

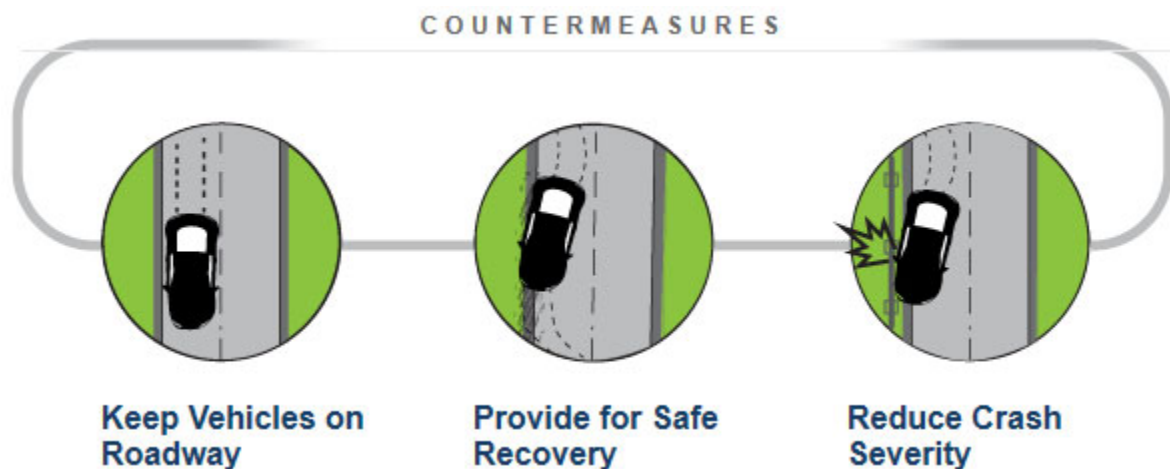
Per FHWA's Roadway Departure Safety guidance, safety countermeasures may be broadly grouped into three categories:

- **Keeping vehicles on the roadway**, for actions such as signage, striping, rumble strips, and friction treatments that keep drivers on the road and in their lane;
- **Providing for safe recovery**, for actions such as Safety Edge and clear zones that allow vehicles to safely steer back onto the roadway; and
- **Reducing crash severity**, for actions such as guiderail and breakaway sign supports that reduce the severity of crashes for vehicle unable to recover.

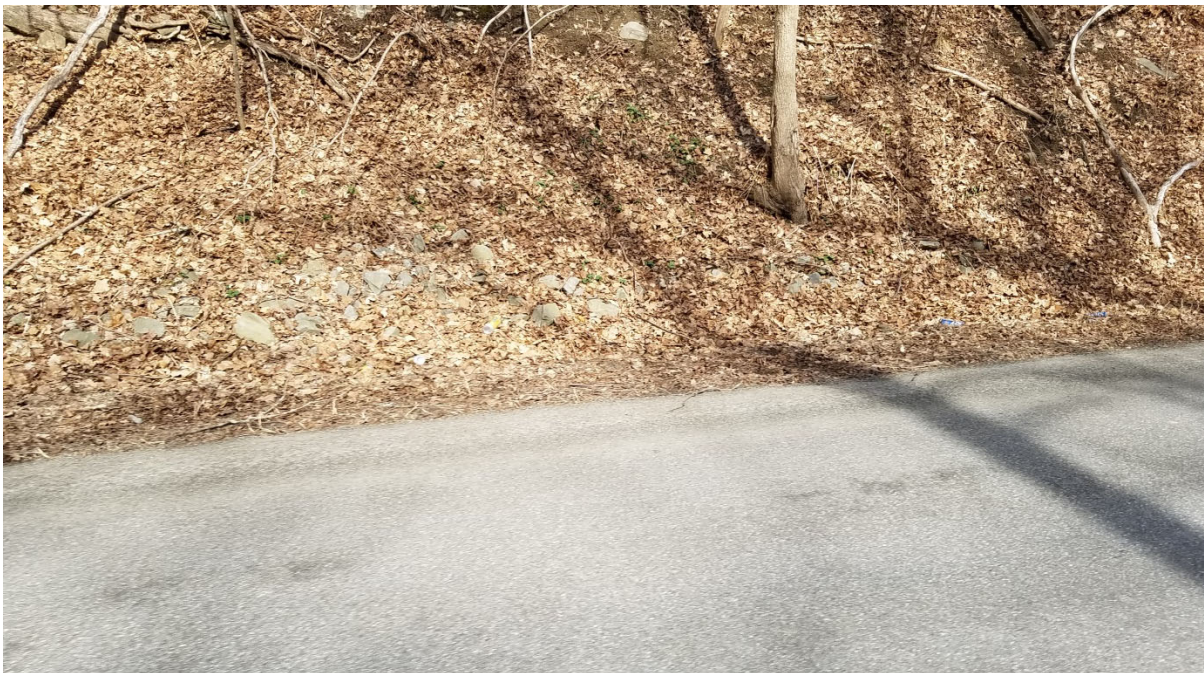
*Above: photo from field visit showing edge line striping is no longer visible*

Retro-reflective edge line striping: Over time, the retroreflectivity of pavement markings fade and must be maintained for nighttime visibility. The white edge line striping on Hoffman Hill Road is faded throughout the study area. Because there is no shoulder, it is especially important to maintain edge line striping so that drivers can see changes in horizontal alignment at night.

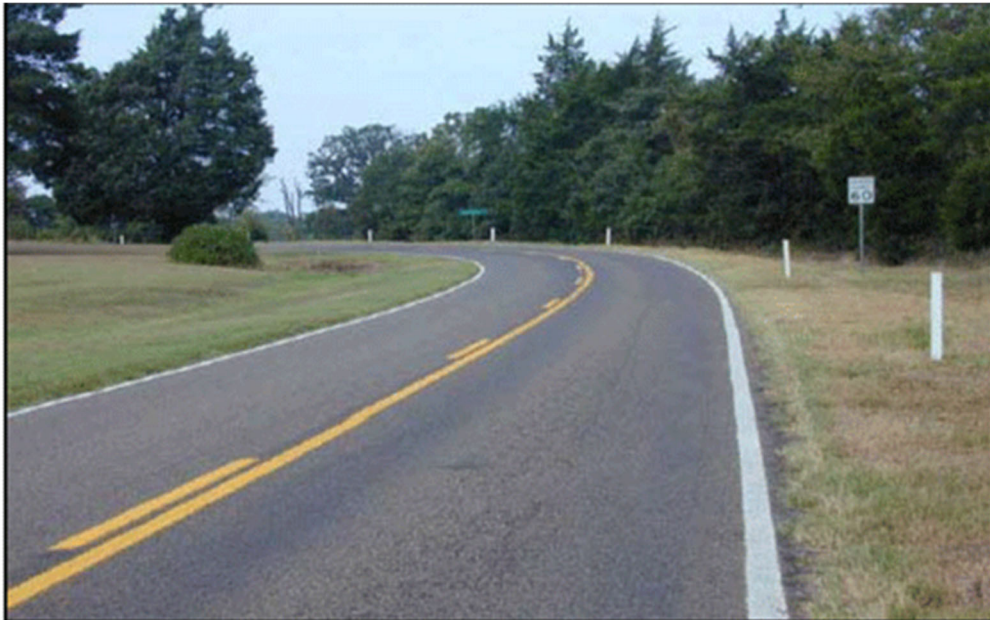
Per FHWA, delineators may also be used to indicate changes in horizontal alignment. Delineators are retroreflective devices mounted above the roadway surface and along the side of the road in a series. Delineators are white in color to match the edge line. Delineators should be placed 2 to 8 feet outside

*Above: retroreflective delineators on a rural horizontal curve. Source: FHWA*

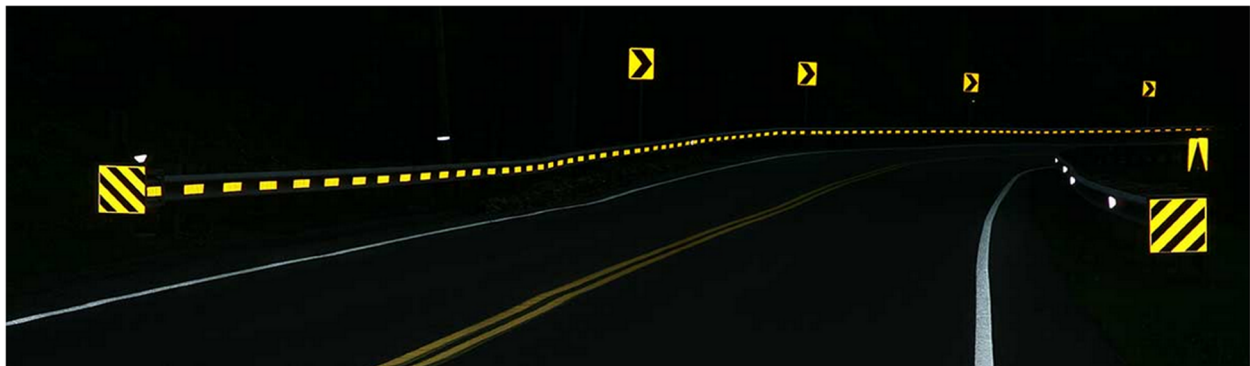
*Above: Retroreflective chevron signage, and guide rail linear delineators. Source: 3M.*

Both the north and south curve would benefit from the installation of chevrons. Per FHWA, chevron signage has been shown to reduce nighttime crashes by 25%, and all fatal and injury crashes by 16%.

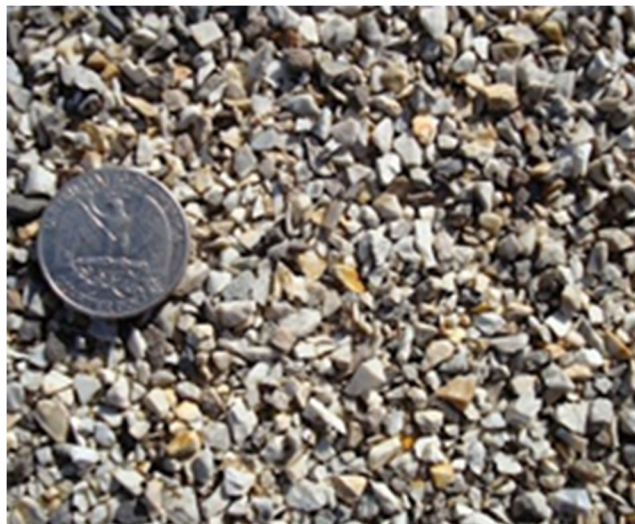
HFST installation involves the use of a thin layer polish- and abrasion-resistant aggregate (such as crushed bauxite) applied to the road with epoxy. HFST may extend the lifecycle of the pavement surface on which it is applied by reducing surface wear. FHWA estimates the expected lifecycle of HFST to be approximately 10 years.

*Above: close-up of HFST application. Source: FHWA.*

On Hoffman Hill Road, the horizontal curves at the north and south end of the study area would benefit from the installation of HFST. The north curve has a crash cluster that it likely caused by the combination of the steep grade and sharp curve; both conditions may be treated through HFST.

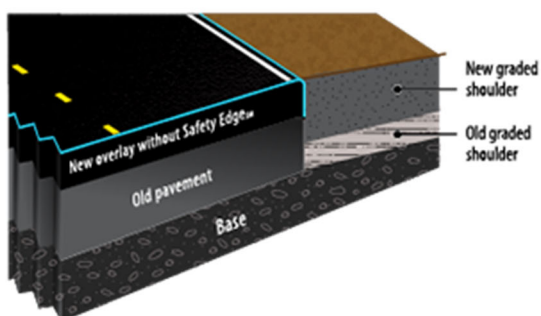
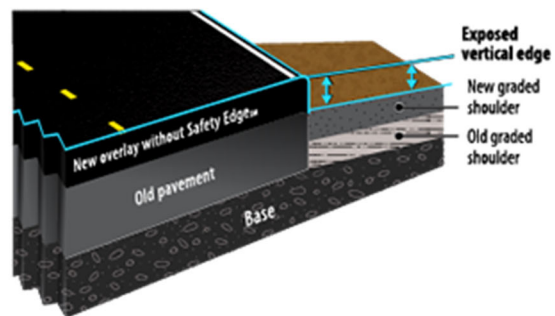
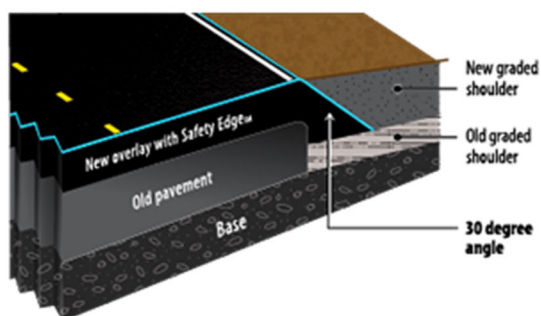
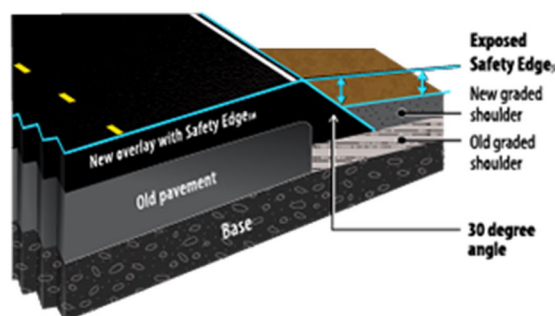
### EDGE COMPARISONS

Safety Edge: Safety Edge is a 30-degree tapered pavement edge that aids in vehicle recovery back onto the roadway. Safety Edge is one of the FHWA Every Day Counts initiatives. FHWA recommends using a Safety Edge on all roadway resurfacing projects where there is a height difference between the paved road and the adjacent graded material. Shaping the pavement edge to a 30-degree taper reduces 'tire scrubbing' that occurs when vehicles attempt to steer back onto the roadway.

Above: Safety Edge reduces drop-off when graded material has worn away. Source: FHWA

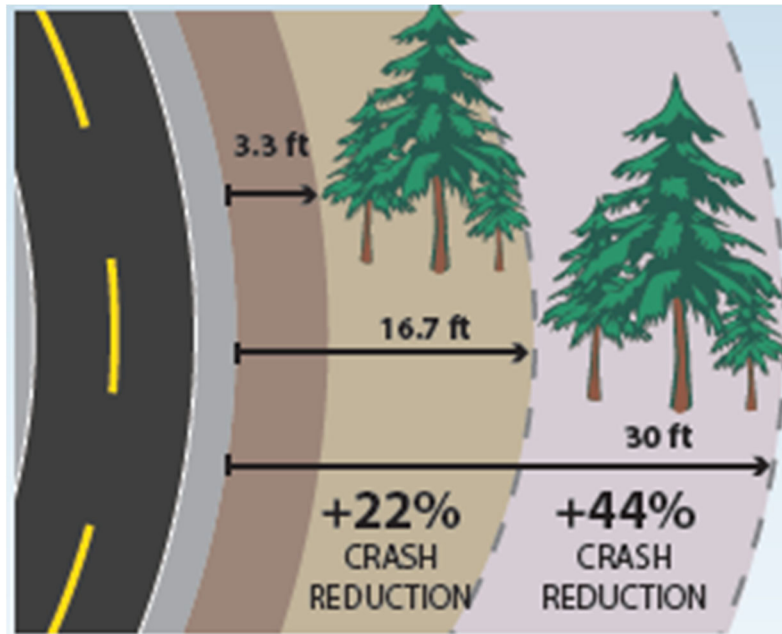
Roadside clear zones: Per FHWA, a roadside clear zone is an unobstructed, traversable area beyond the pavement edge for the recovery of errant vehicles. Clear zones are free of rigid fixed objects such as trees and utility cabinets or poles. Clear zones may be used in conjunction with adding or widening shoulders.

*Above: crash reduction factors for 16.7-foot and 30-foot clear zones. Source: FHWA.*

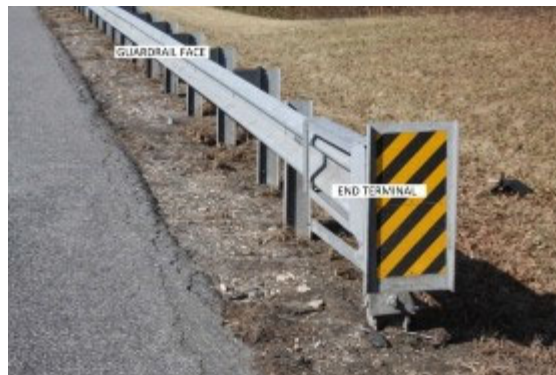
FHWA publishes extensive device-specific guidance and memoranda on guiderail. Manufacturers must have their guiderail assessed for crashworthiness before being issued an Eligibility Letter by FHWA. Guiderail should also have an appropriate 'End terminal' (or end treatment, crash plate) at each end. The end terminal should have a retroreflective surface for nighttime visibility.

Above: Guiderail end terminal
