BRIDGE PRESERVATION REPORT

Identification of Bridge Preservation Candidates, Treatments, and Costs for Locally Owned Capital District Bridges

August 2021

Capital District
Transportation
Committee

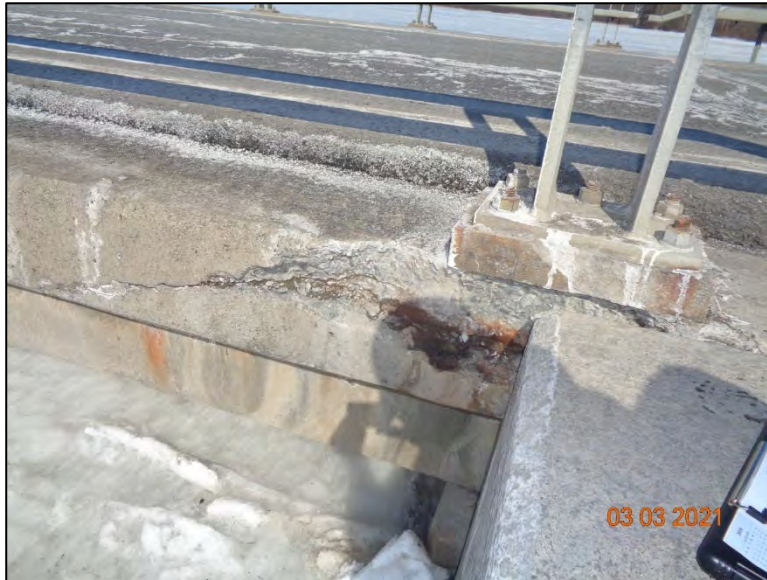
Photo 2: BIN 3301580 – Looking Towards Left at End Right (Other Locations Similar)

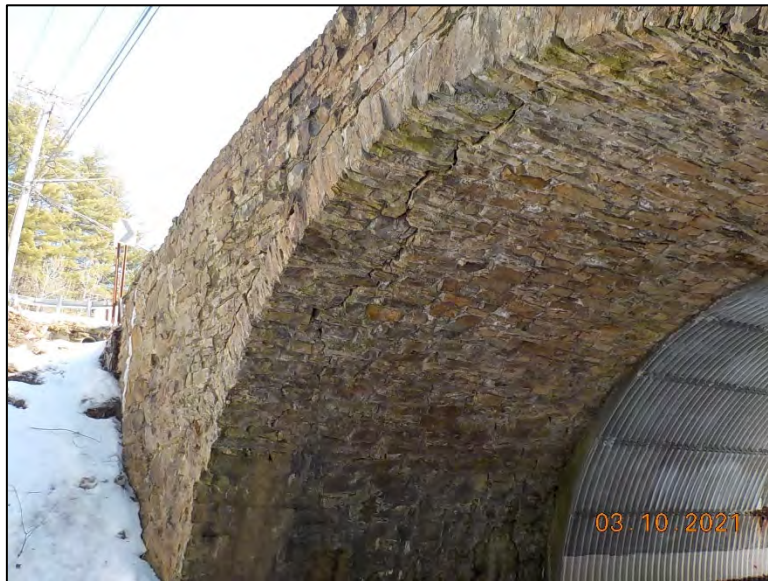
Photo 4: BIN 3304790 – Looking Towards End at Underside of Stone Masonry Arch (Steel Plate Arch in Background)

- BIN 3304790: additional superstructure and substructure repairs (Refer to Photo 4), stream bank armoring, approach rail replacement, wearing surface replacement, approach slab reconstruction

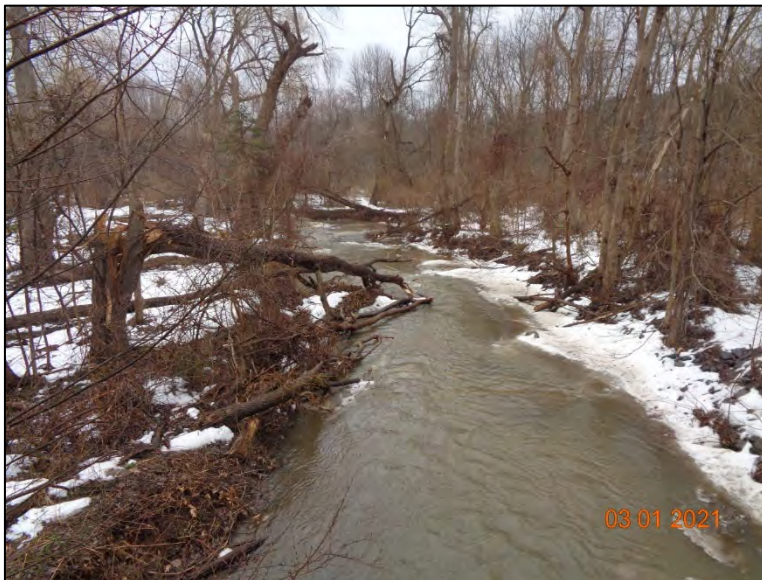
Photo 6: BIN 3050510 – Looking Right From Bridge at Downstream Channel

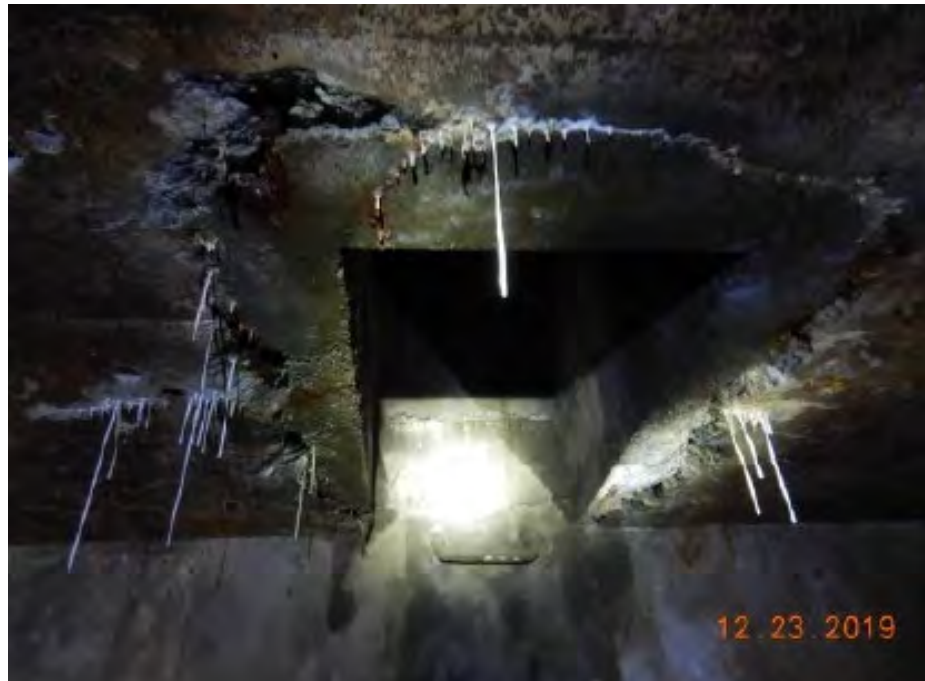
Looking at Top
Slab of Culvert
at Manhole 3
Entrance
(Photo From
2019 Biennial
Inspection
Report)

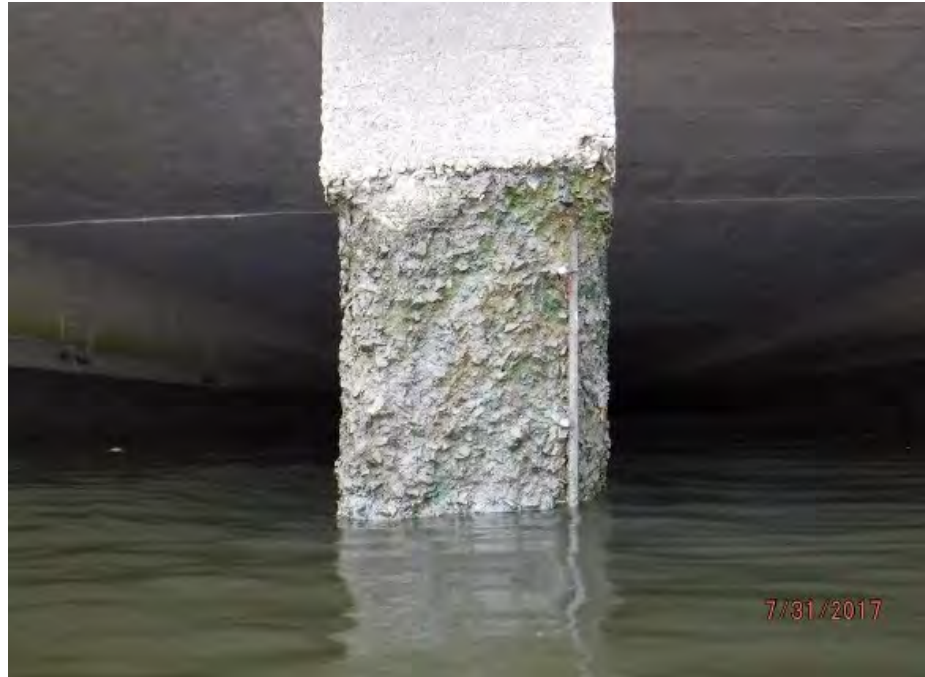
Looking at
Centerwall/Pier
at Outlet
(Photo Taken
From 2017
Diving
Inspection)

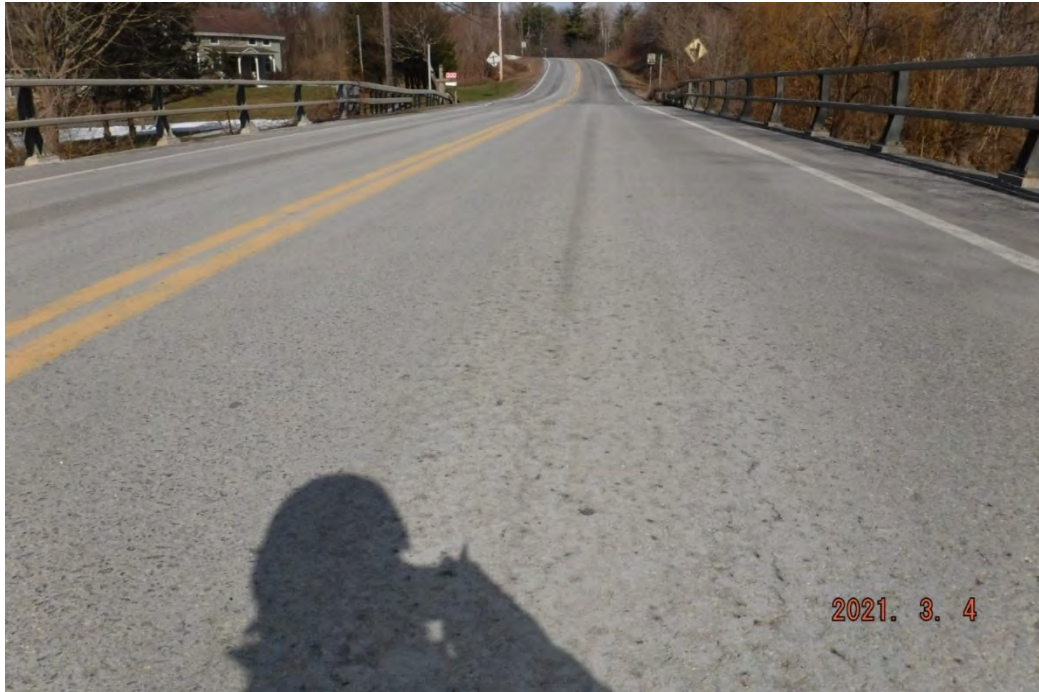
Top of Deck,
Looking
Towards The
end

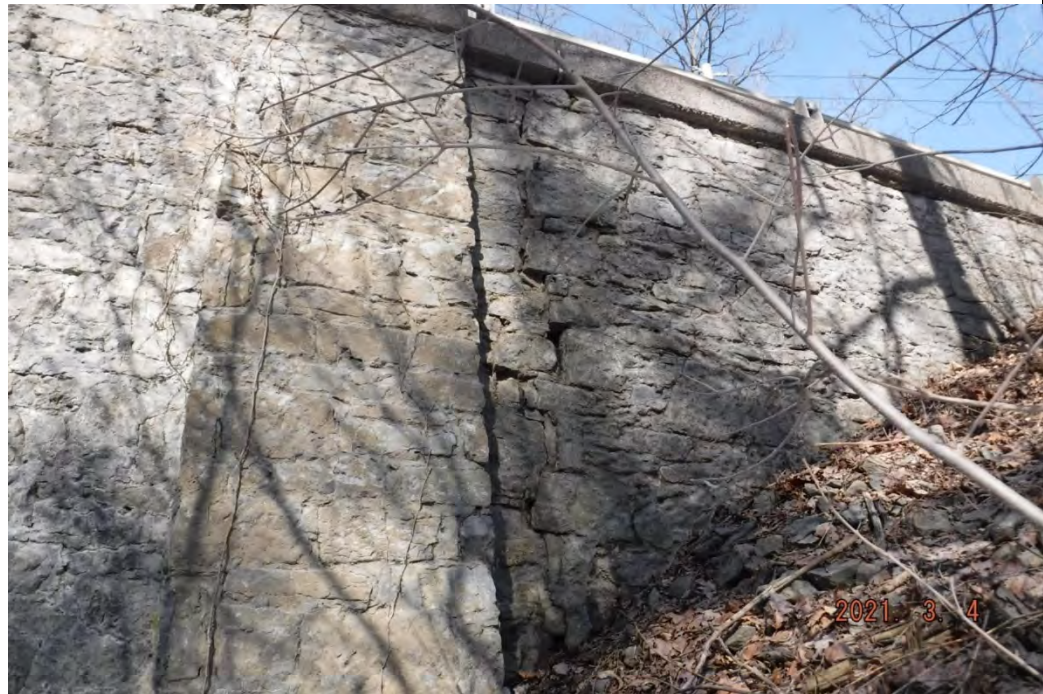
End Right
Wingwall,
Looking
Towards The
Left.

Re-point
masonry.

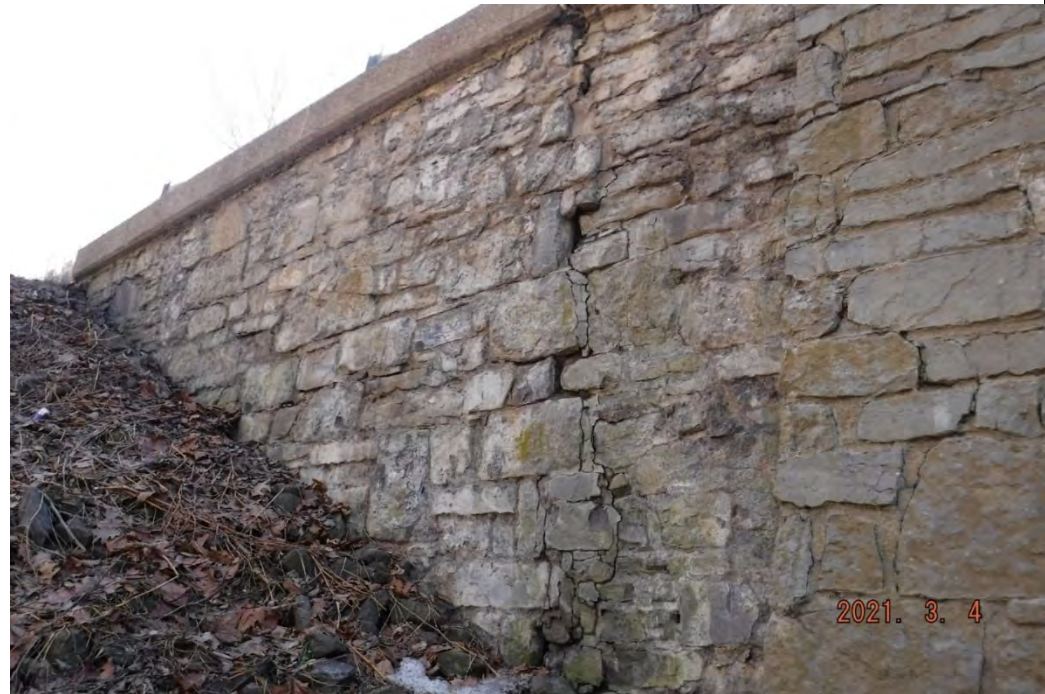
PHOTO NO:
7

DESCRIPTION:
End Left
Wingwall,
Looking
Towards The
Right.

Re-point
masonry.

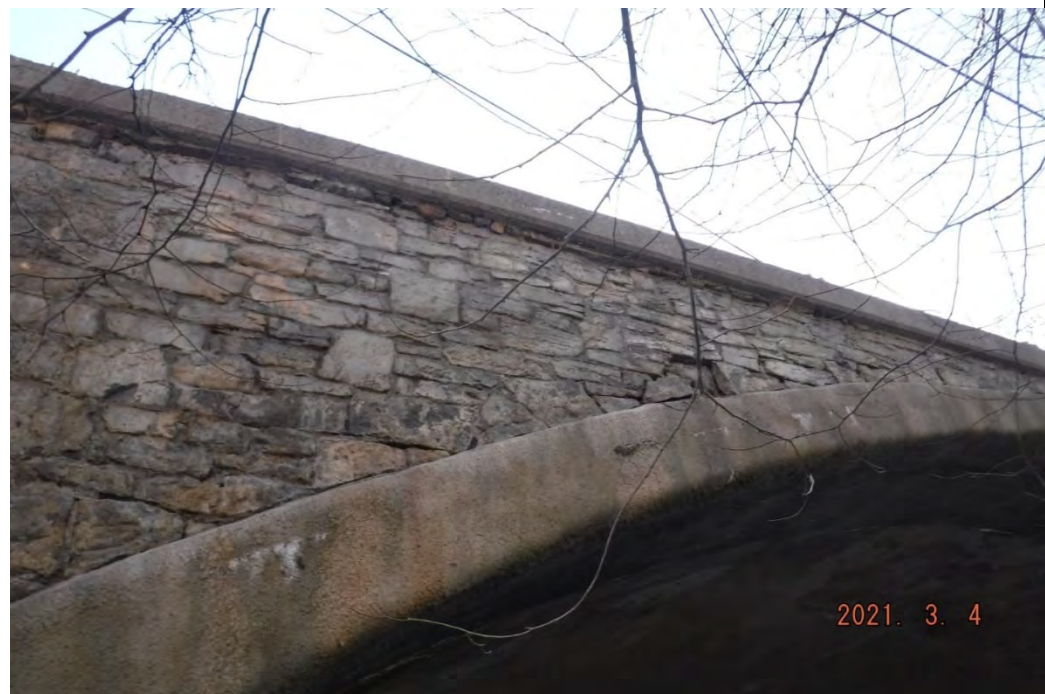
PHOTO NO:
8

DESCRIPTION:
Left Headwall
Beyond
Midspan,
Looking
Towards The
Right.

Re-point
masonry and
reset masonry
stones.

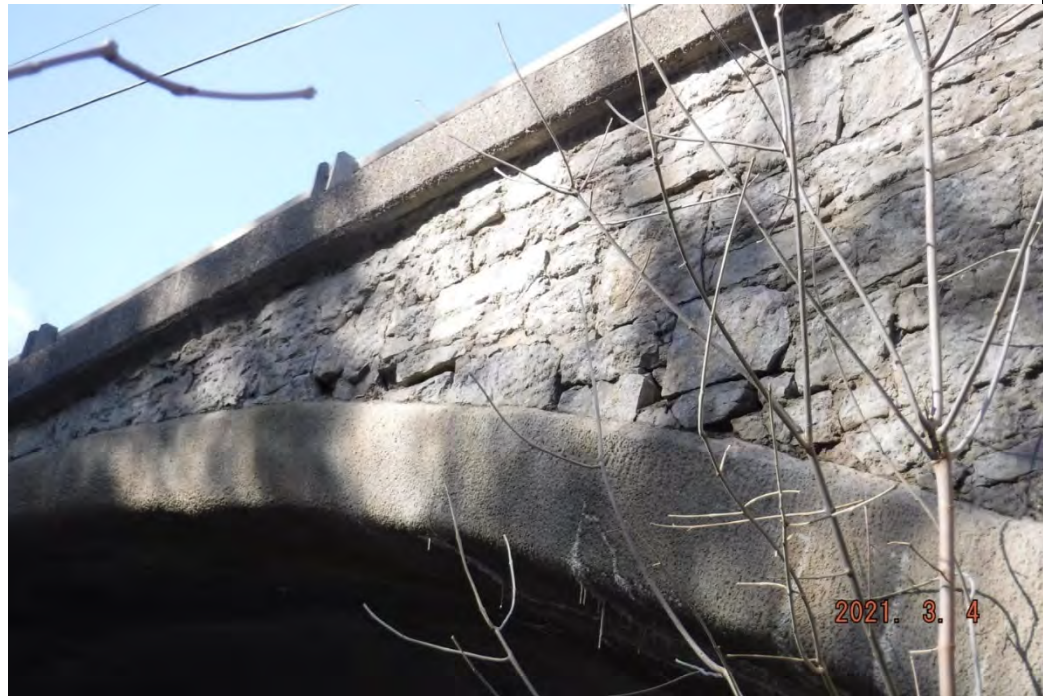
PHOTO NO:
9

DESCRIPTION:
Right
Headwall
Beyond
Midspan,
Looking
Towards The
Begin Left.

Re-point
masonry.

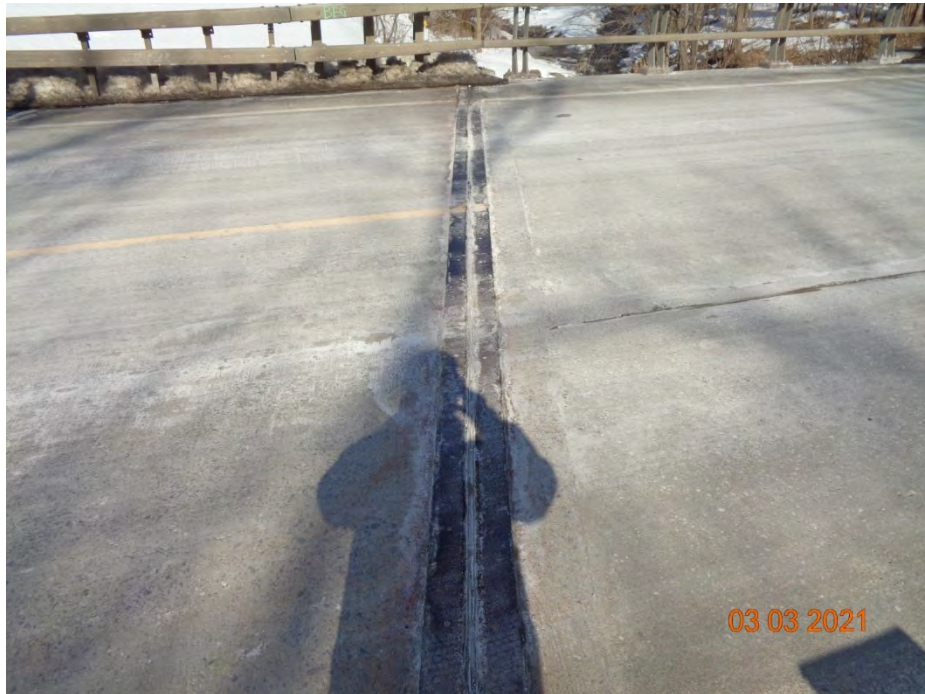
Looking
Towards Left
Across Top of
Begin Joint

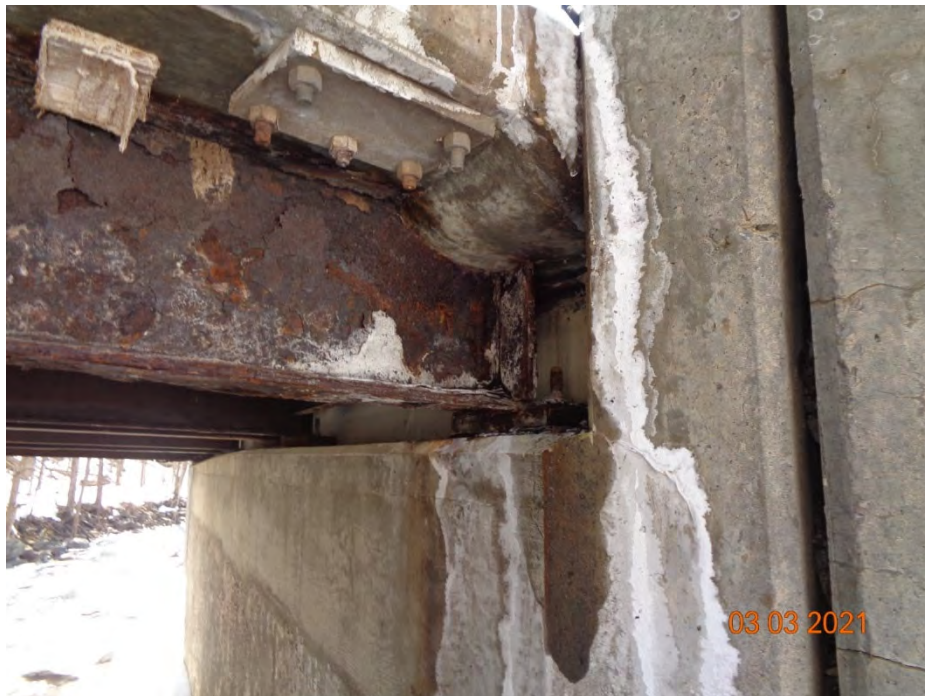
Looking
Towards Begin
Right at Left
Face of Girder
G1 at Begin
Abutment
(Other Fascia
Girder Beam
Ends Similar)

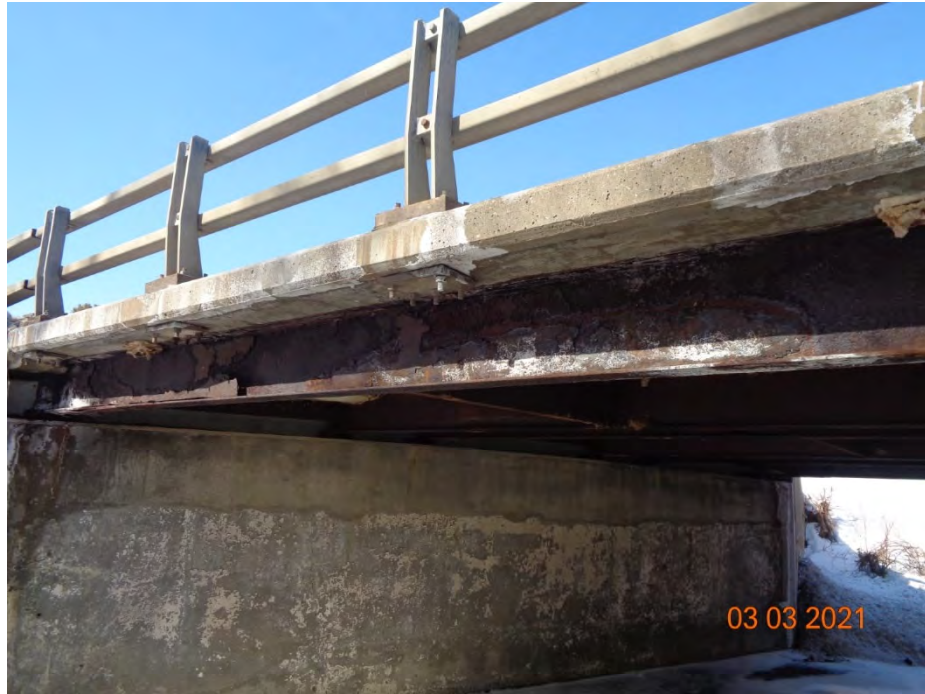
Looking
Towards Begin
Left Along
Right Face of
Girder G6
(Girder G1
Similar)

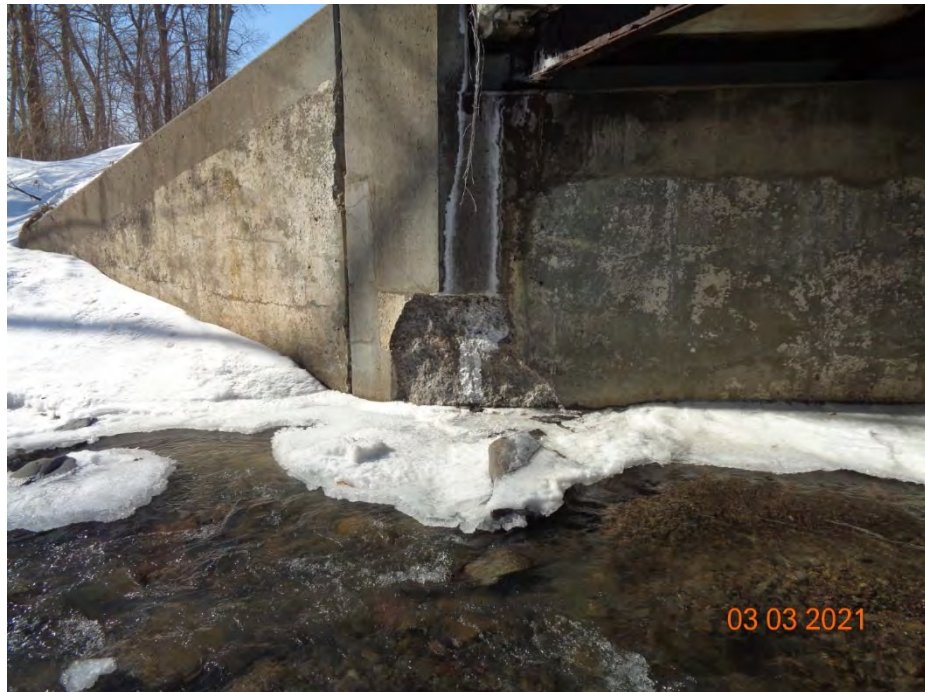
Looking
Towards Begin
at Begin
Abutment
Stem and
Begin Right
Wingwall (End
Abutment
Spalling
Similar)

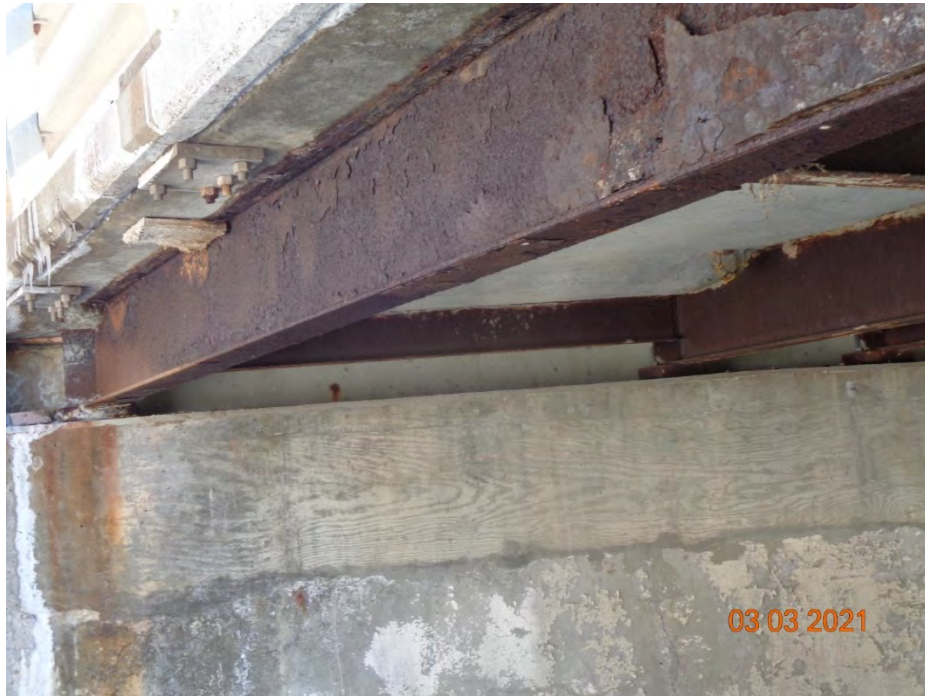
PHOTO NO:
5**DESCRIPTION:**
Looking
Towards Begin
at Lack of
Water
Leakage in
Girder Bay 1
(Typical
Condition)

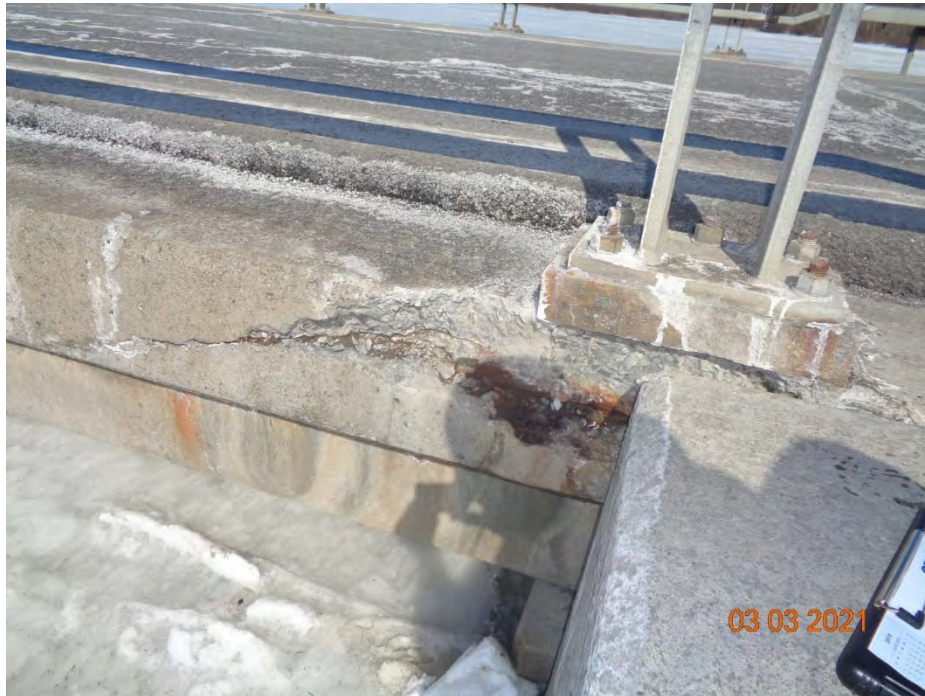
Looking
Towards Right
at Left Fascia
Adjacent to
End Abutment
(Other
Locations
Similar at Each
Rail Post on
Both Fascias)

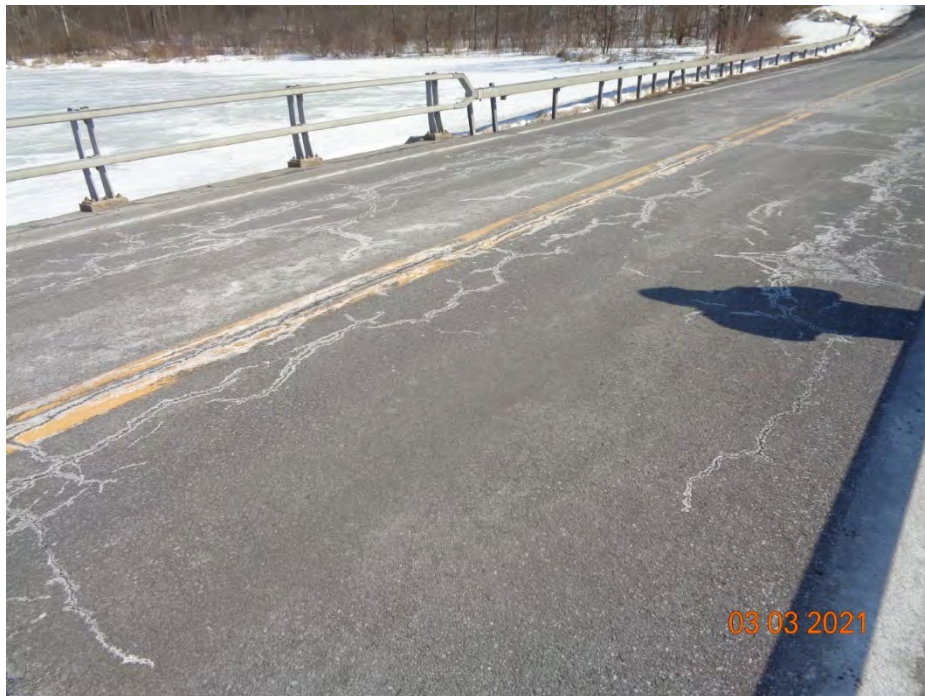
Looking
Towards End
Left Across
Top of Bridge

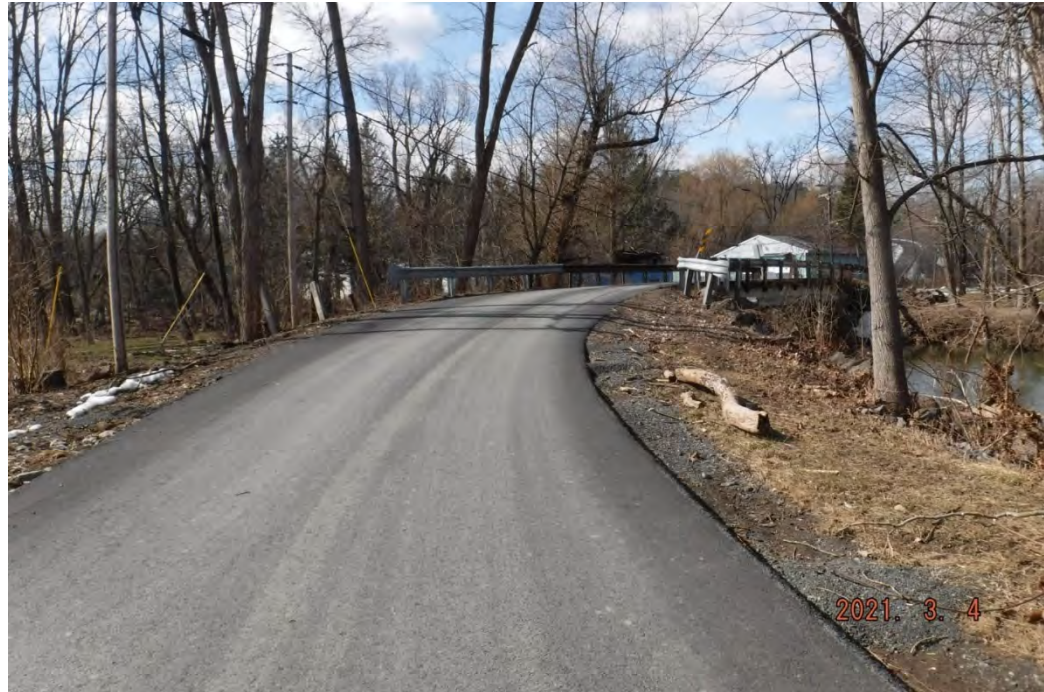
End
Approach,
Looking
Towards The
Begin.

Asphalt
Wearing
Surface
Placed at the
approaches
and Deck

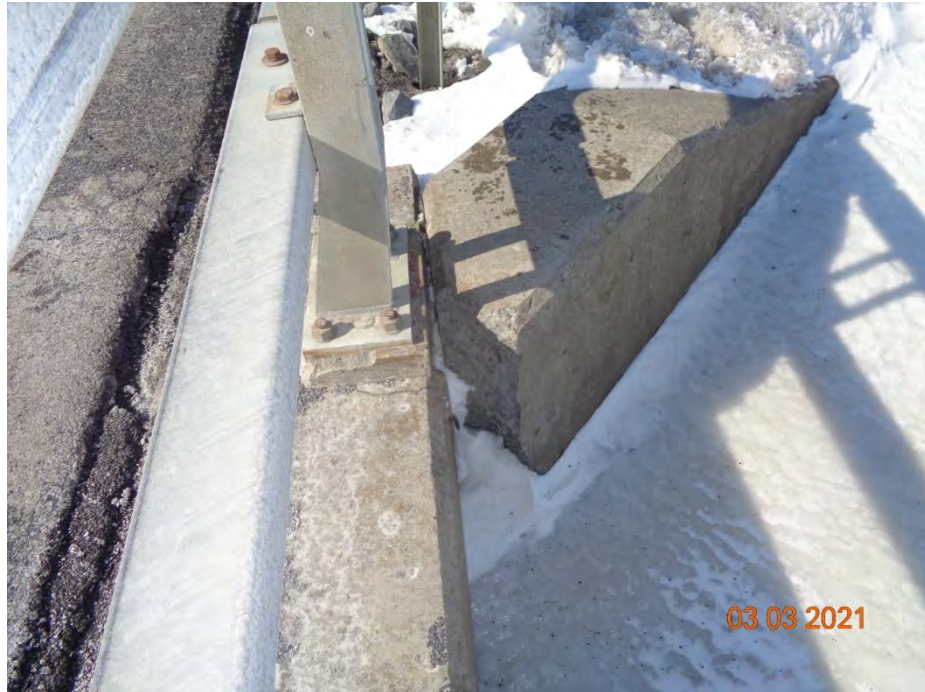
PHOTO NO:
3**DESCRIPTION:**
Looking
Towards Begin
at Begin Left
Wingwall
Adjacent to
Bridge

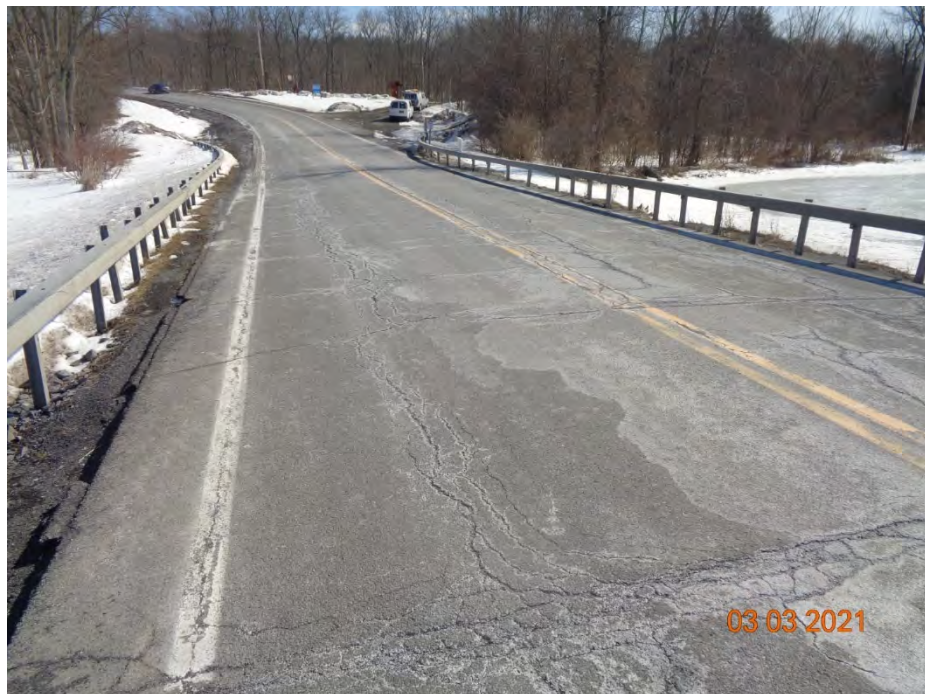
**PHOTO NO:**
4**DESCRIPTION:**
Looking at End
Approach
From Bridge
(Begin
Approach
Similar)

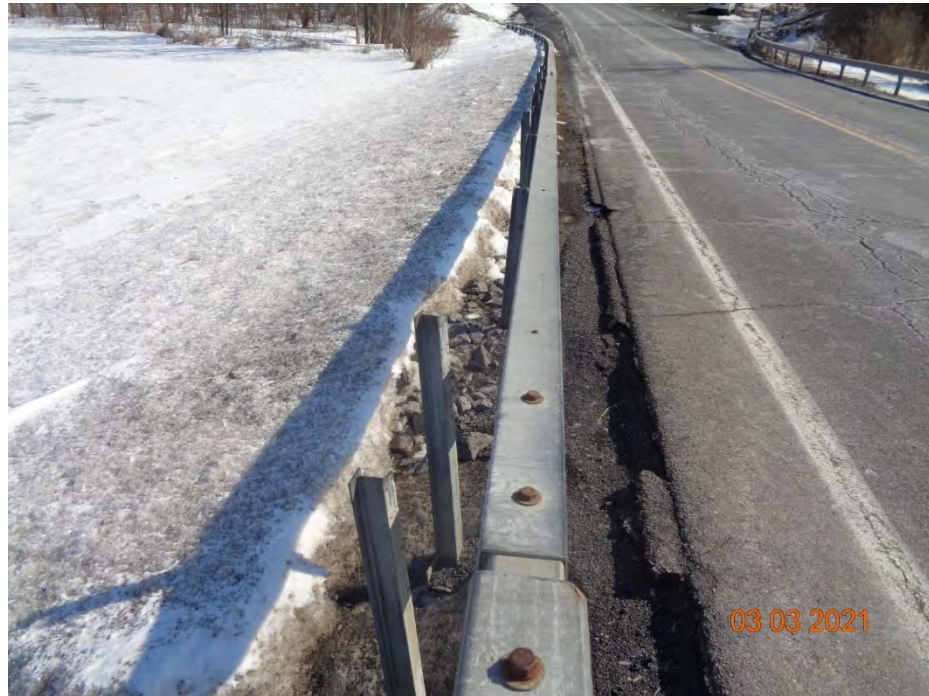
PHOTO NO:
5

DESCRIPTION:
Looking at End
Left Approach
Railing From
Bridge (Other
Quadrants
Similar)

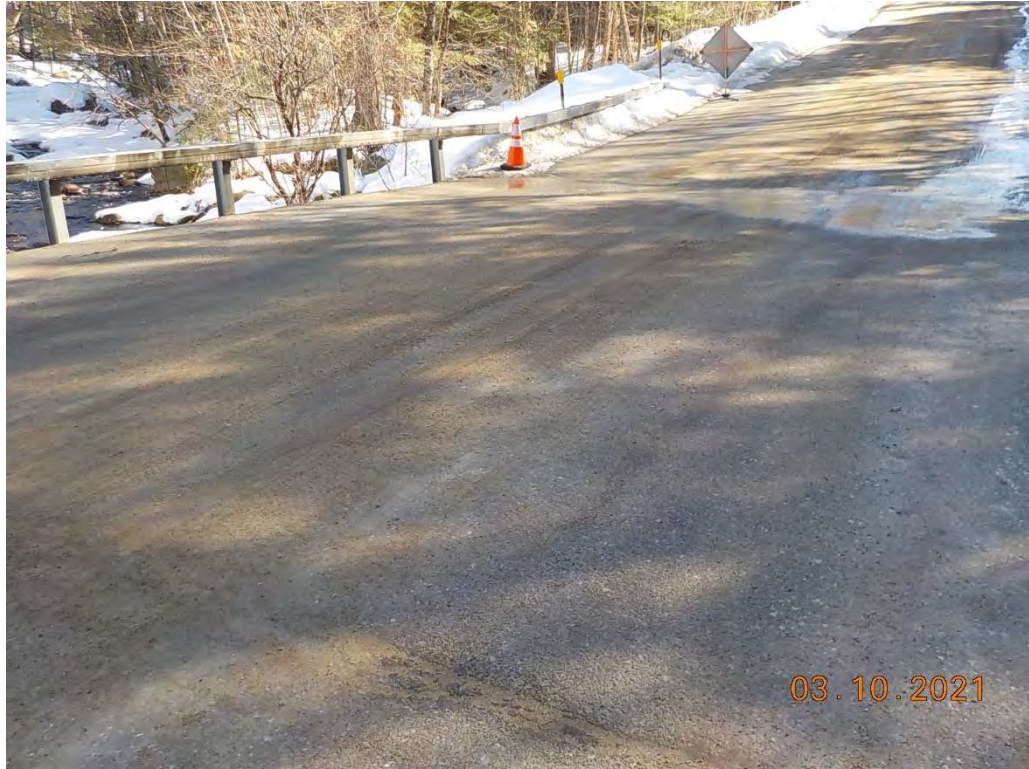
The deck wearing surface
(Looking towards end left).

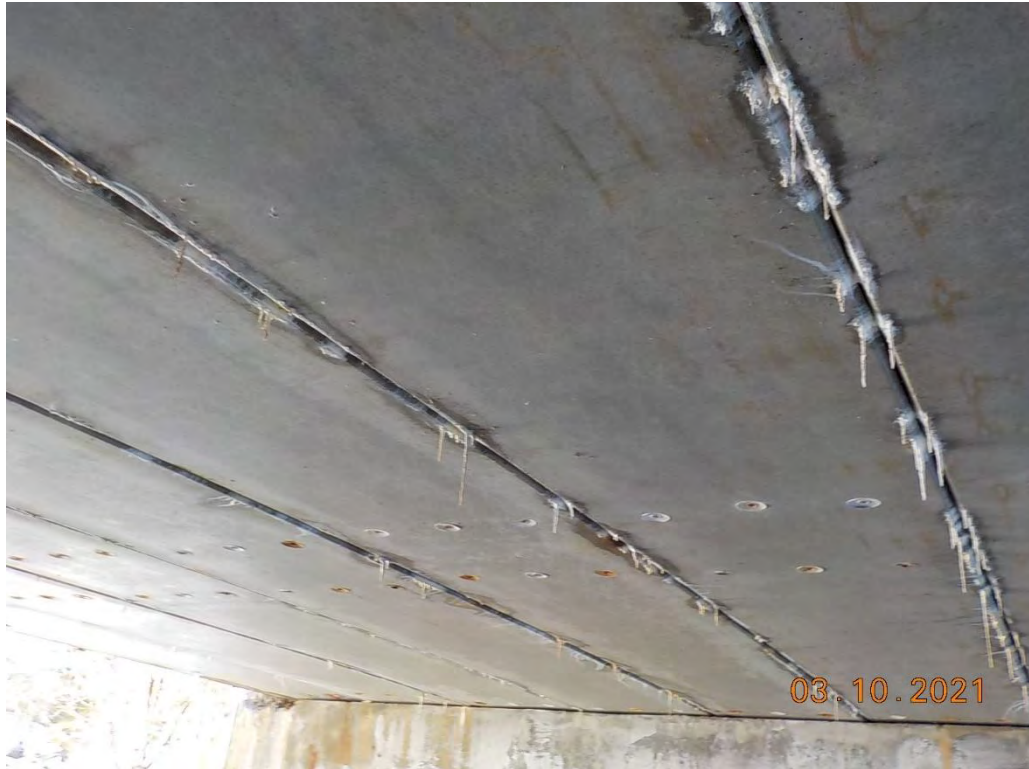
Typical framing
(Looking towards end left).

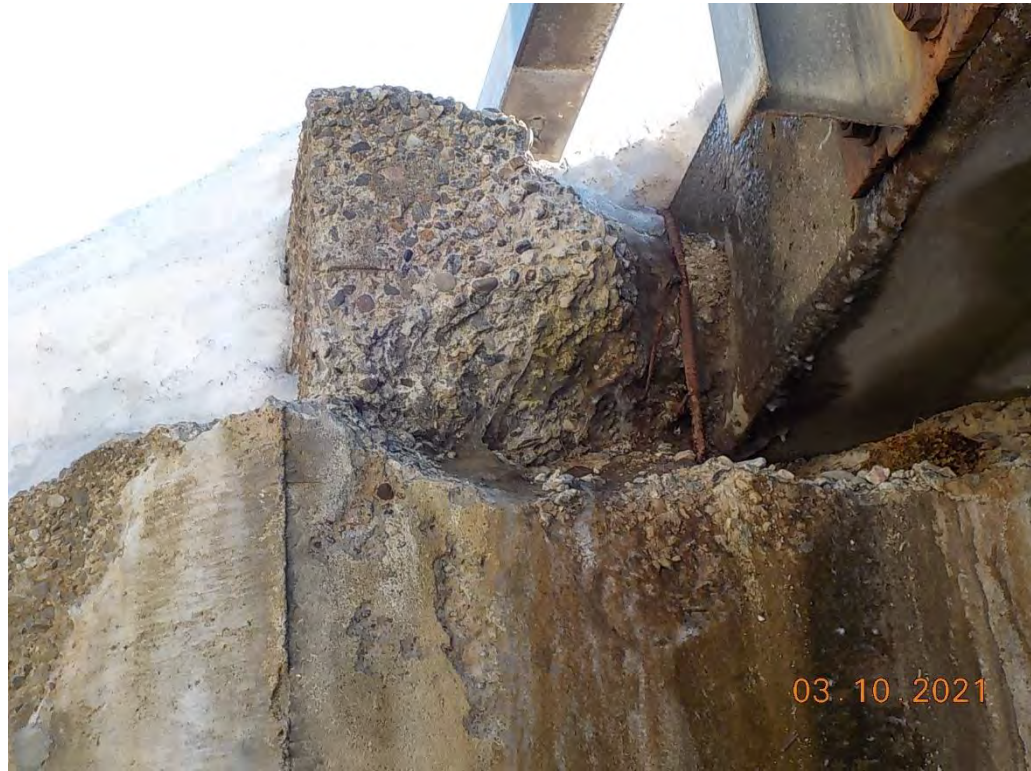
End abutment
left cheek wall
(Looking
towards end).

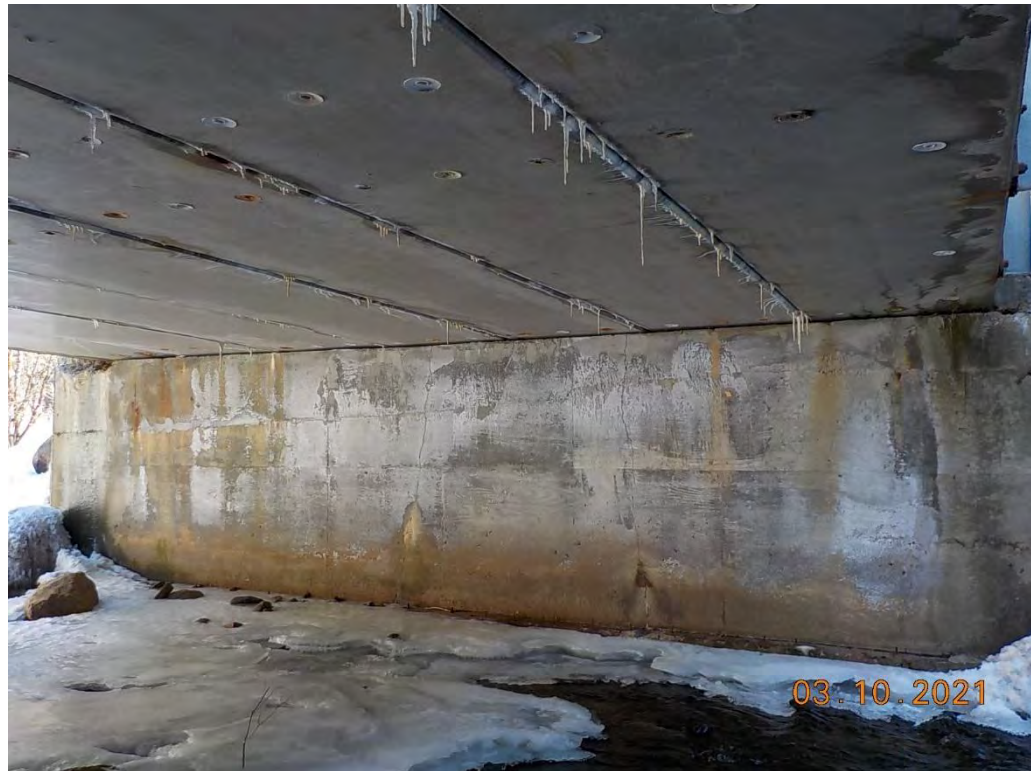
Begin
abutment
(Looking
towards begin
right).

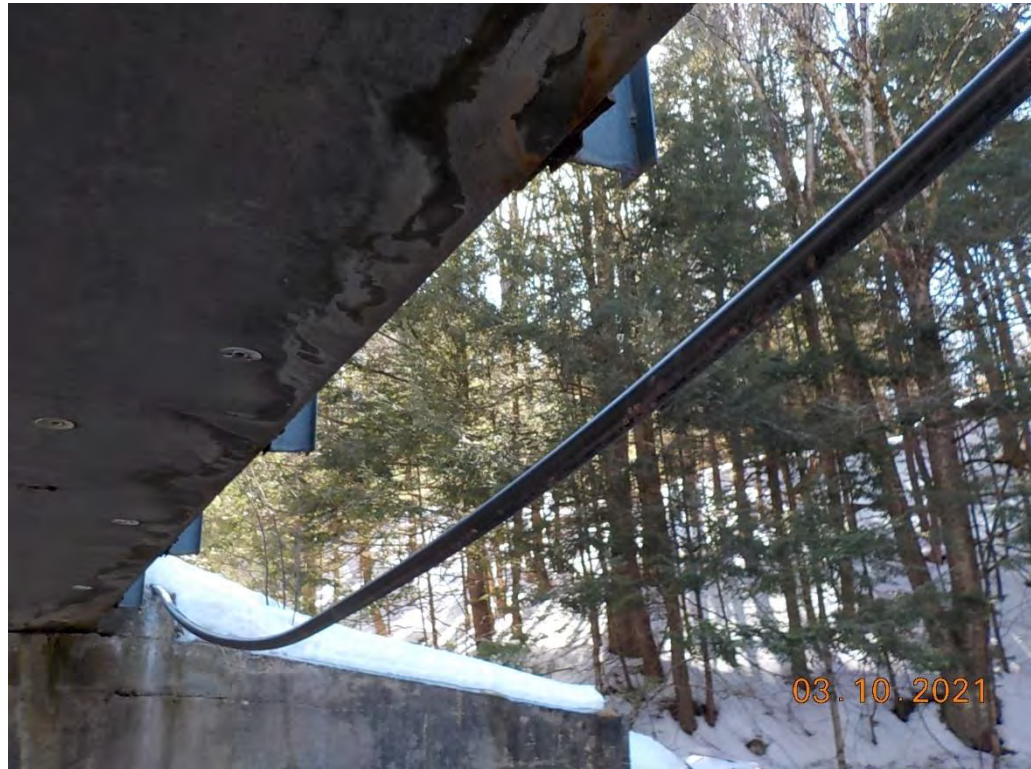
Right fascia
utility
(Looking
towards end).

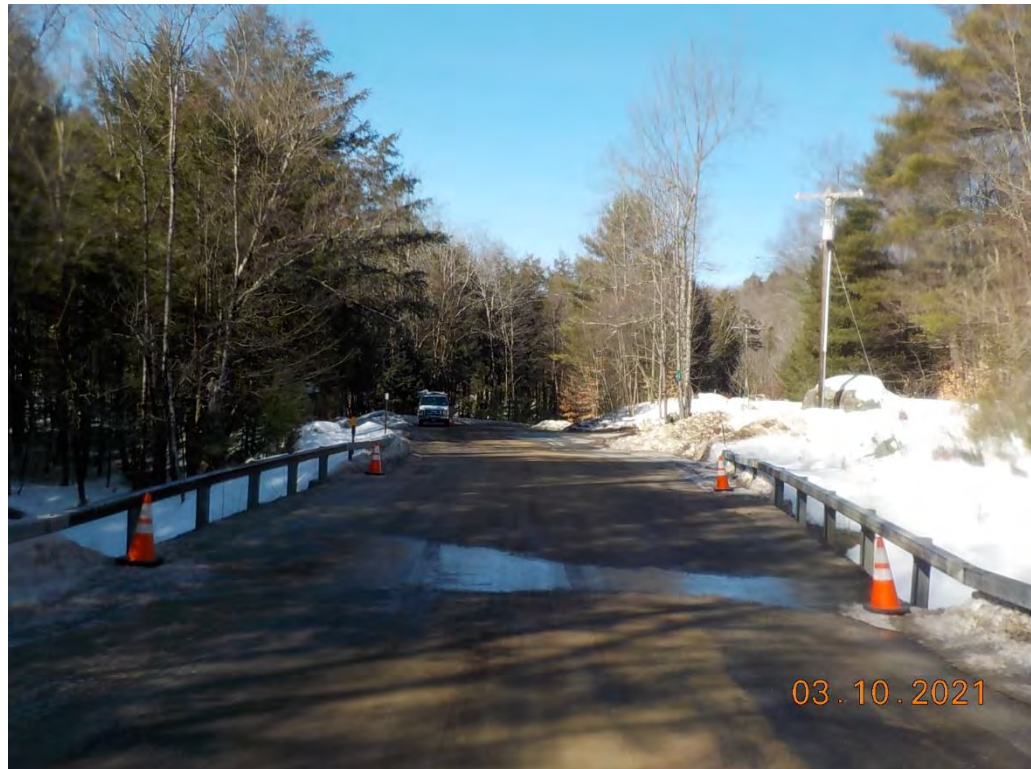
End
Approach.

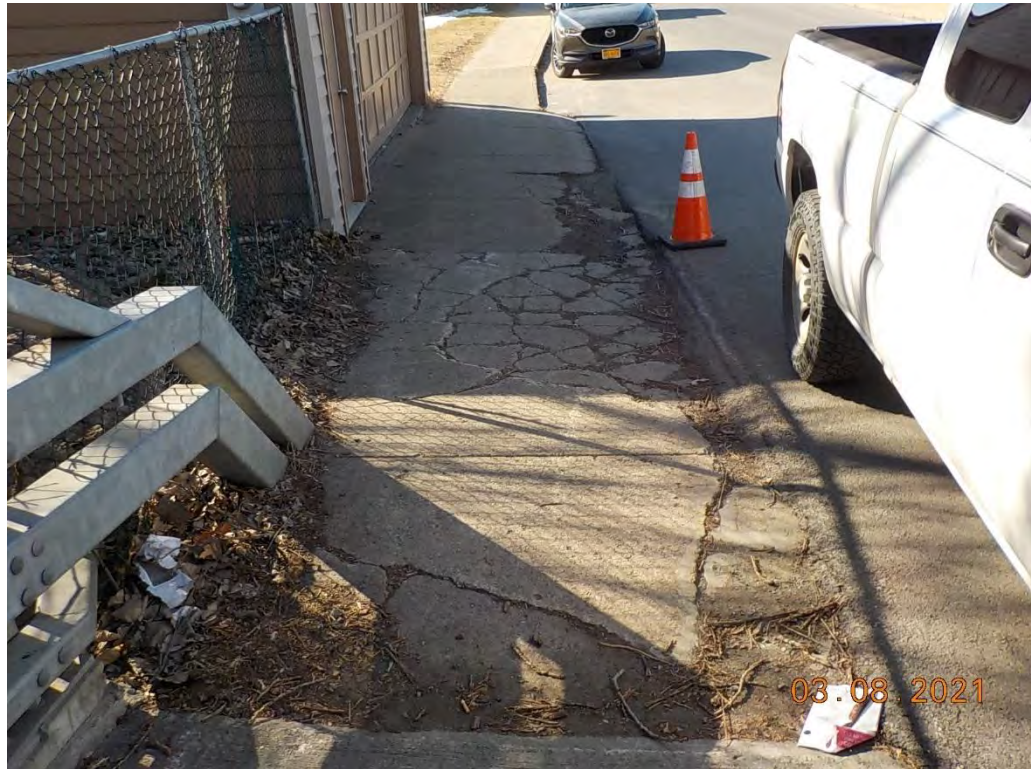
Begin right approach sidewalk, begin left approach sidewalk similar (looking towards begin).

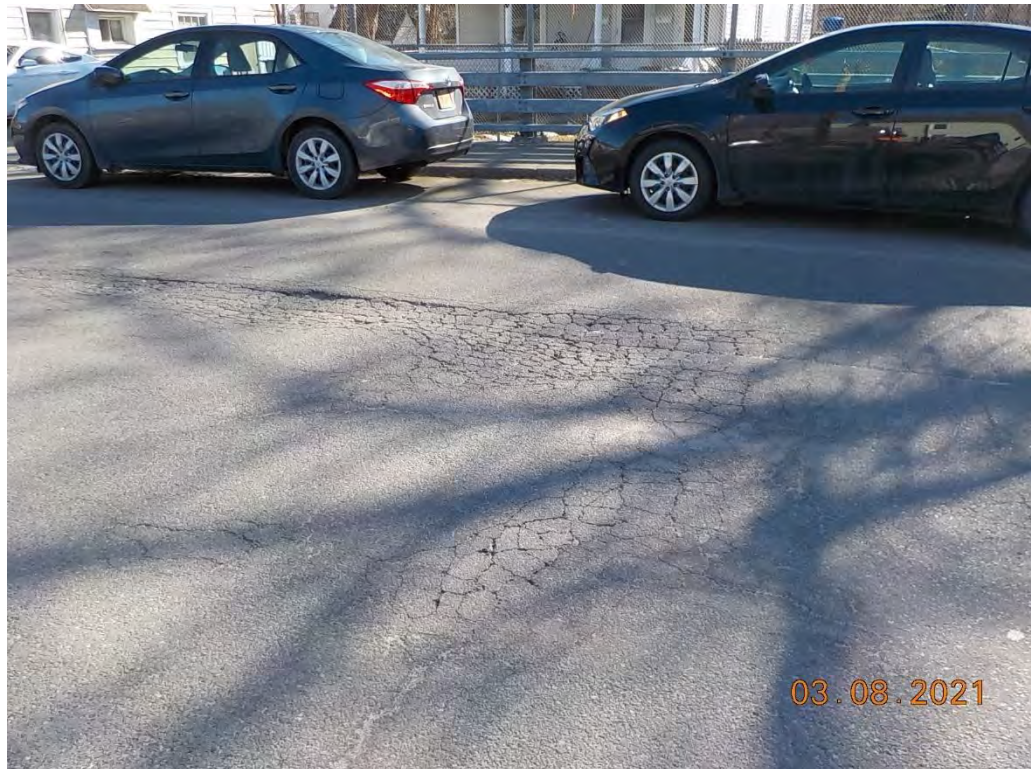
Wearing surface along the center near the begin (looking towards right).

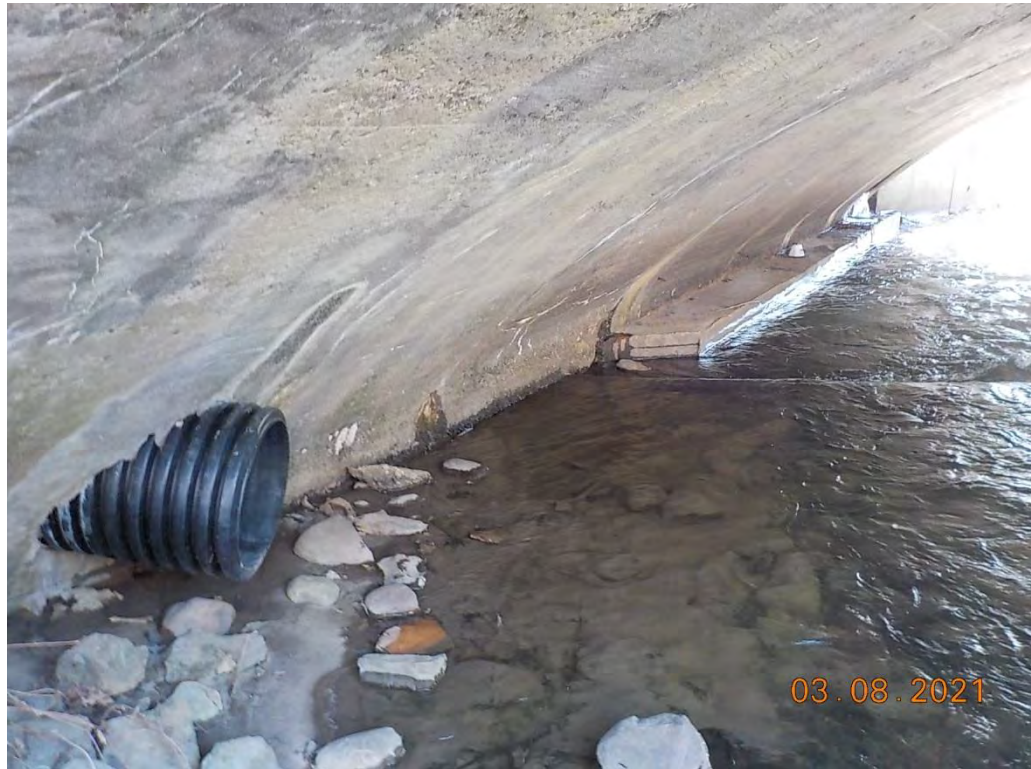
The end abutment footing, begin footing is similar (Looking towards right).

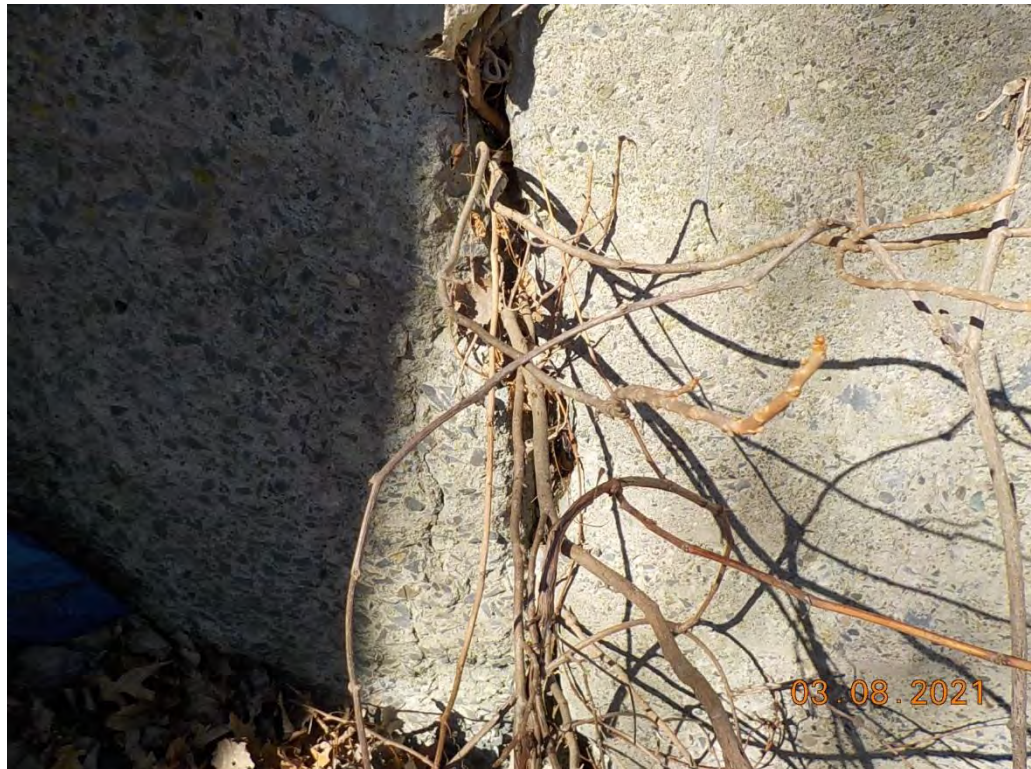
Begin right wingwall (looking towards begin left).

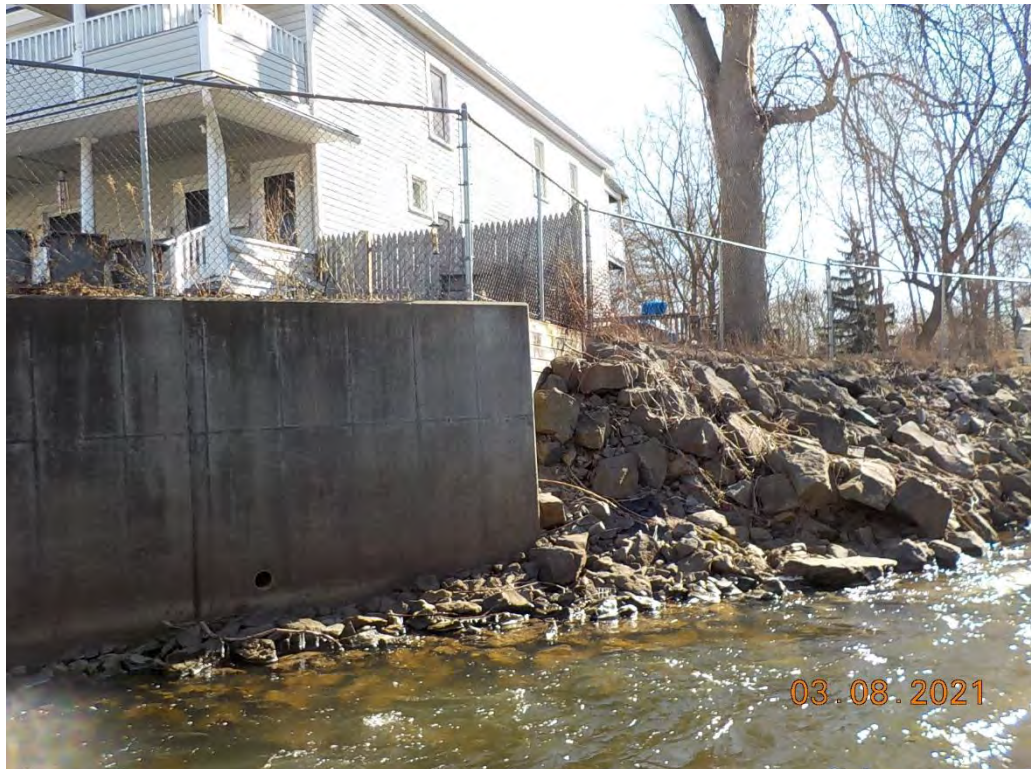
End right stone bank protection (looking towards end right).
