BRIDGE PRESERVATION REPORT

Identification of Bridge Preservation Candidates, Treatments, and Costs for Locally Owned Capital District Bridges

August 2021

Capital District
Transportation
Committee

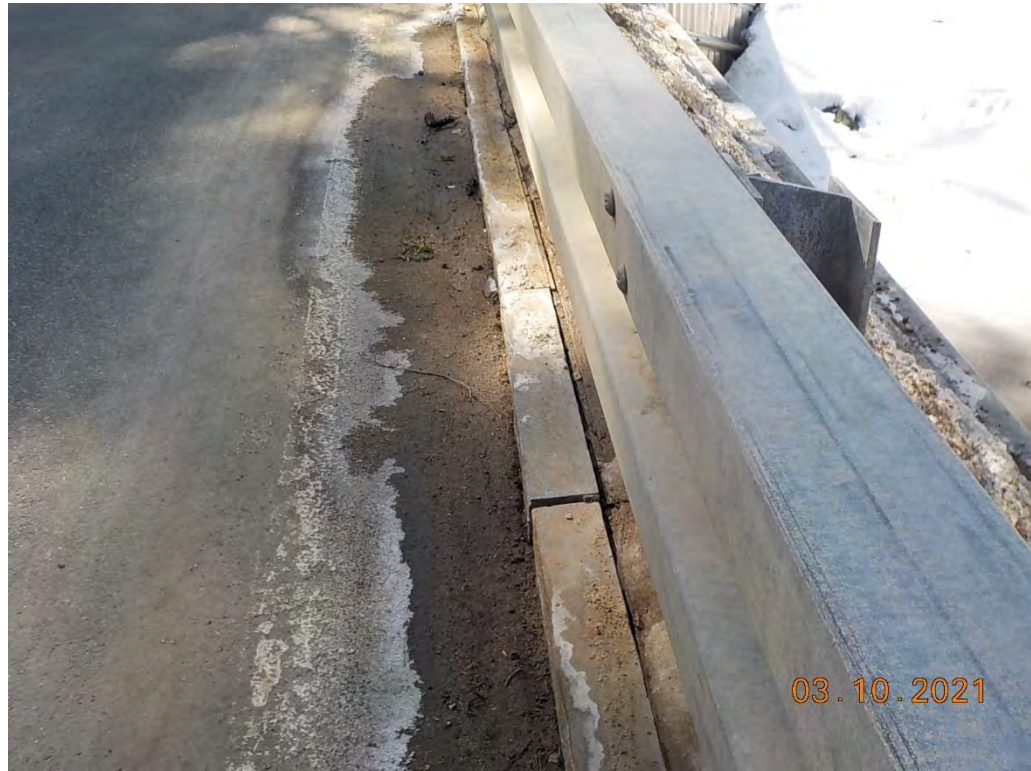
Left bridge
curb near the
end, right
curb similar
(Looking
towards
begin).

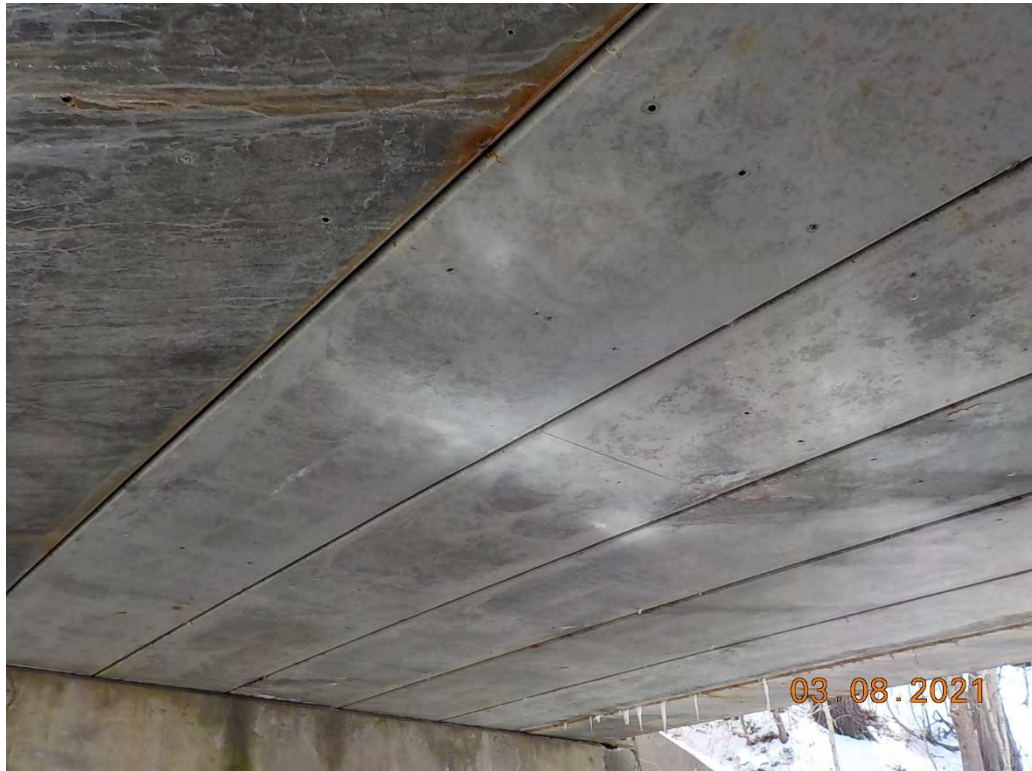
- There is leakage between the longitudinal joints, as well as some rust stained leakage from the beam drains (PH 1). Beam B5 is spalled near the end (appears to be as-built condition, PH 2). There are reflective cracks in the wearing surface above indicating the shear keys have failed and are allowing some movement (PH 3). Removing the existing asphalt wearing surface and placing a new concrete wearing surface are recommended.

DESCRIPTION:

Typical
framing
(Looking
towards
begin).

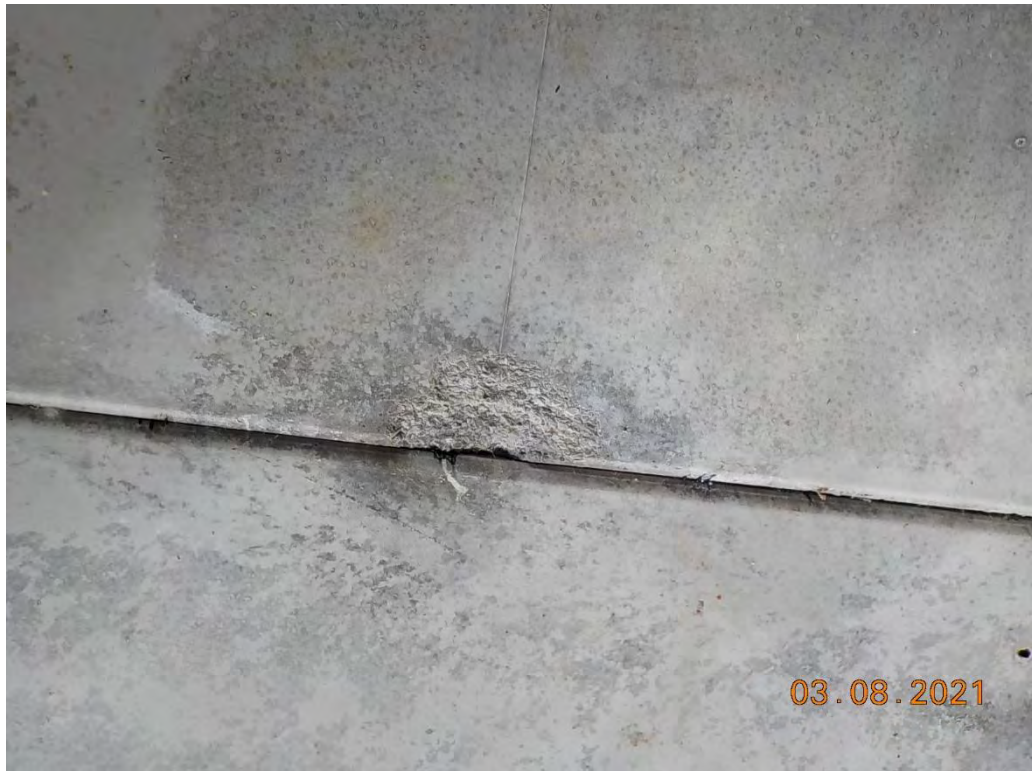
2

Left
edge of Beam
5 near the end
(Looking
towards left).

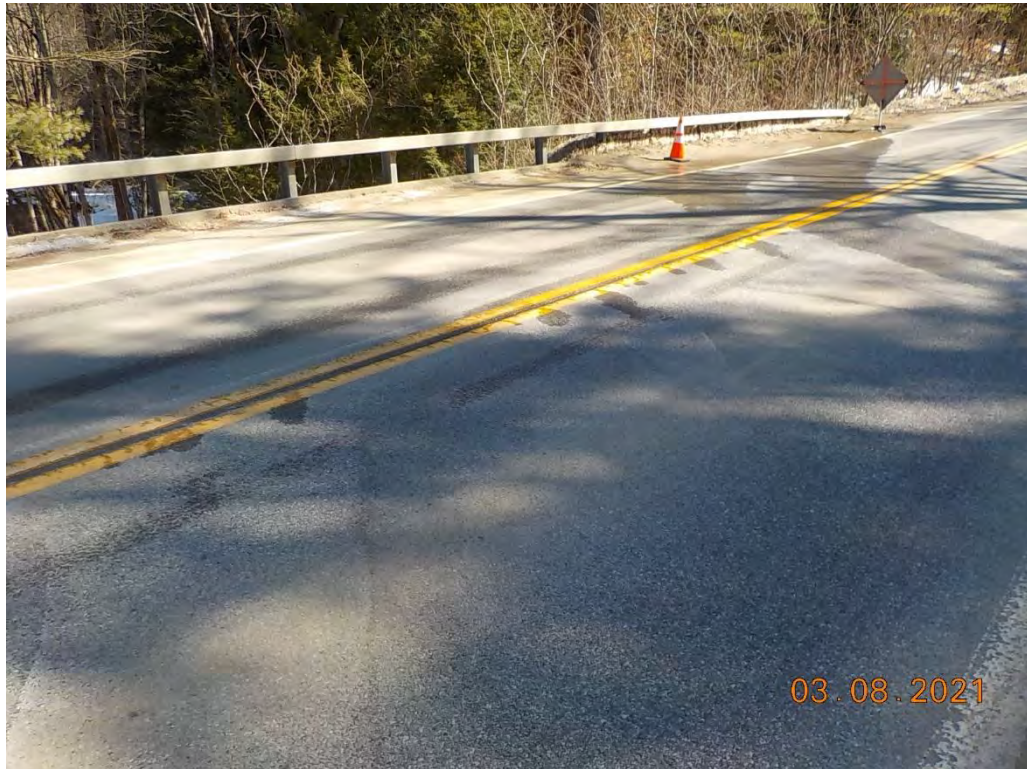
3

The deck wearing surface
(Looking towards begin right).

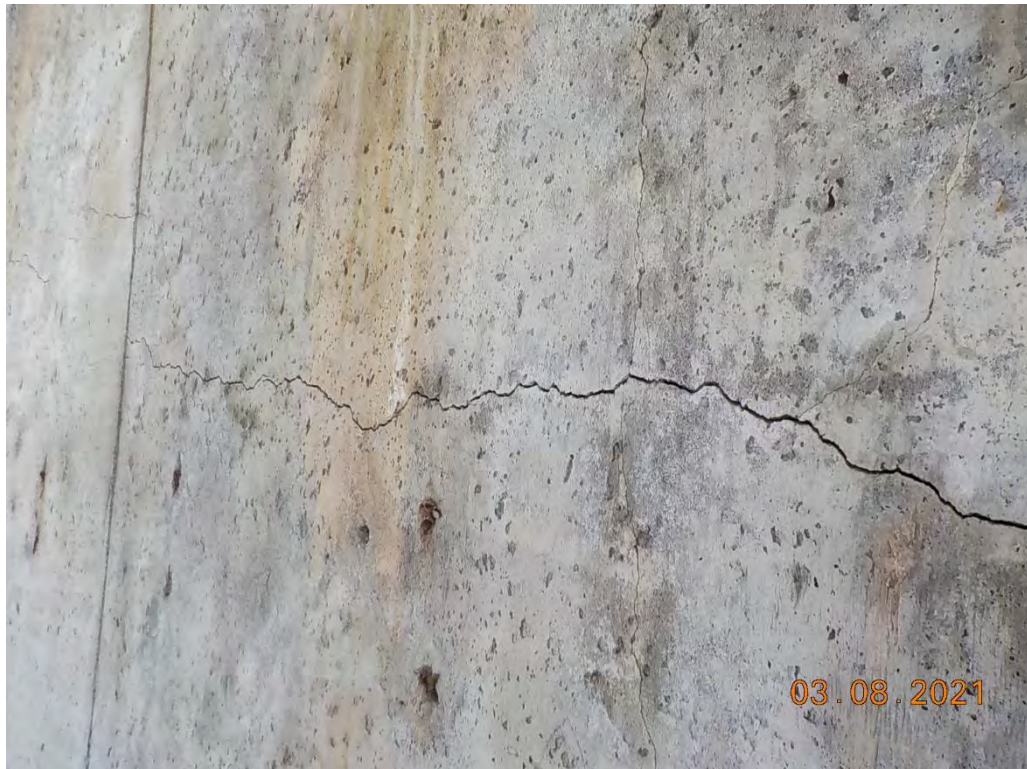
4

- Begin and end abutment stem and wingwalls exhibit multiple up to 1/8" wide x 1/2 to full stem width horizontal cracks (PH 4). Class A concrete repair is recommended.

End abutment stem near the middle
(looking towards end).

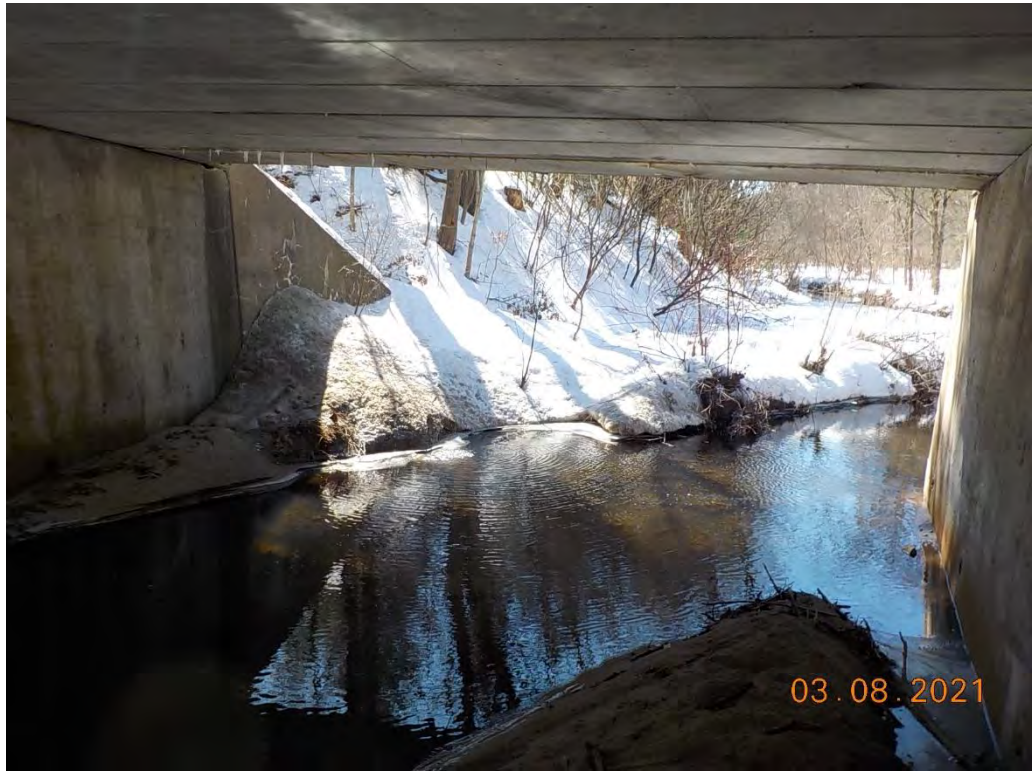
- Waterway opening is reduced due to a silt/vegetation island built up under the bridge. In addition, the stream alignment has resulted in bank erosion and substructure footing exposure (PH 5 & 6). Stream channel regrading with stone bank protection is recommended.

Upstream
Channel
(Looking
towards left).

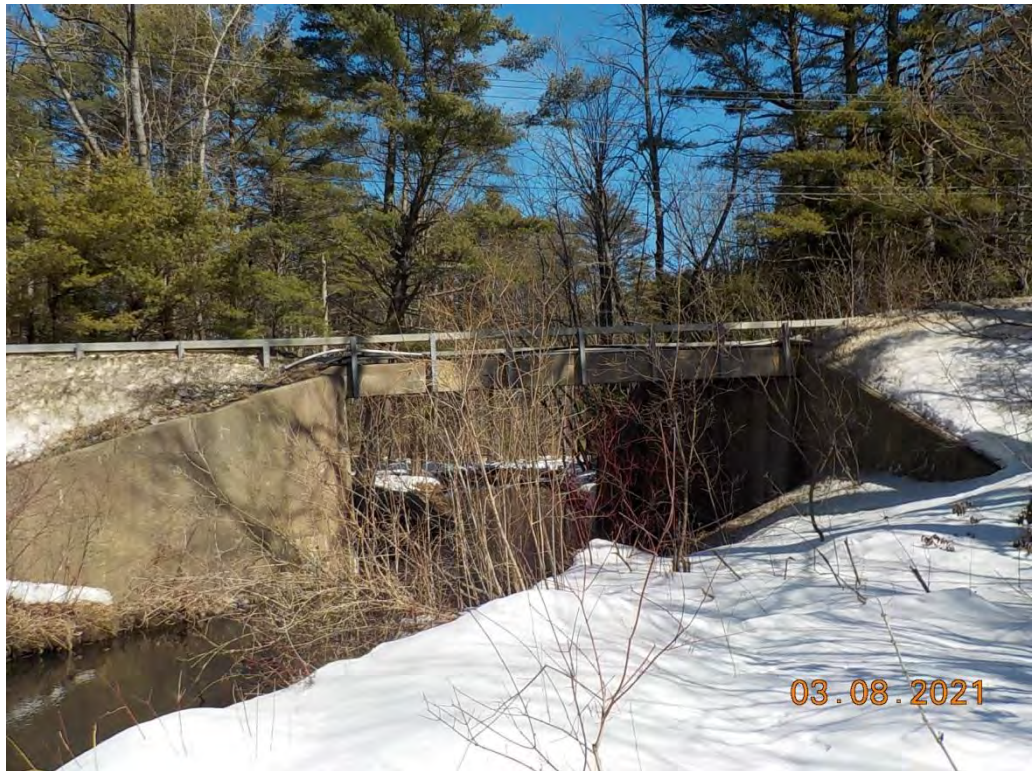
6

Left elevation
(Looking
towards right).

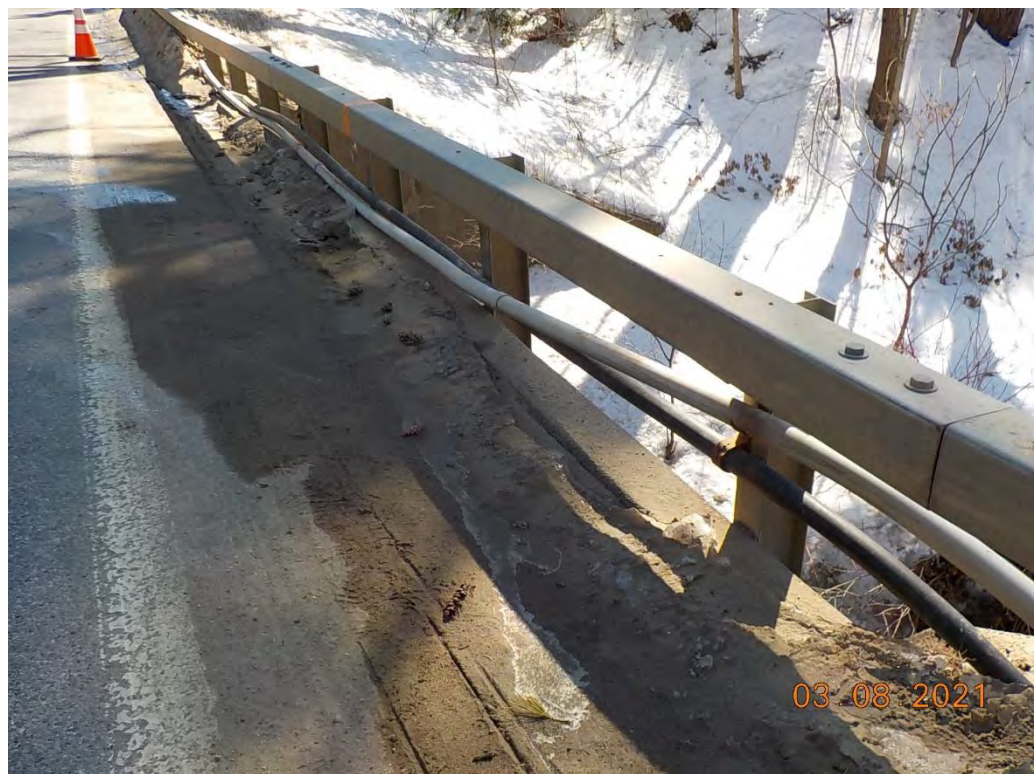
7

- The bridge has a build-up of sand debris along the curb and the curb is trapping drainage on the deck, leading to leakage through the beam shear keys (PH 7). Removing curb to improve drainage is recommended.

Utility at left fascia, Debris along the curb (Looking towards begin left).

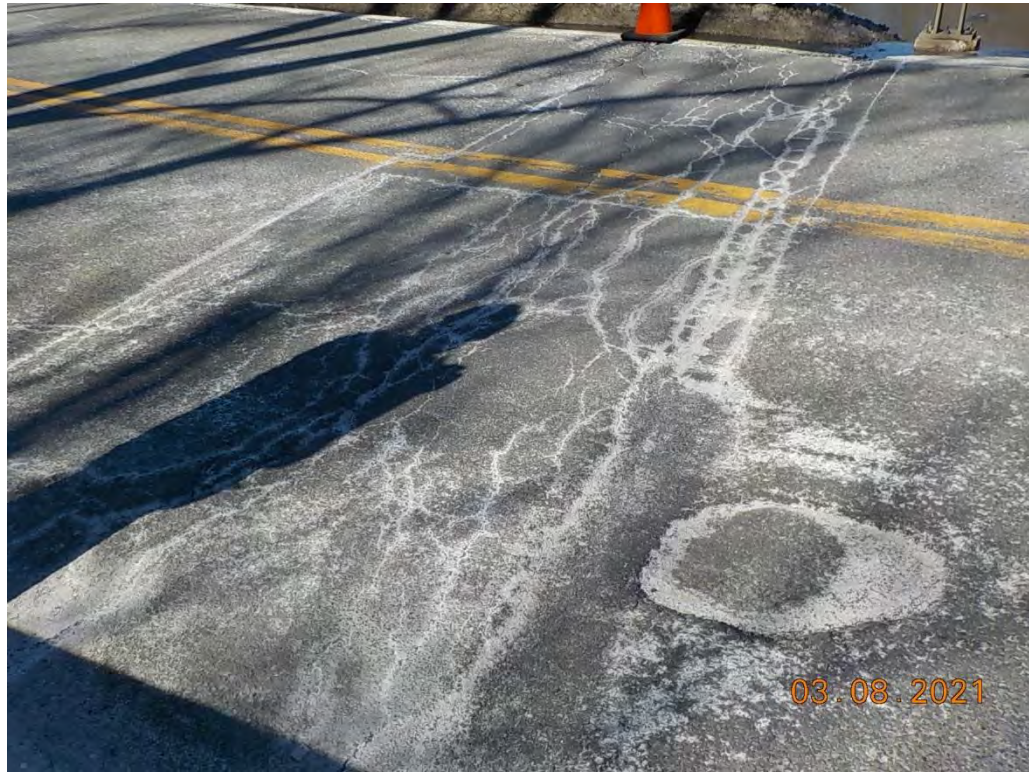
- Both approach pavements are cracked and/or settled up to 2" (PH 1). Replacing existing deck and approach wearing surface is recommended.
- The begin left, end left and end right guide railings exhibit impact damages (PH 2). Repairing guide railing is recommended.

Begin approach wearing surface, end approach similar (looking towards left).

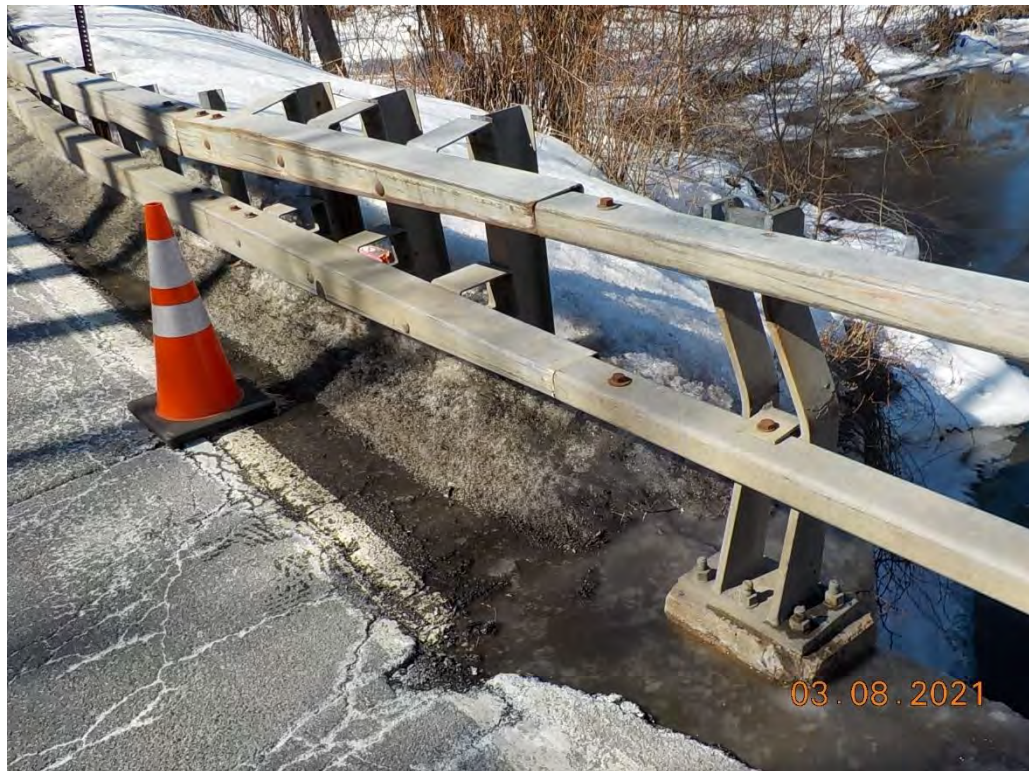
2

Begin left guide railing (looking towards begin left)

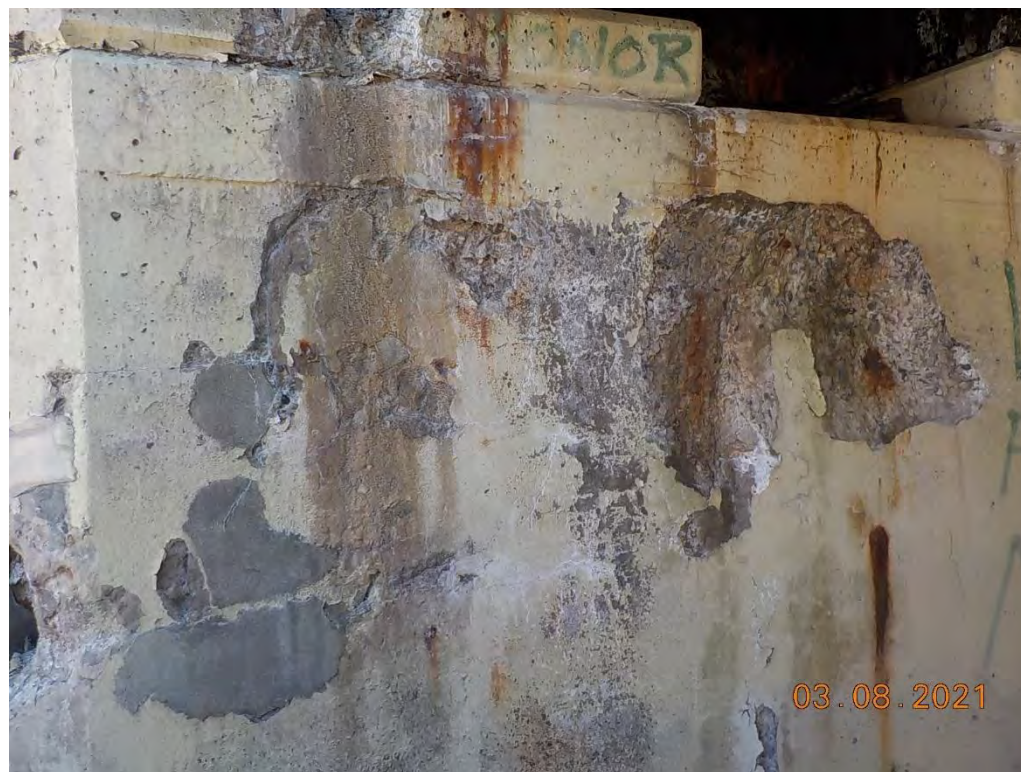
- The begin and end abutments exhibit random spalls up to 4" deep (PH 3 & 4). Concrete repair (Class D) is recommended.
- The steel protective coating (patina) is in poor or failed condition throughout (PH 5 & 6). The condition is worse at the exterior side of fascia girders and girder ends. Painting of those areas is recommended.

End abutment stem (looking towards end right).

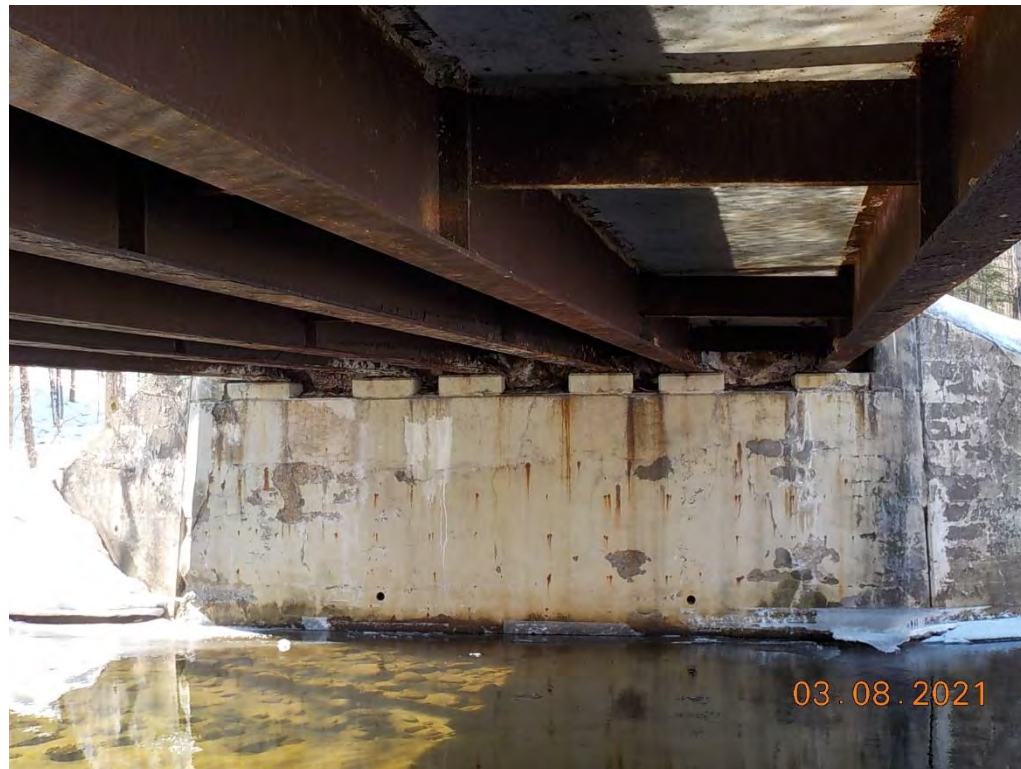
4

Begin abutment stem (looking towards begin)

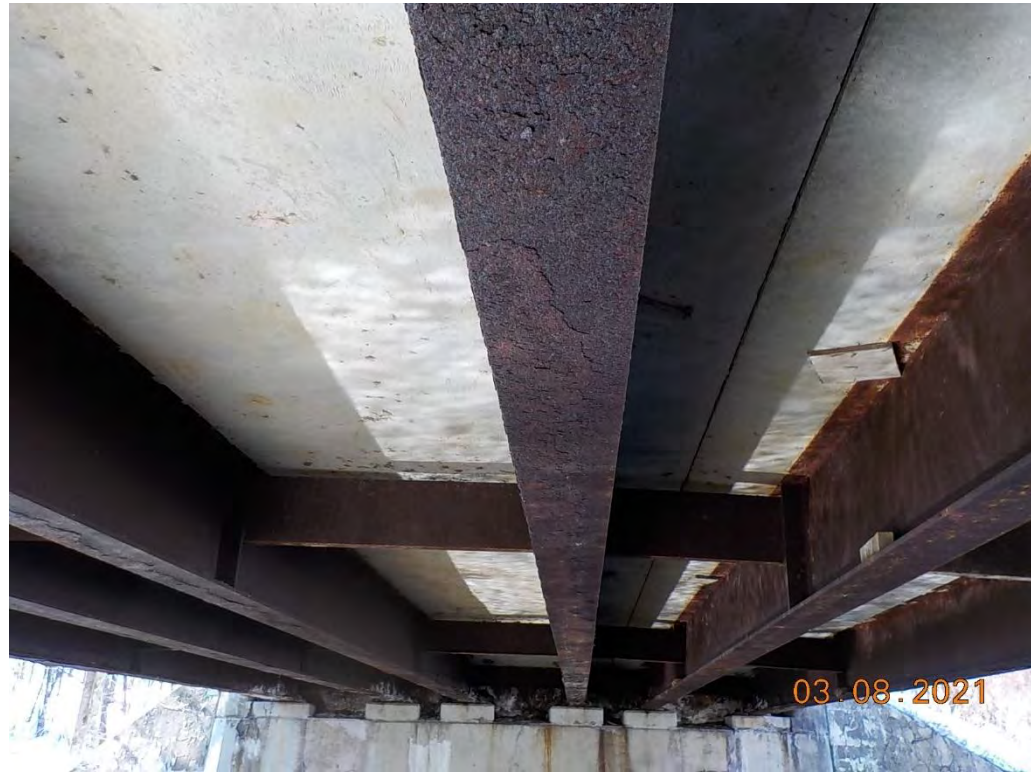
5

Typical
framing
(looking
towards
begin).

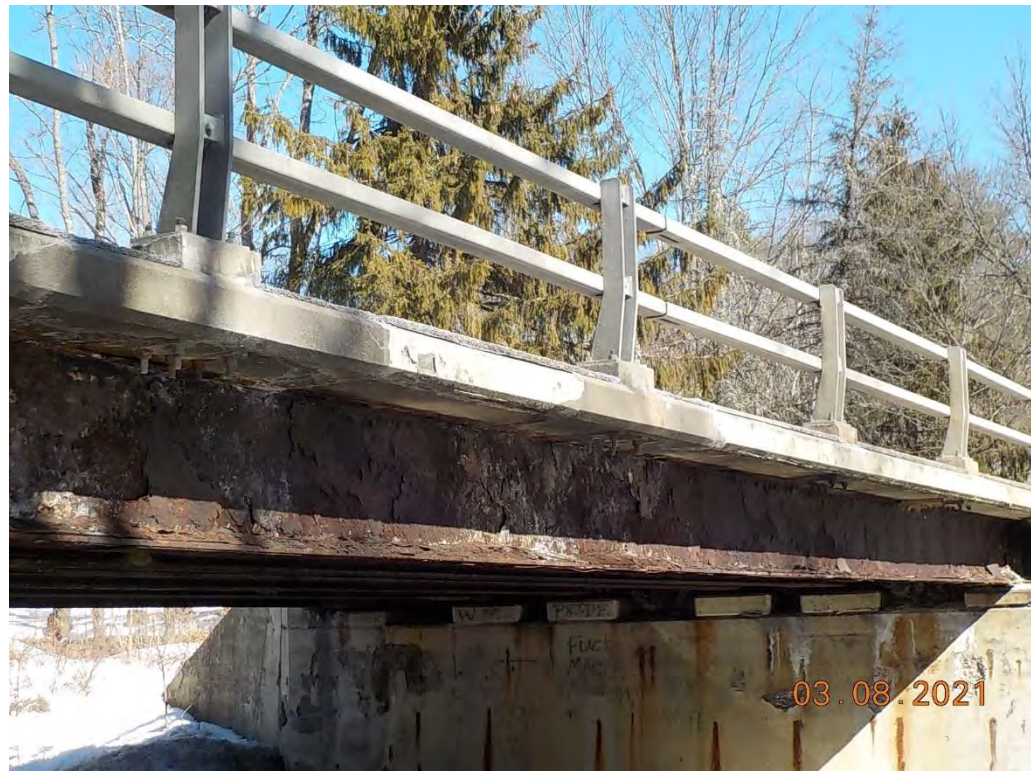
6

The steel
protective
coating of
Girder G6
(looking
towards end
left).

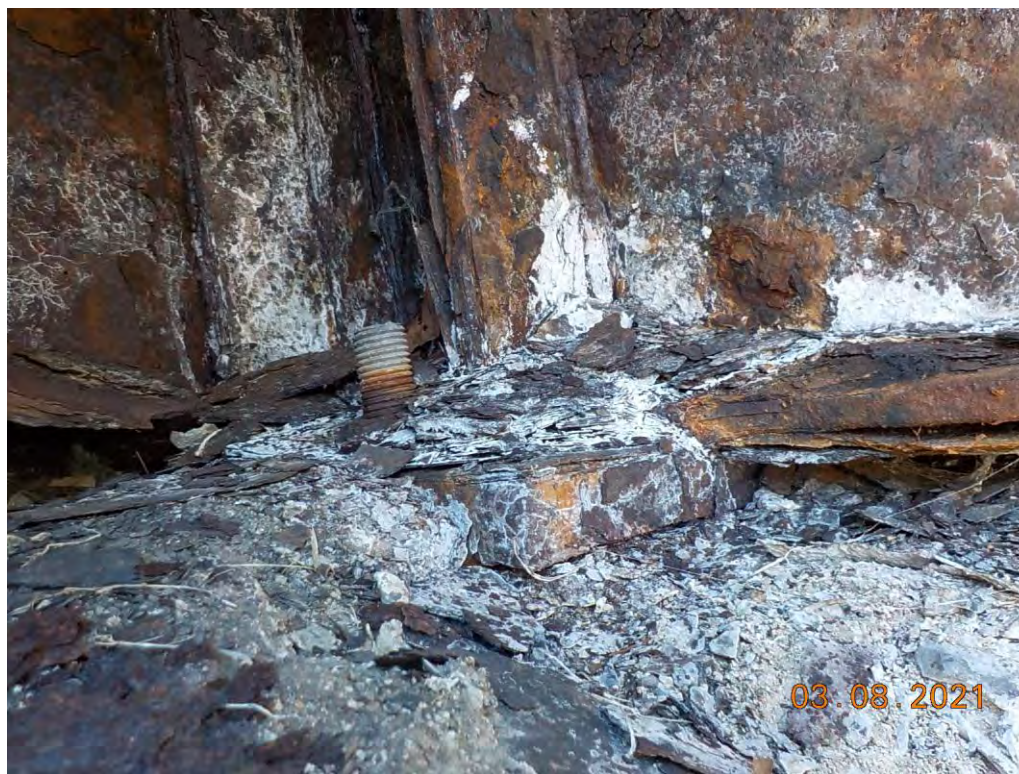
7

- All bearings are rusted with thin delaminations to steel plates and minor section losses (PH 7). Cleaning and lubricating all bearings are recommended.

Girder G1
bearing at end
abutment
(Looking
towards end
right).

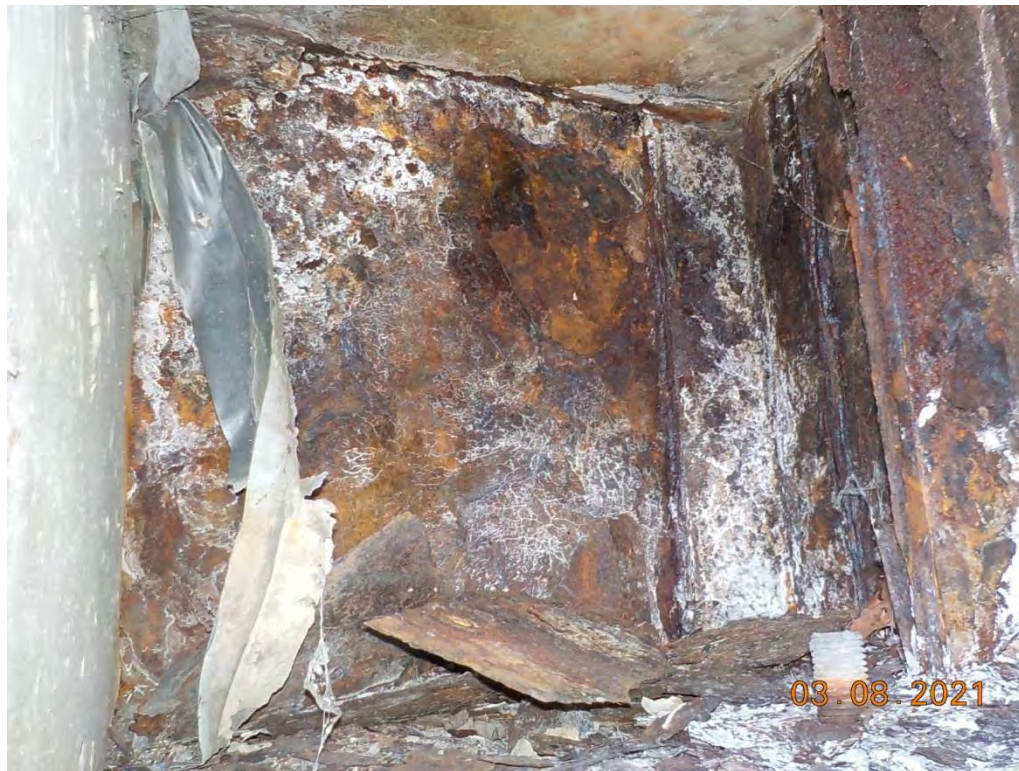
8

- All steel backwalls are rusted with thin delaminations to steel plates and minor section losses (PH 8). Replacing steel backwalls with new concrete backwall to improve drainage over abutment is recommended.

End abutment
backwall at
left fascia, typ.
(looking
towards end
right).

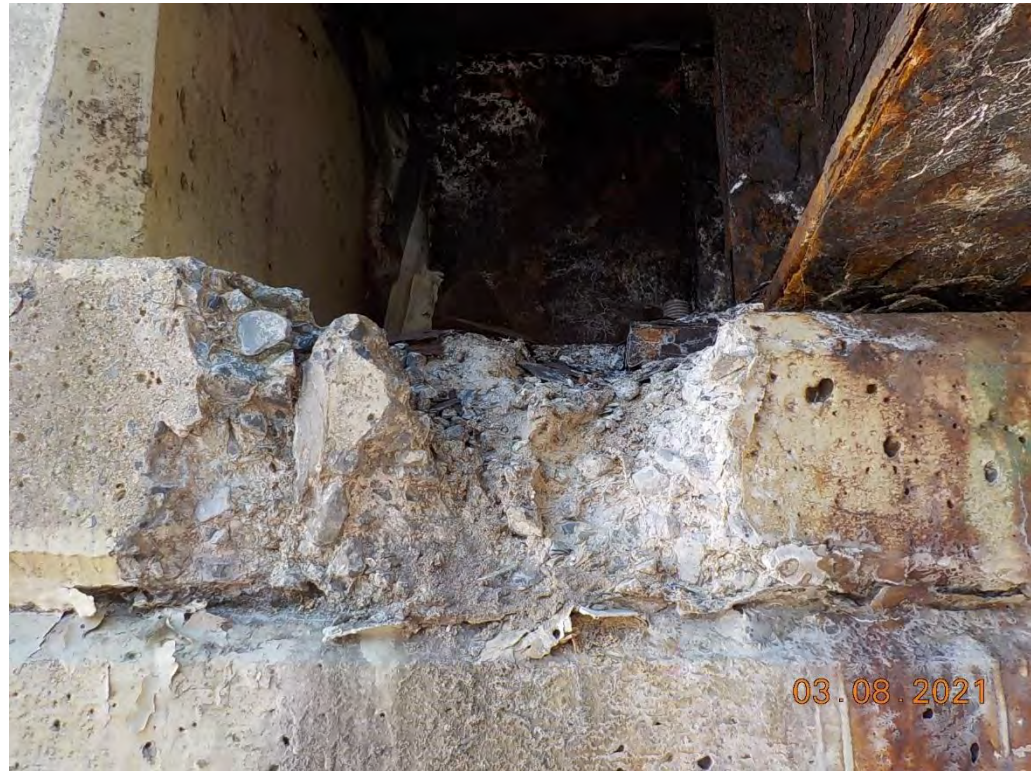
PHOTO NO:
9

- Girders G1 and G6 pedestal at the end abutment exhibit spalls up to 4" deep (PH 9). Concrete repair (Class D) is recommended.
- The streambank adjacent to the end right wingwall exhibits signs of erosion. Adding stone bank protection in this area is recommended (PH 10)

Girder G1
pedestal at
end
abutment, G6
pedestal
similar but
less severe
(Looking
towards end
end).

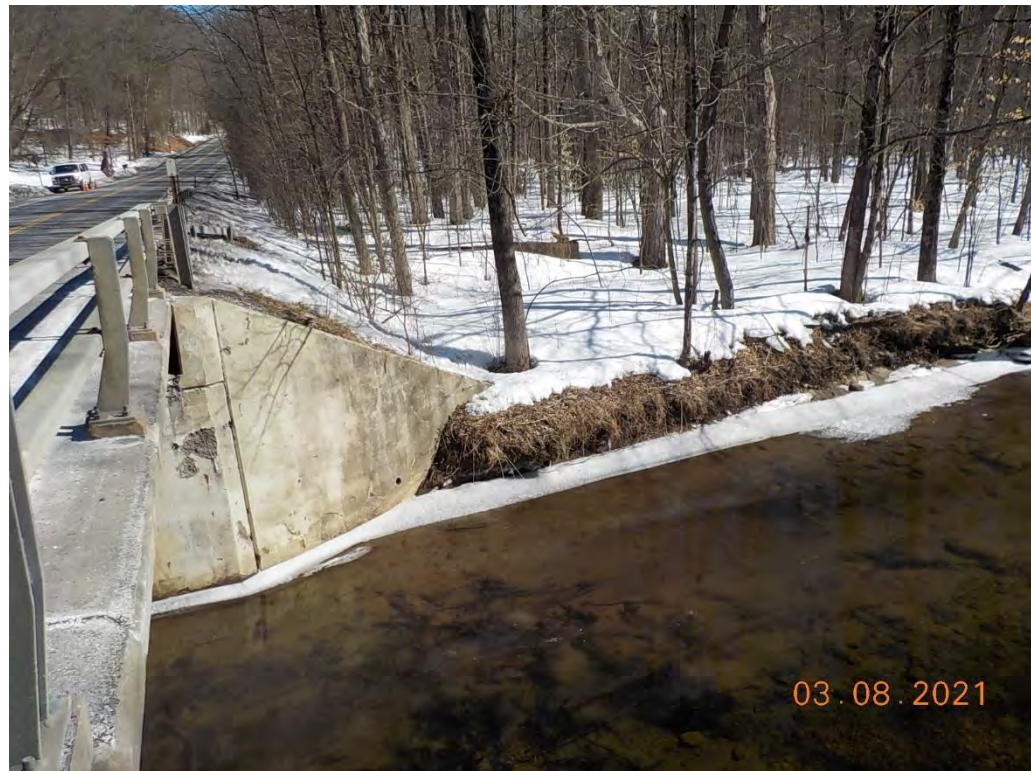
PHOTO NO:
10

End right bank
(Looking
towards end
right).

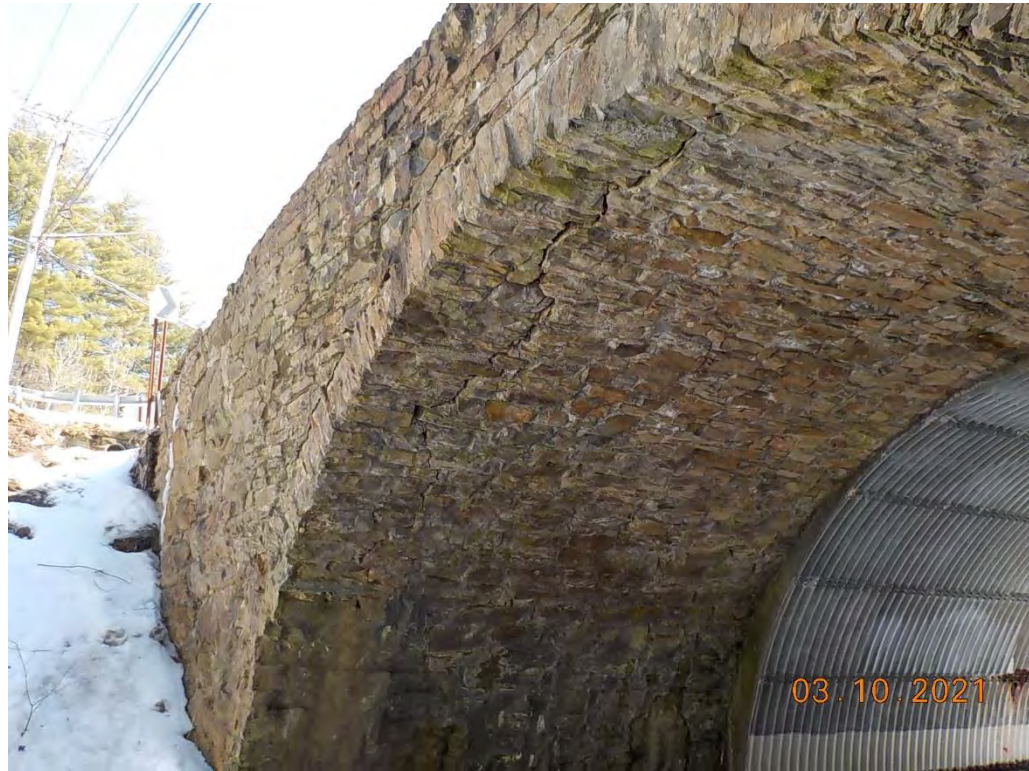
The underside of the stone masonry arch on the left side exhibits longitudinal cracks up to 3" wide along the left fascia (PH 1). There are several small loose stones along the cracks. The left spandrel wall exhibits up to ½" wide crack on the end side (PH 1). These cracks were first reported in the 2006 inspection and are progressively getting wider since then. The spandrel wall also bulges 4" near the end. Active leaking through the left headwall is noticed near the begin and end (PH 2). The capstones are missing along the arch and end left wingwall. Rebuilding/Repairing/Repointing stone masonry arch is recommended.

The left side
of the stone
masonry arch
(Looking
towards end).

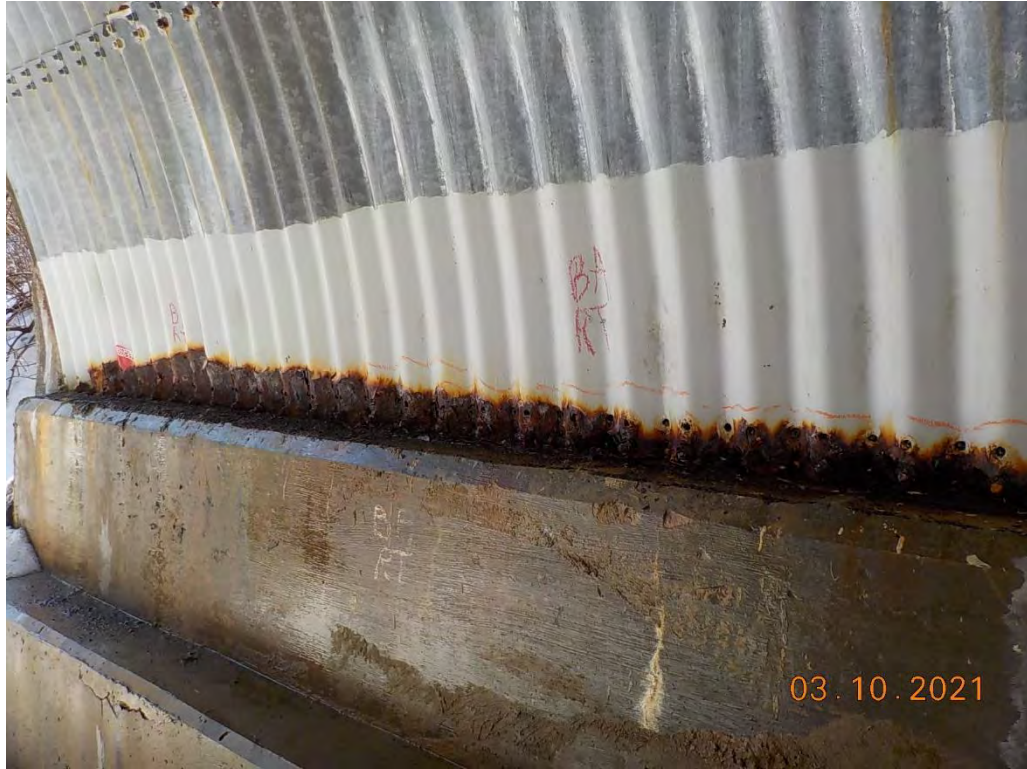
3

The steel arch on the right side exhibits corrosion with perforations along the begin and end footings (PH 3). The worst conditions were observed on the right side. Concrete encasement for the lower 1' of the steel arch is recommended.

The steel arch at the begin, end side is similar (Looking towards begin right).

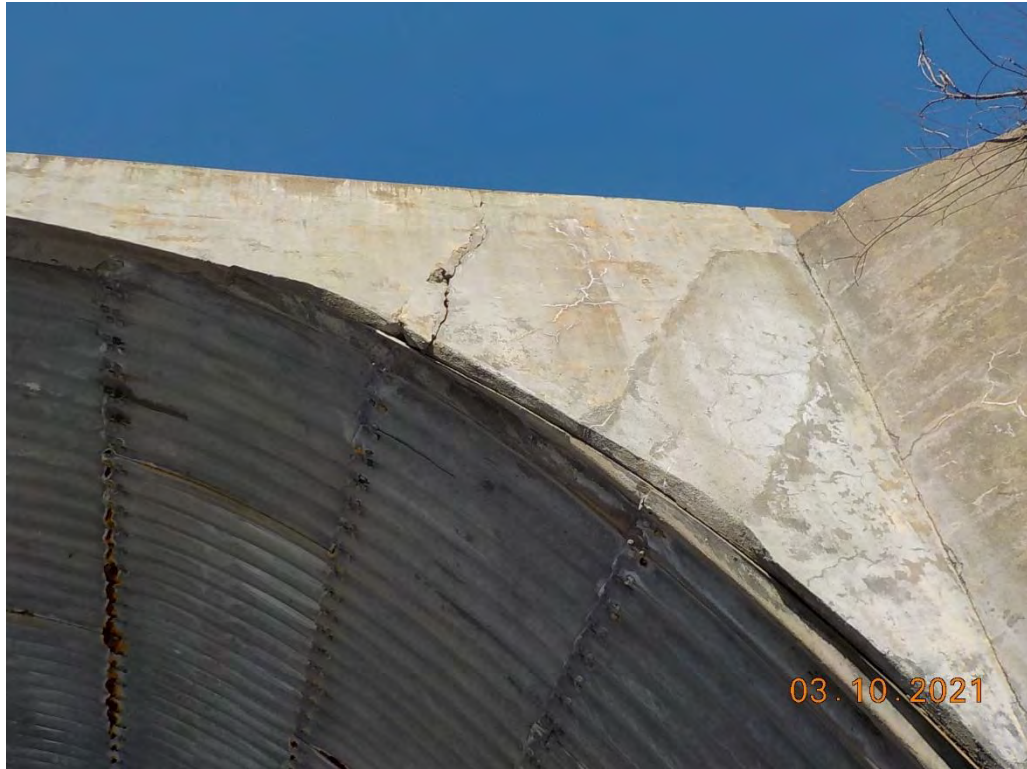
4

- The right concrete headwall near the end exhibits up to 1/8" wide diagonal cracks (PH 4). Class D concrete repair of the right headwall is recommended.
- The begin scour apron exhibit cracks and spalls near the left side (PH 5). Class D concrete repair of the begin scour apron is recommended.
- The begin right, end left and end right streambanks exhibit signs of erosion. The existing stone protection is displaced. The begin left wingwall is undermined due to erosion. Adding stone bank protection in these areas is recommended (PH 6)

The right concrete headwall near end abutment (looking towards left).

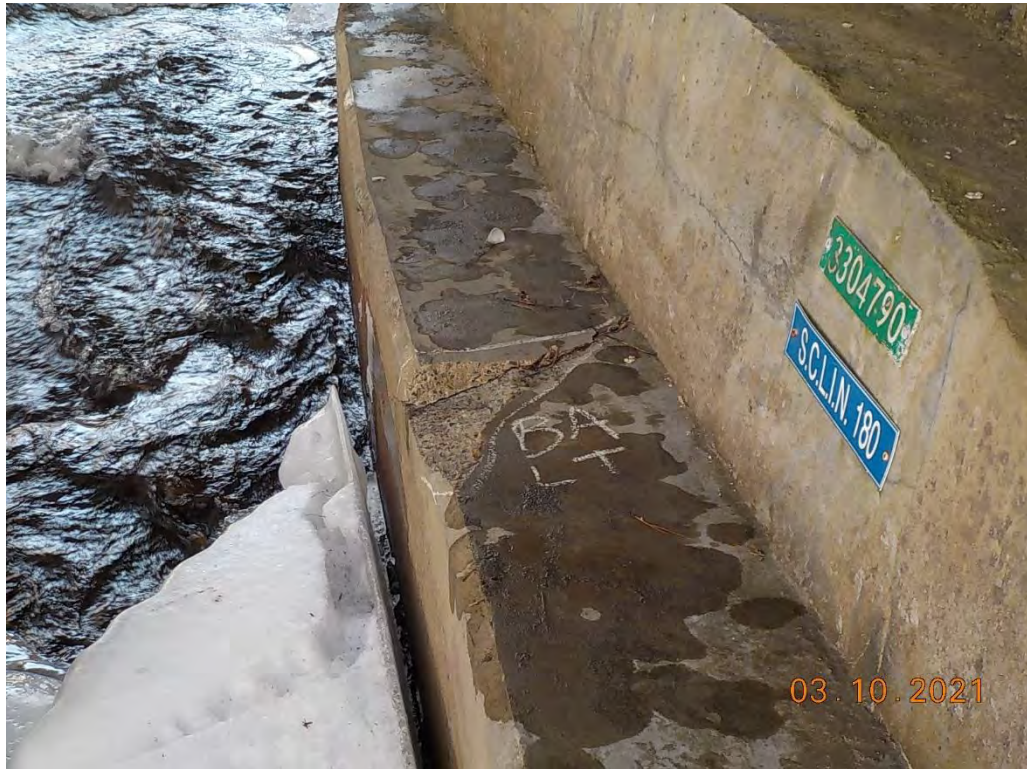
5

The concrete apron of the begin footing (Looking towards right).

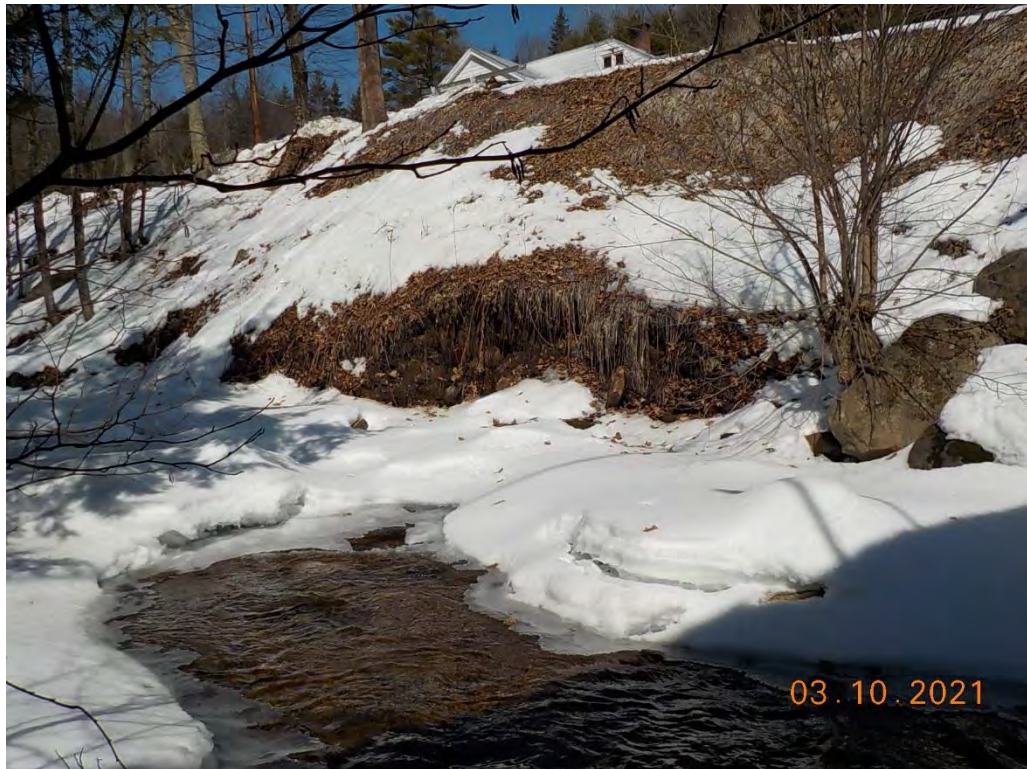
6

The end left streambank (Looking towards end left).

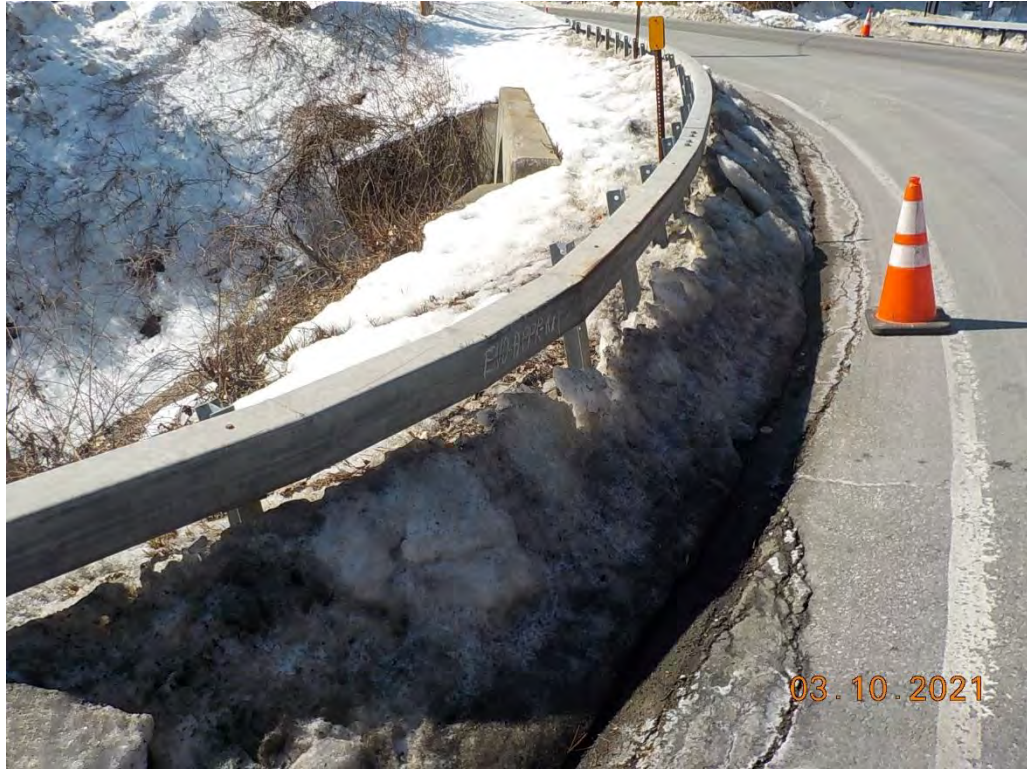
7

- The end left and end right guide railings exhibit impact damages (PH 7). Many of the left and right deck railing posts are not connected and leaning away. Replacement of the guide railing is recommended.
- The approach and deck wearing surface exhibits up to 1/8" wide cracks for approximately 40% of area. Replacing the wearing surface is recommended (PH 8).

The end right approach guide railing (looking towards begin left).

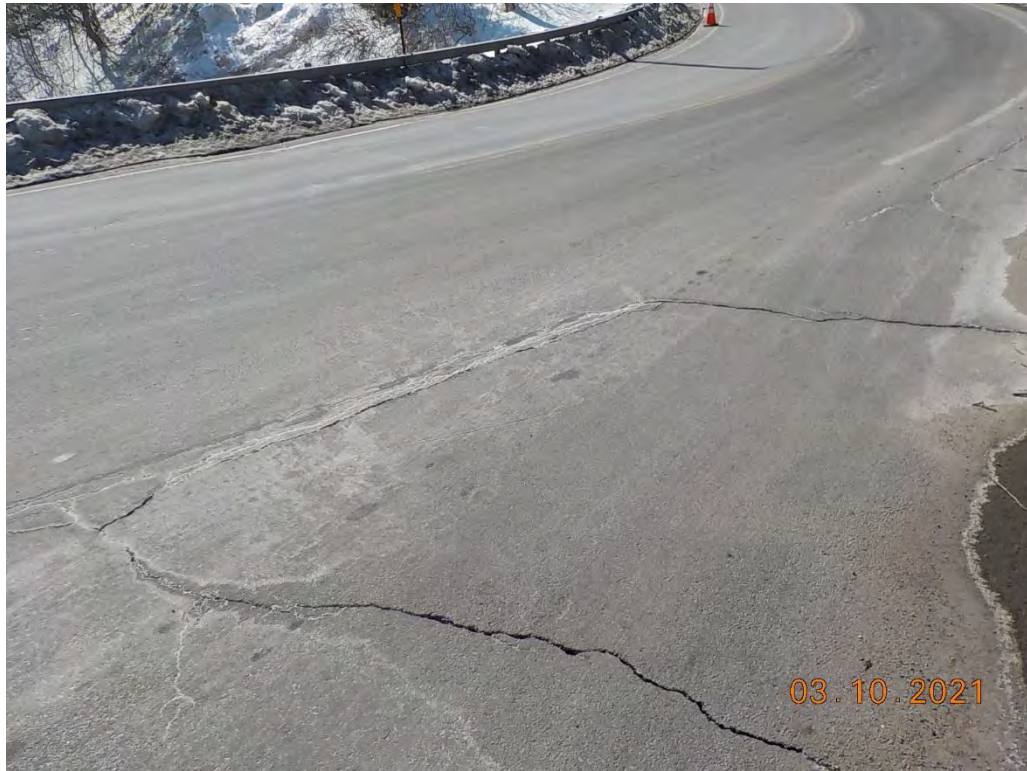
8

The deck wearing surface (Looking towards begin right).

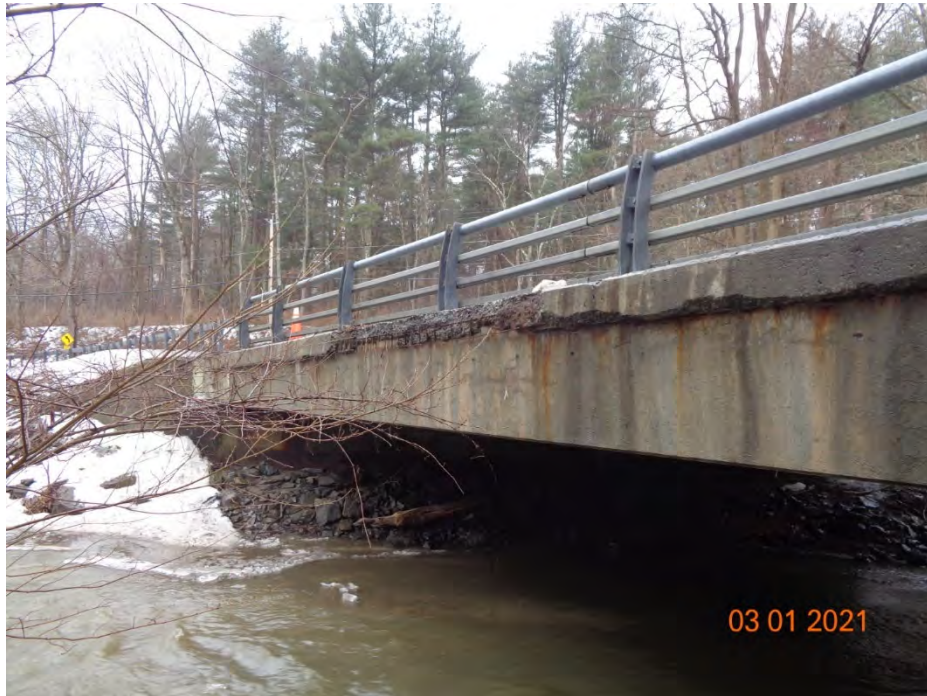
Preliminary Recommendations: Repair concrete deck overhangs and fascias (PH 1), scour repairs, armor stream banks (PH 2), repair 2 pedestals (PH 3)

Looking
Towards Begin
Along Left
Fascia (Right
Fascia Similar
But Less
Severe)

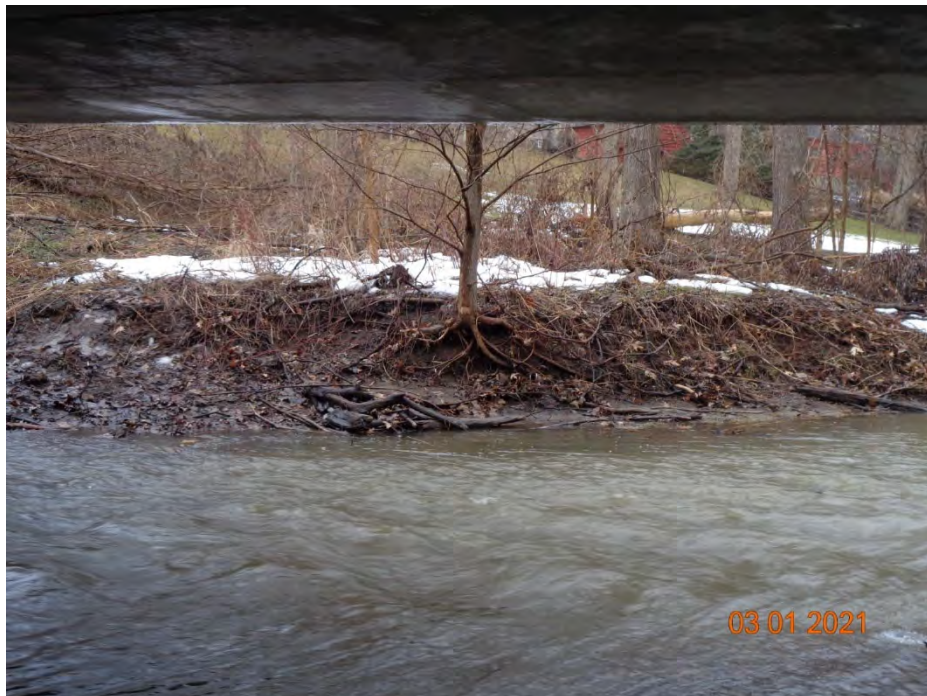
2

Looking at End
Right Stream
Bank (Other
Locations
Similar)
