BRIDGE PRESERVATION REPORT

Identification of Bridge Preservation Candidates, Treatments, and Costs for Locally Owned Capital District Bridges

August 2021

Capital District
Transportation
Committee

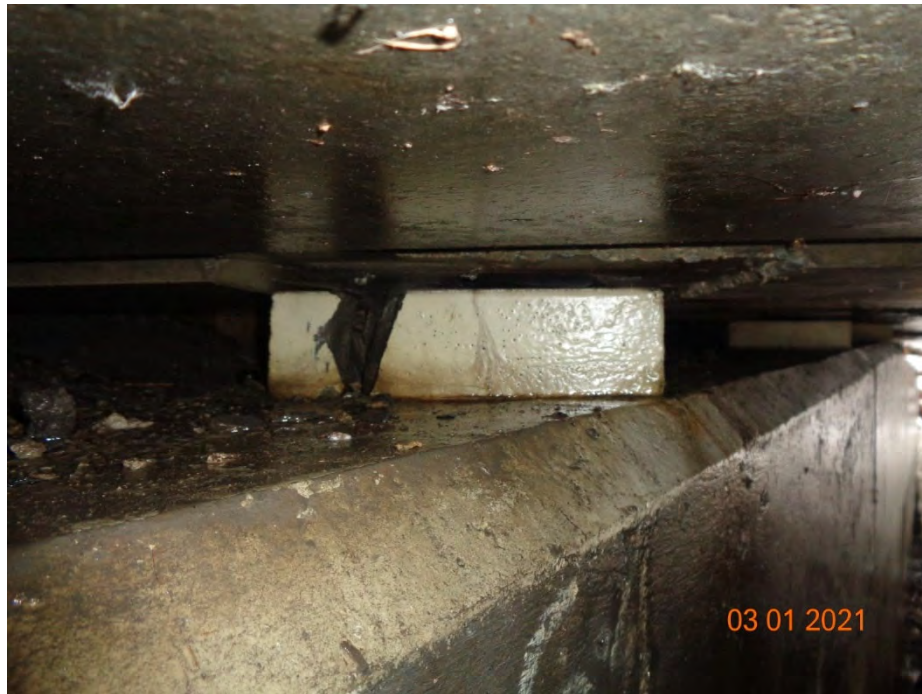
Preliminary Recommendations: Repair concrete deck overhangs and fascias (PH 1), scour repairs, armor stream banks (PH 2), repair 2 pedestals (PH 3)

PHOTO NO:
3**DESCRIPTION:**
Looking
Towards Left
at Right Face
of Girder G4
Pedestal
(Girder G9
Pedestal
Similar)
